"Faulty model": iPad MINI5

"Failure phenomenon": no battery data

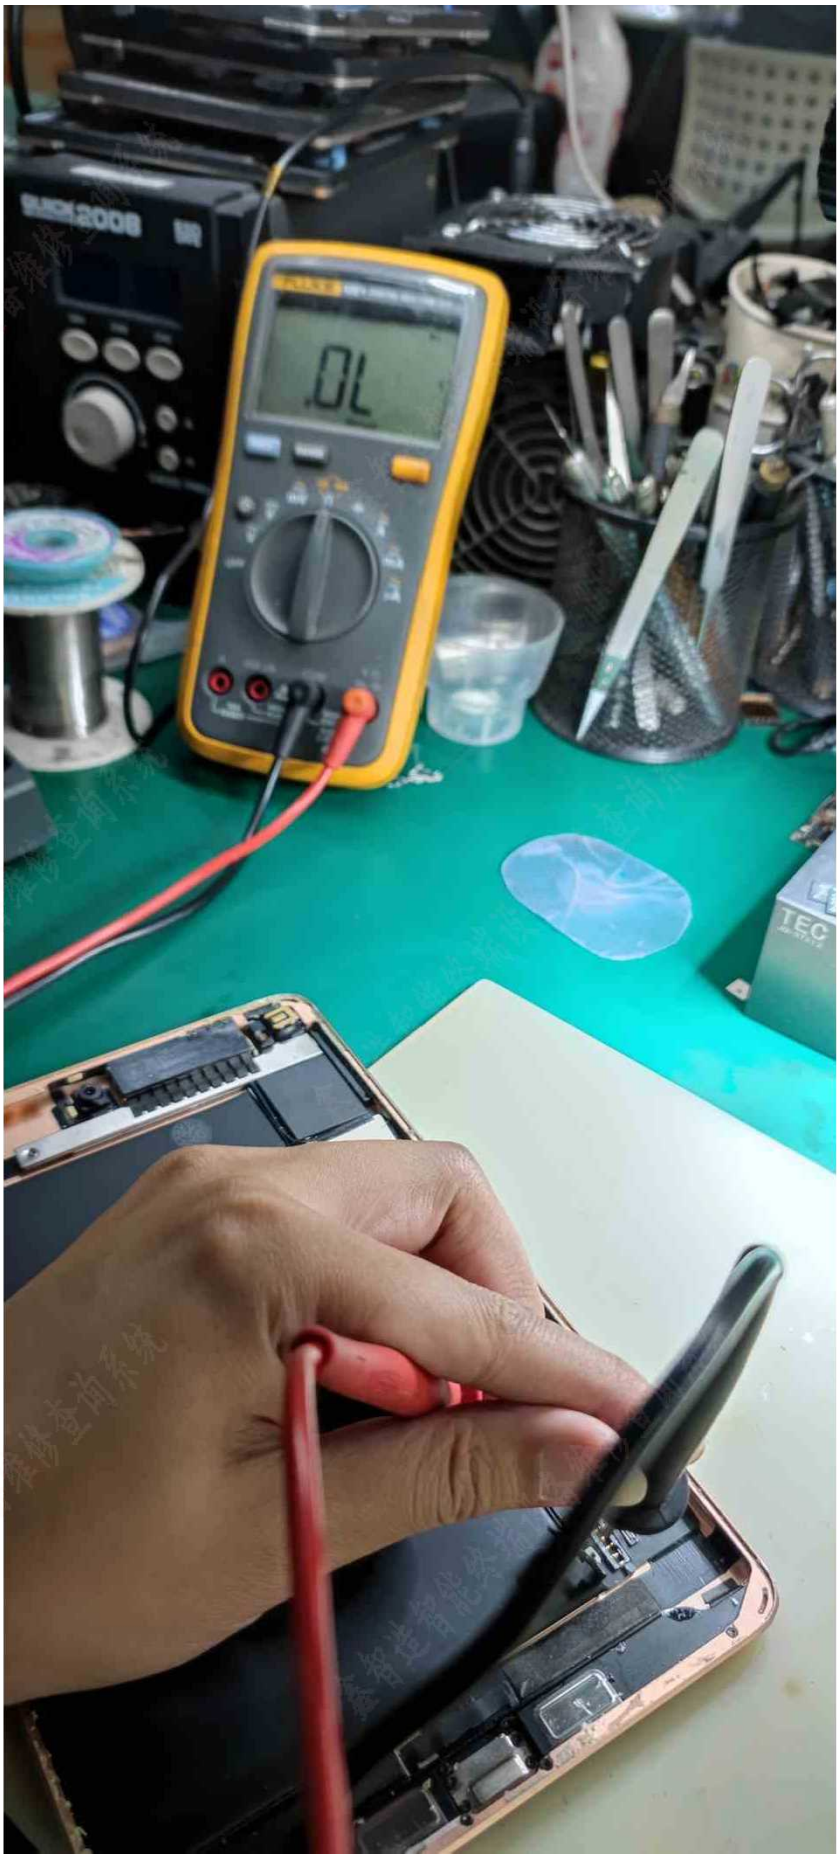
According to the description, it appeared after the screen was replaced, so it is assumed that it was caused during disassembly and assembly. Disassembling the flat plate and measuring the battery socket, it was found that the battery data detection foot position was infinite to the ground, which seemed to be disconnected.

OL

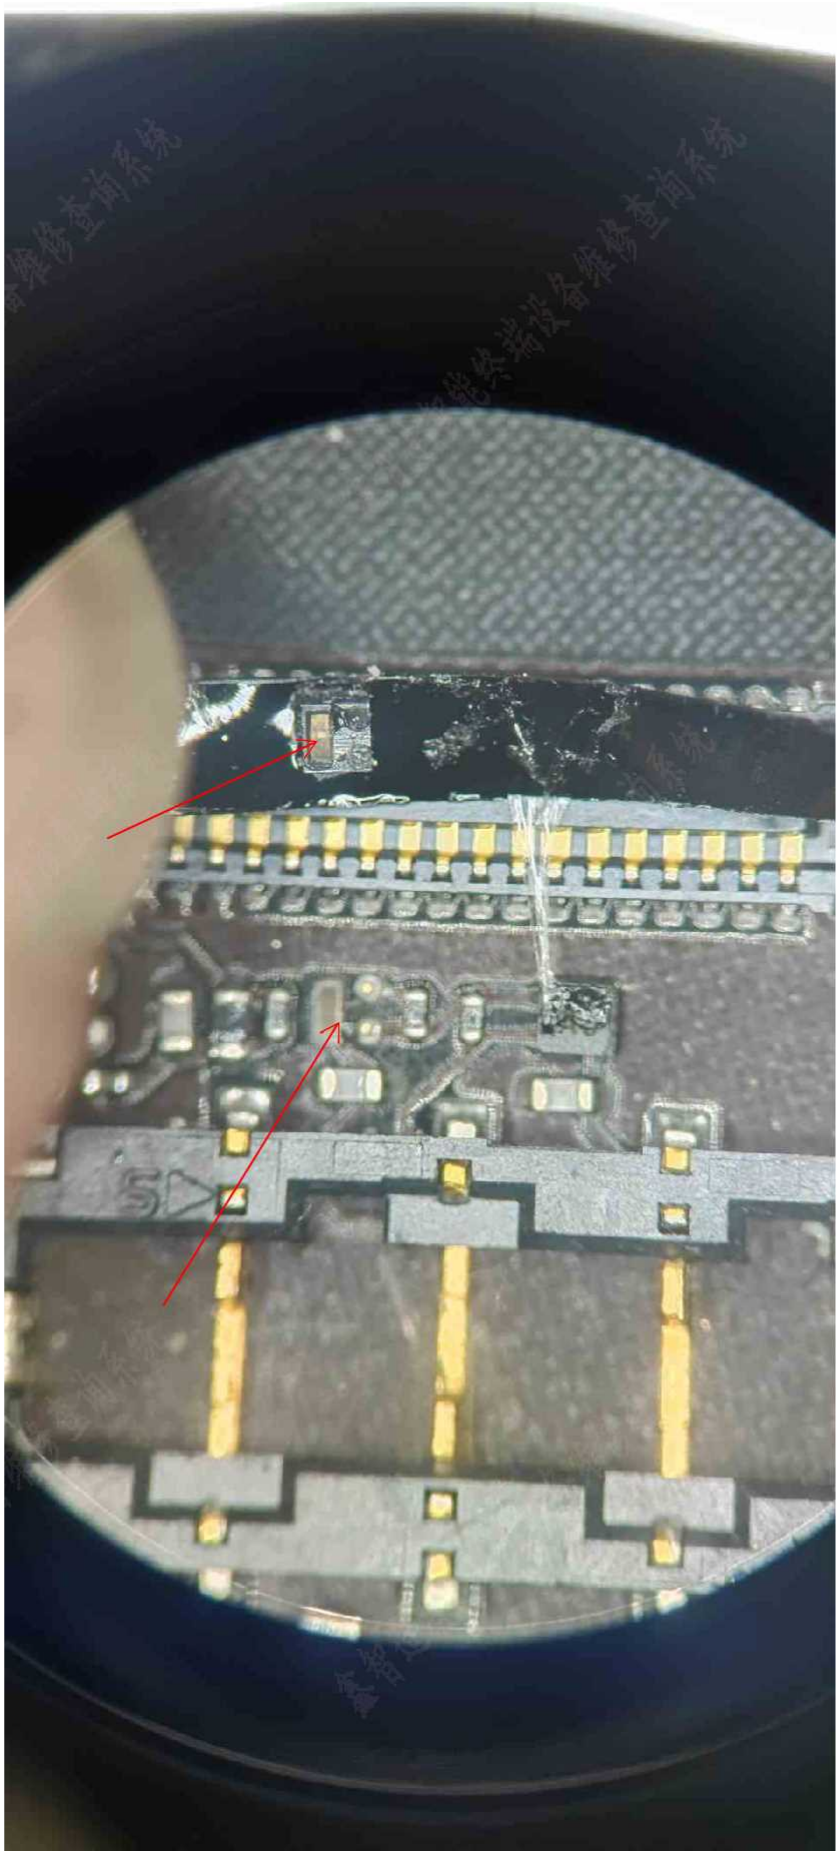
Microscopically, it was found that Q8900 tube had fallen off.

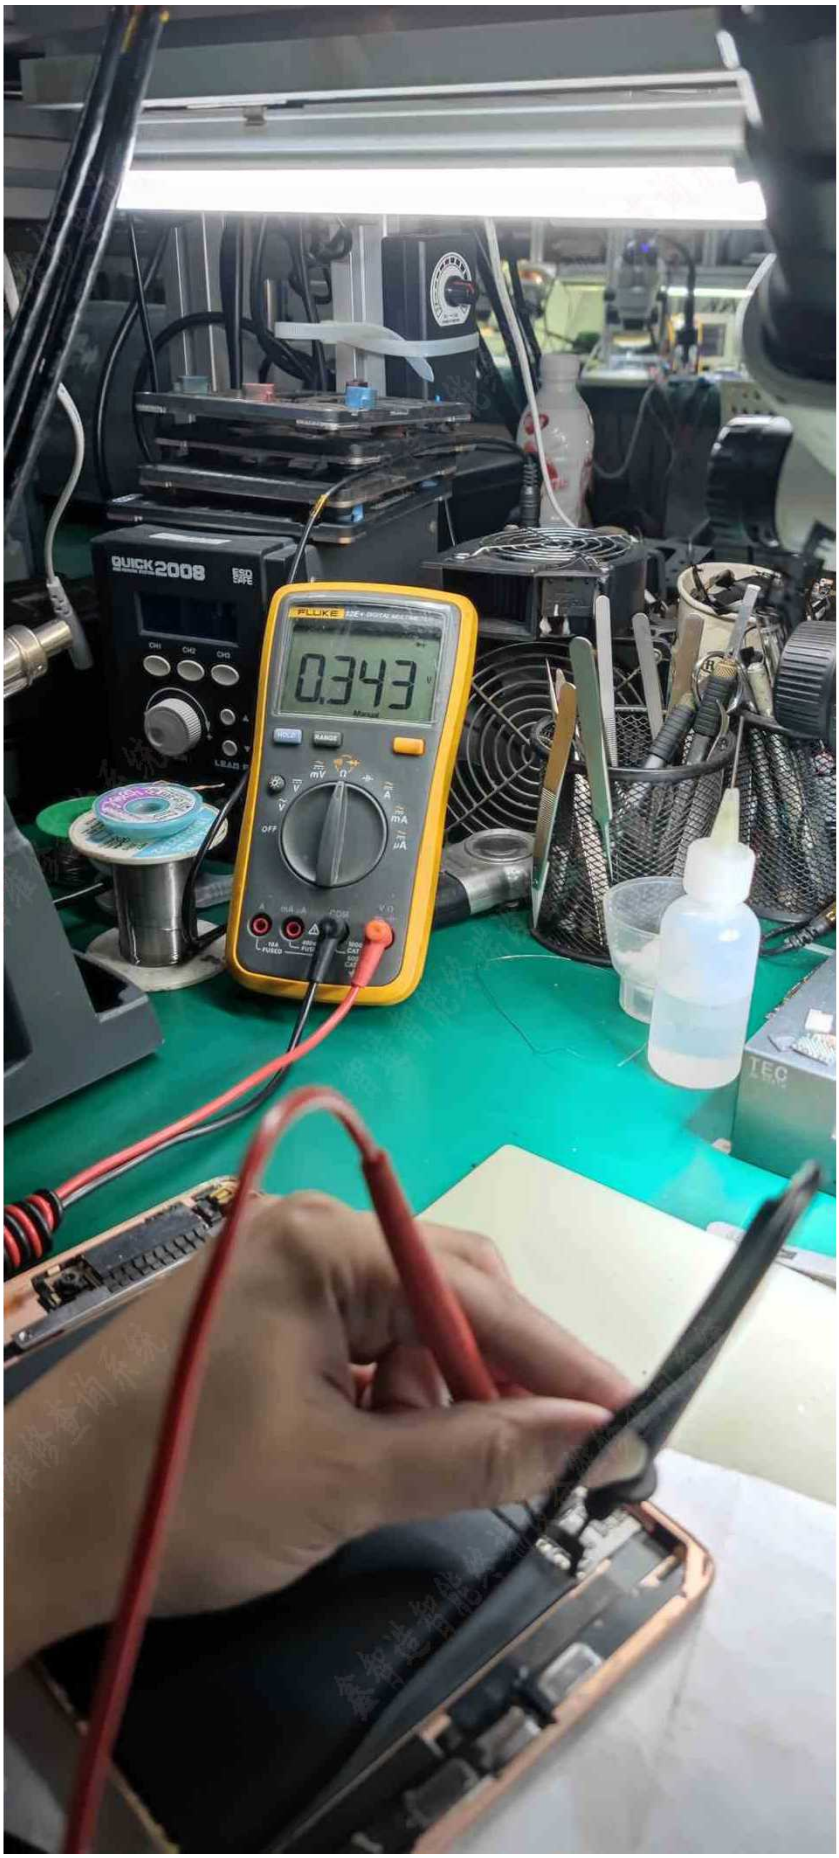
The resistance to ground measured by multimeter returns to normal.

QUICK 2008
FLUKE
0.343
HOLD
RANGE
OFF
