[Failed models] iPad5 2017

[Failure Phenomenon] Customer description is not on, hot on

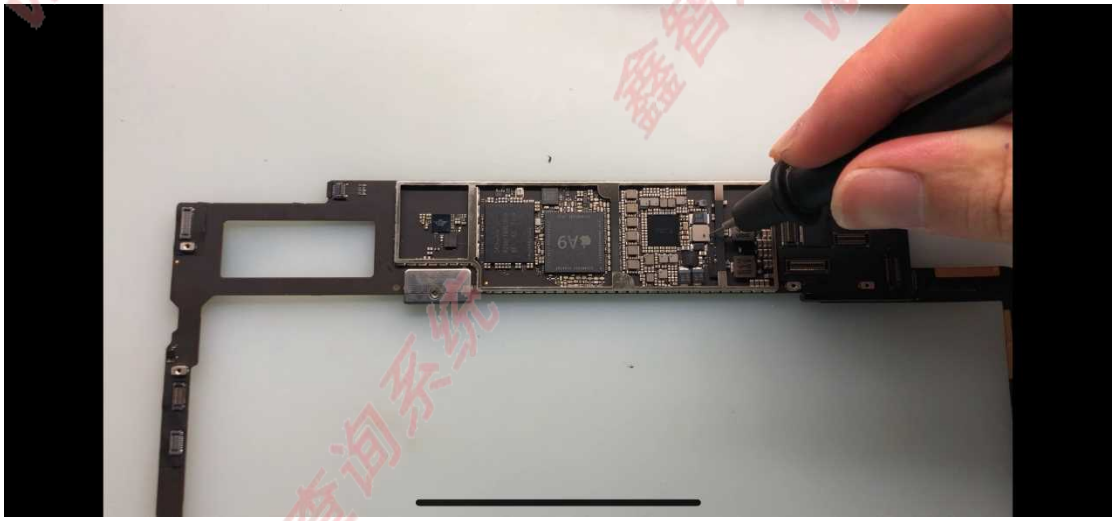
Leakage 559ma.Remove the radiator cover to measure the second short circuit as shown in Fig.

As shown in the figure above, the secondary system is almost completely ground-to-ground. Observed under a magnifying microscope as shown in the figure below:

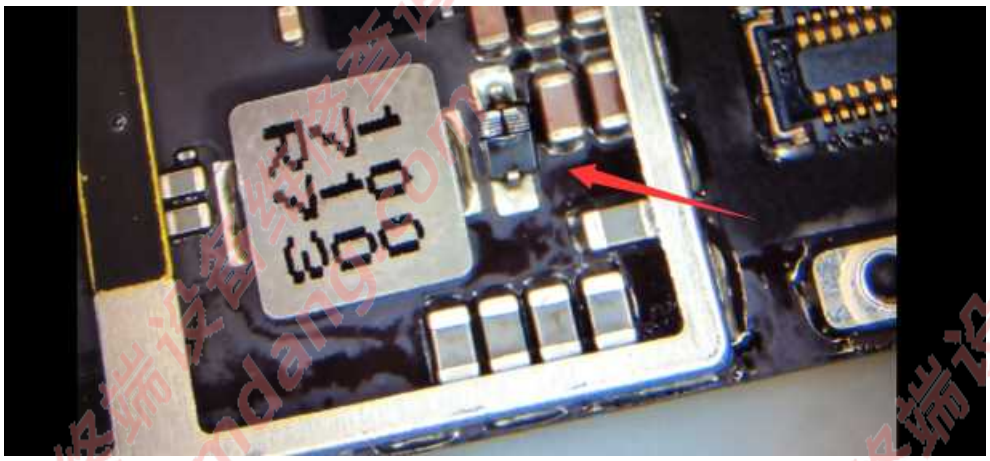
Backlight rectifier diode has been found to be damaged by breakdown. The common reason for this failure in iPhone is that short circuit of filter capacitor causes instantaneous enlargement of current and breakdown of diode. Remove the damaged secondary tube and find the short circuit capacitance as shown in Fig.

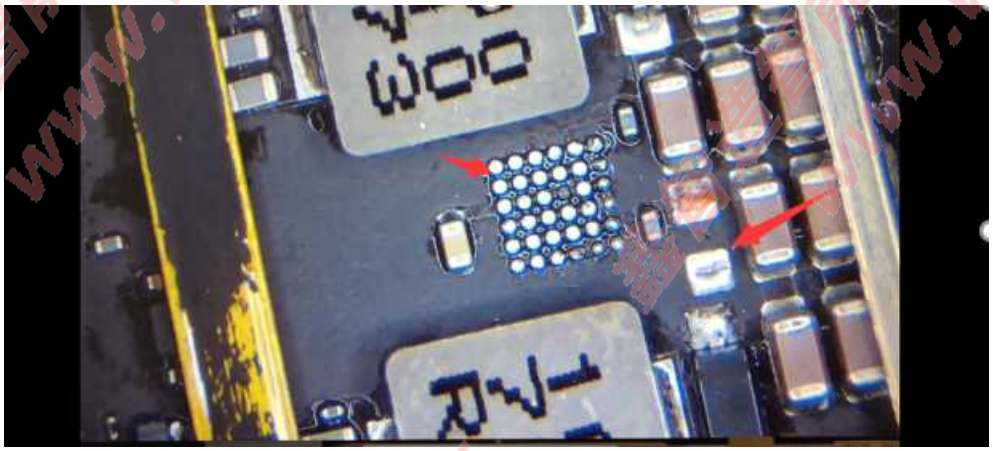
At this time, the backlight IC is also damaged. Remove the second break to the ground secondary system and return to normal as shown in the following figure:

Chip model is 5662 lamp-controlled ic, no such chips in hand need to be ordered, repair to the end of the failure found
