faulty model]: iPad air2

[fault phenomenon]: no charging

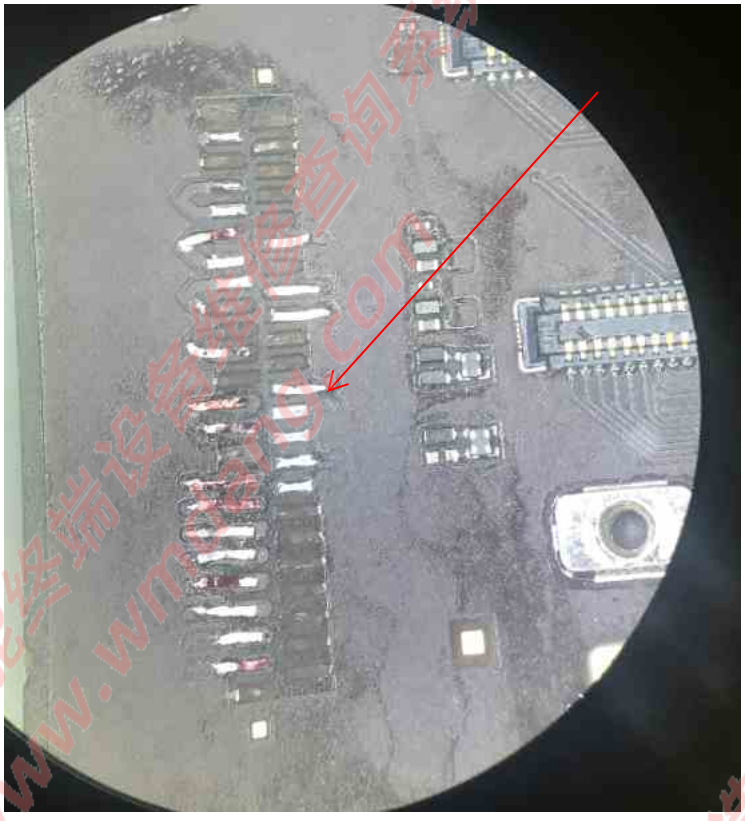
It looks like when removing the tail patch cord, it is hard to remove it before the temperature reaches, causing the solder pad to fall off. It’s just a matter of scraping off the flying wire to make up the spot.

Just fly a few ground wires, and then solidify them with green oil.
