[machine model]: ipad3

[Fault phenomenon]: no charging

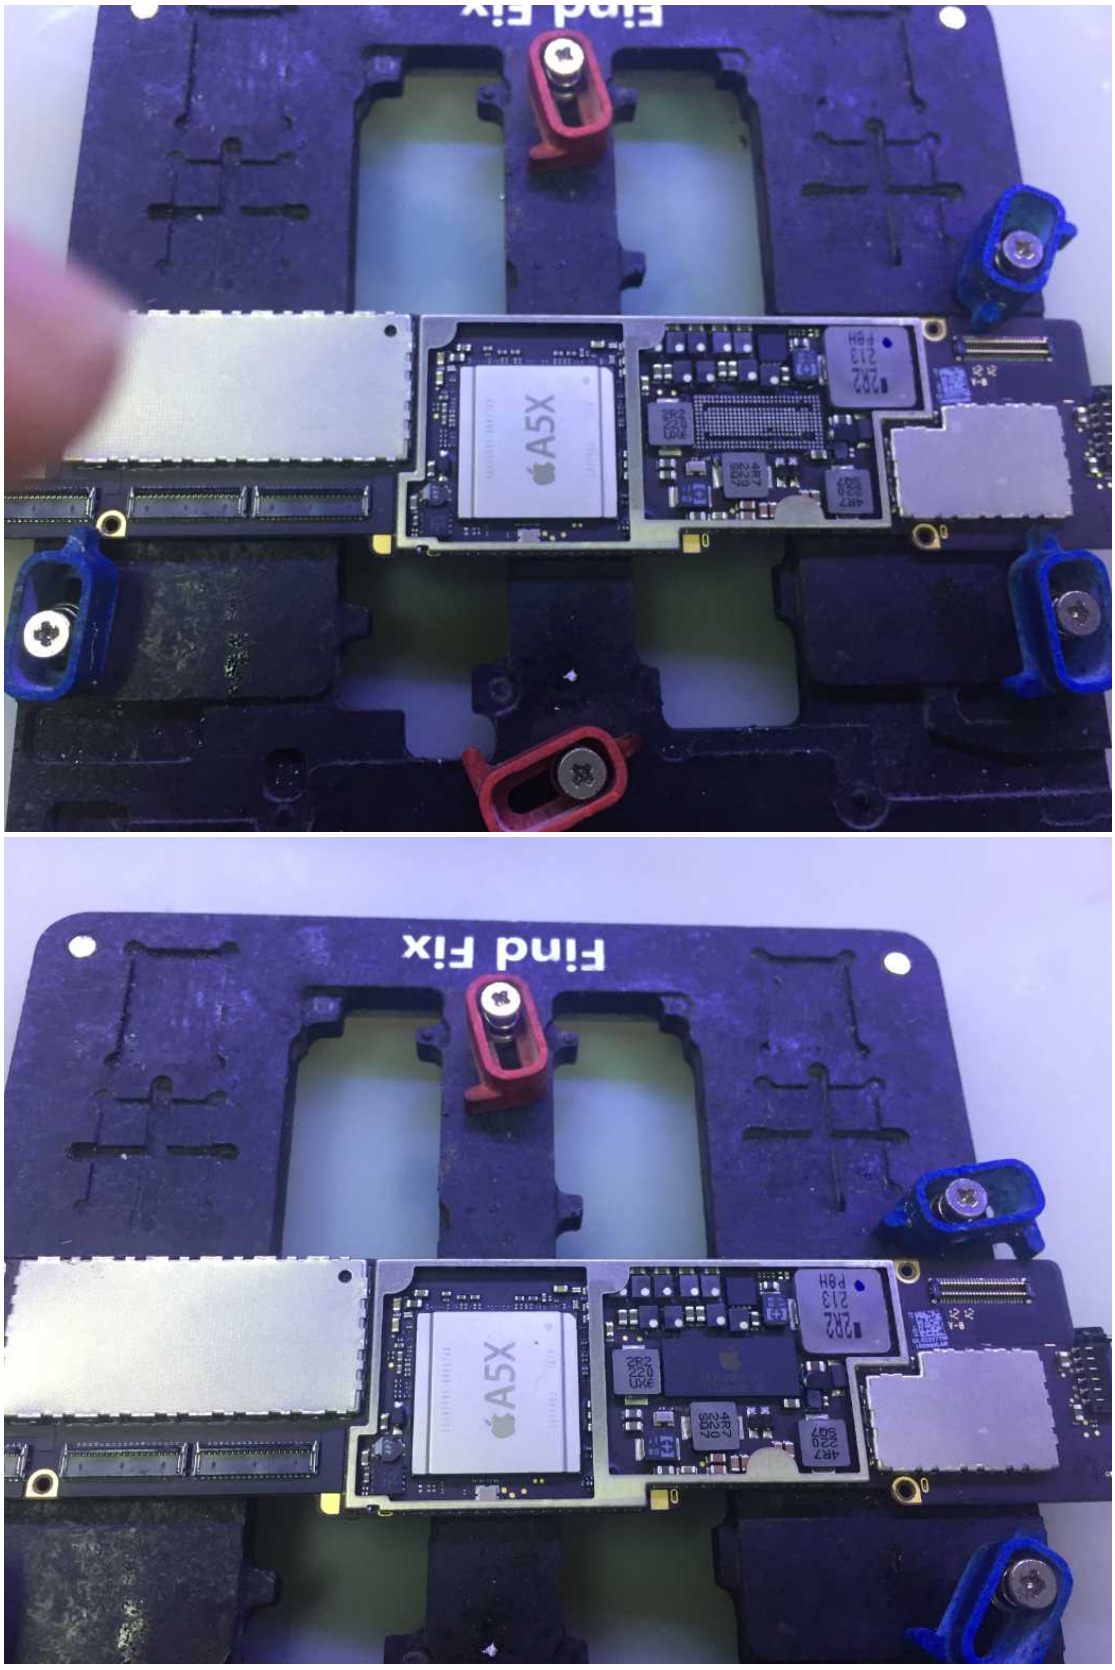
Disassemble, watch the board is no different, view the circuit diagram, the charger goes through the data line, through the J5900charging connector through the L5757Inductor and then through the Q8123 field tube to input to the power supply, ipad3 is no USB management chip, directly power chip management, measured Q8123 The 123 pin of the field tube can measure 5V, which seems to be a problem inside the power chip.Directly replace the power chip U8100.

Remove the power chip, remove the tin, remove the glue, replace the chip

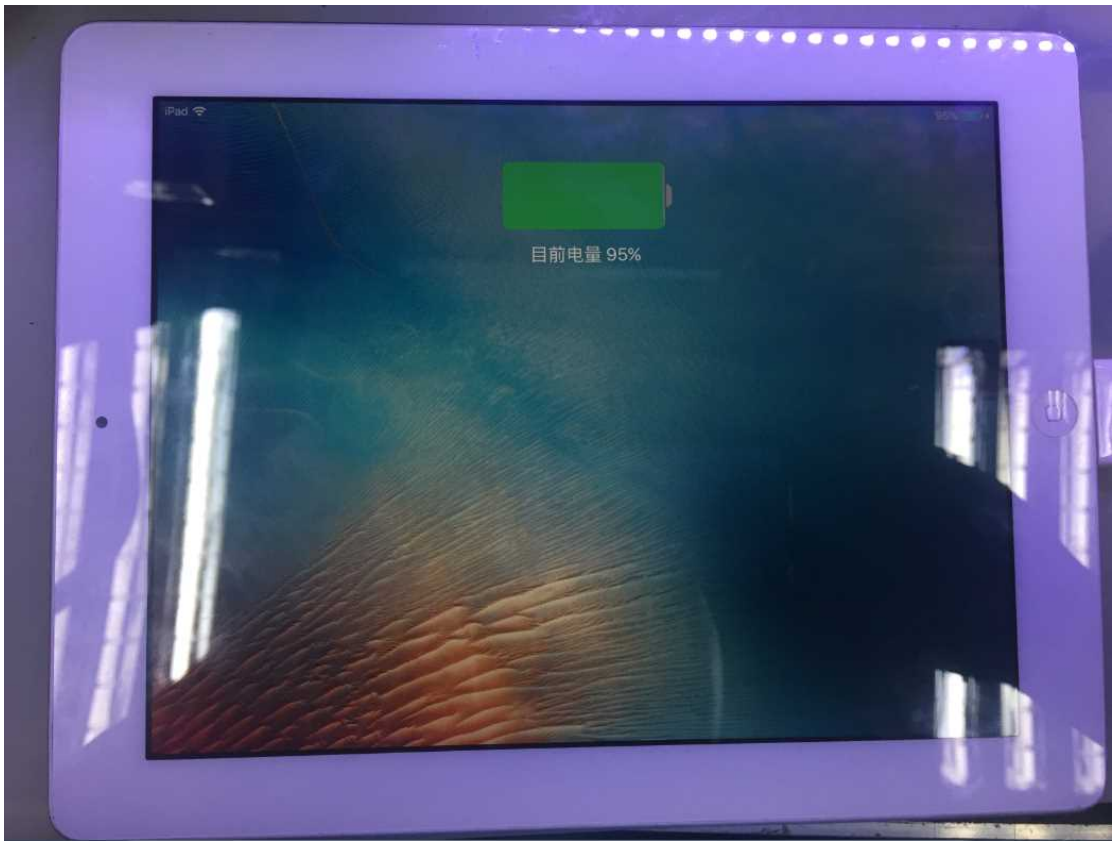
On the machine test, charging is normal, the repair is over!
