[Faulty model] iPad 3

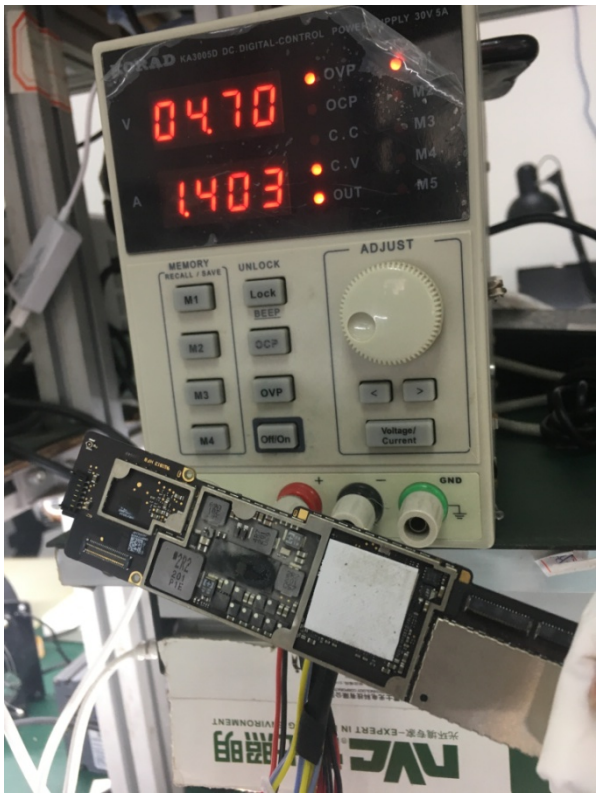
[Fault phenomenon] Customer description No Power ON screen is not displayed, the plug charger does not respond.

[Maintenance process] Disassemble the equipment and connect the current meter to the high current meter.

The motherboard power chip position is smoked on the Colophony (Solder) and the power ic is damaged. Use a heat gun to remove the power and handle the vinyl on the bottom of the solder pad. Install a new power supply ic press the power button to trigger a normal boot.
