Trouble model: iPad5

Symptom: No power is turned off when the screen is replaced.

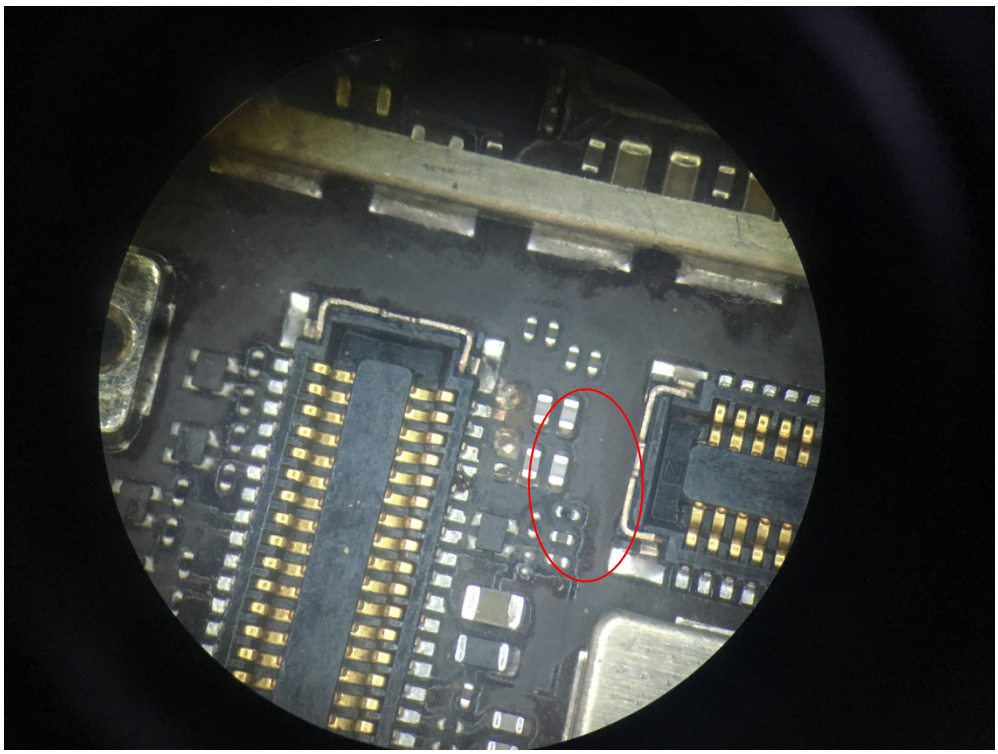
Fault Analysis: This machine is not disconnected from the battery when the LCD(LED) panel in screen is replaced by the VCC, causing the boot to not respond and not displayed.Disassemble the machine under the microscope as shown

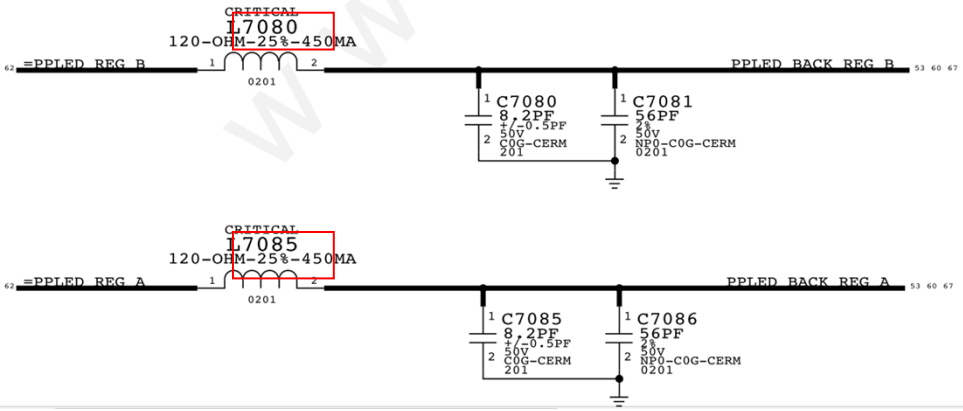
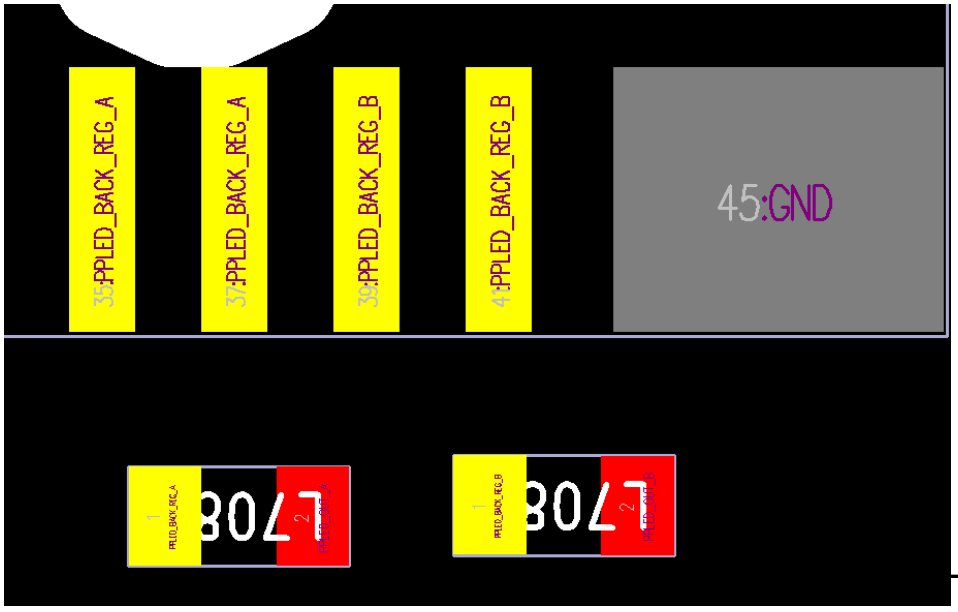
Already even solder pad is gone, check Boardview found that it is backlight VCC Inductor.

The Inductor can be directly connected. Since the solder pad is gone, the line that can see the via can only find the trace down, and the insulated paint (green oil) is fixed.

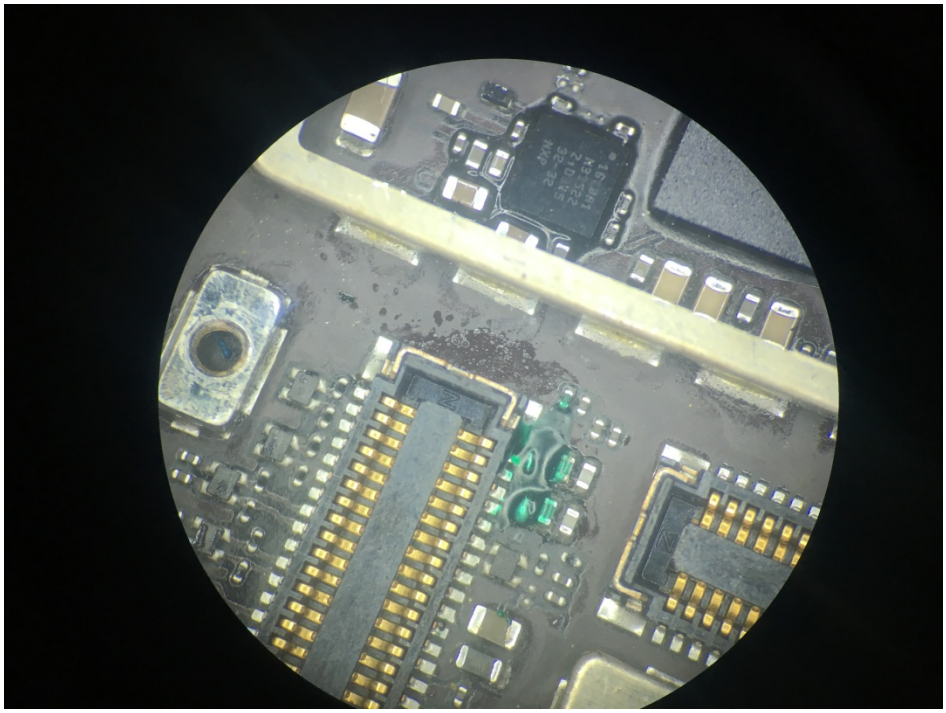
The machine is turned on normally.
