Twisted Ipad5 repair

8th mobile phone manual class deputy squad leader Zheng Yaochao

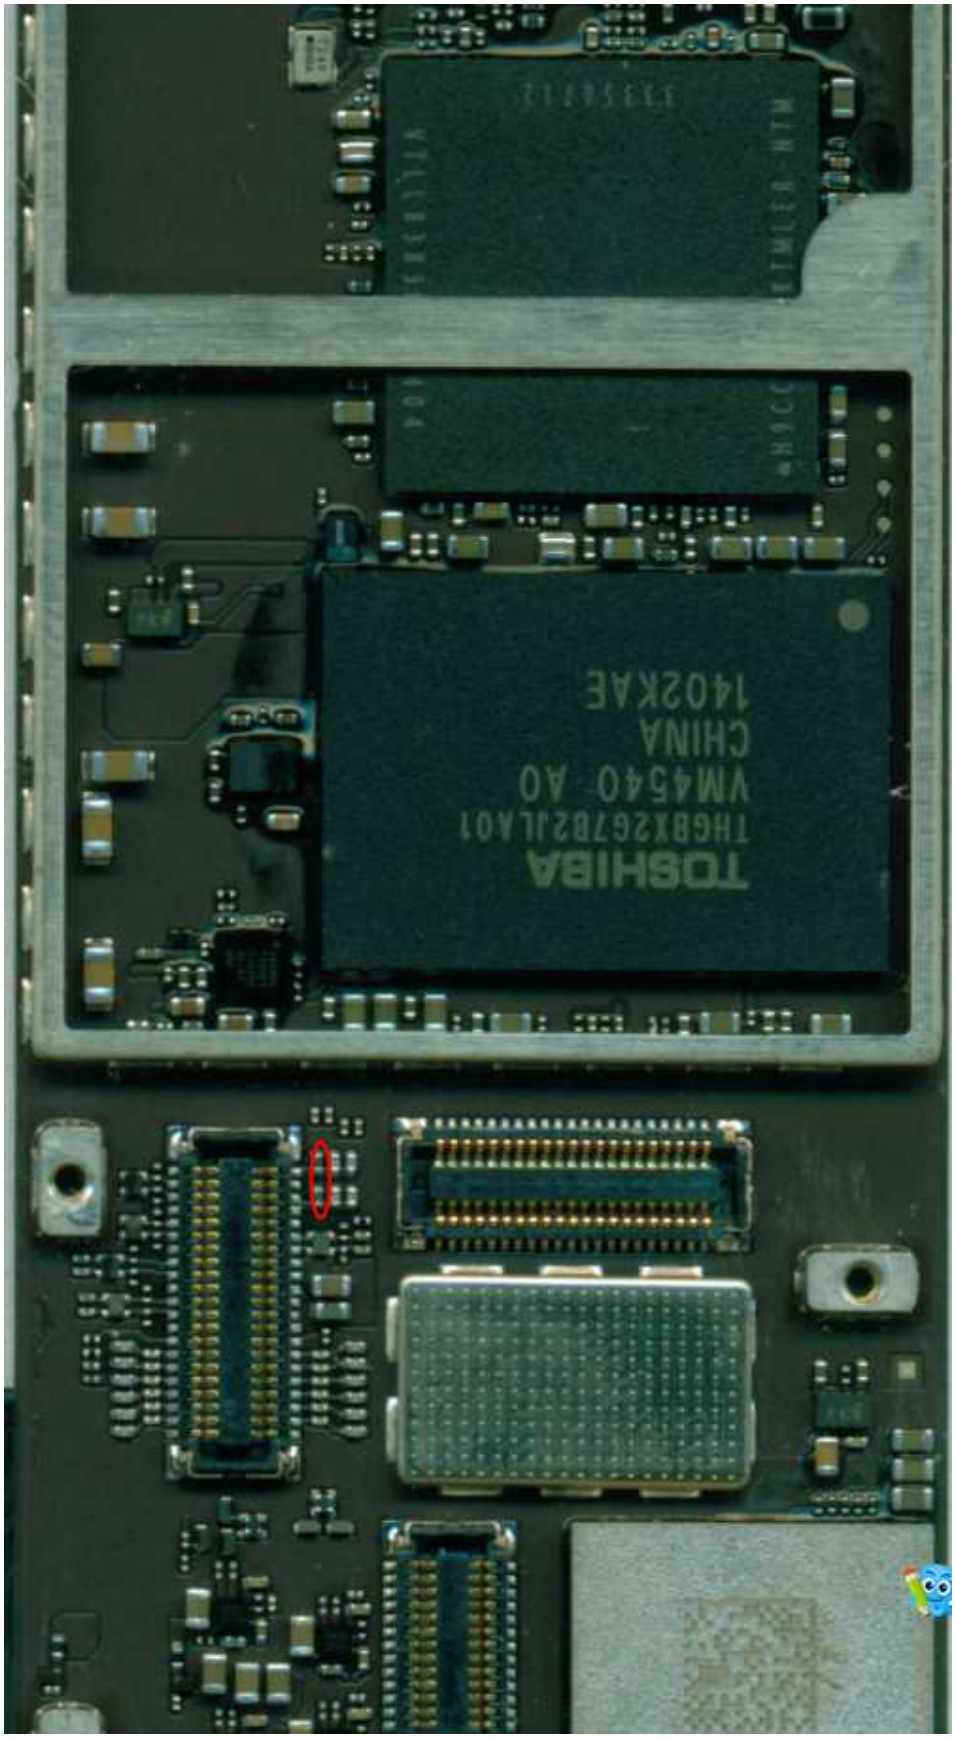
It shows that the connector has been deducted, and the display cable connector is also buckled, and the Inductor is obviously burnt.Compared with the IPAD5connector released by the cake, the boost Inductor has been opened and the other end is normal.The connector is displayed from a certain treasure, and the display cable connector is displayed. After installation, the customer is shown that the LCD(LED) panel in screen backlight is on and the screen is not displayed.The initial judgment screen is bad.Also from a certain treasure to order LCD(LED) panel in screen, it is two days passed, the screen arrived.

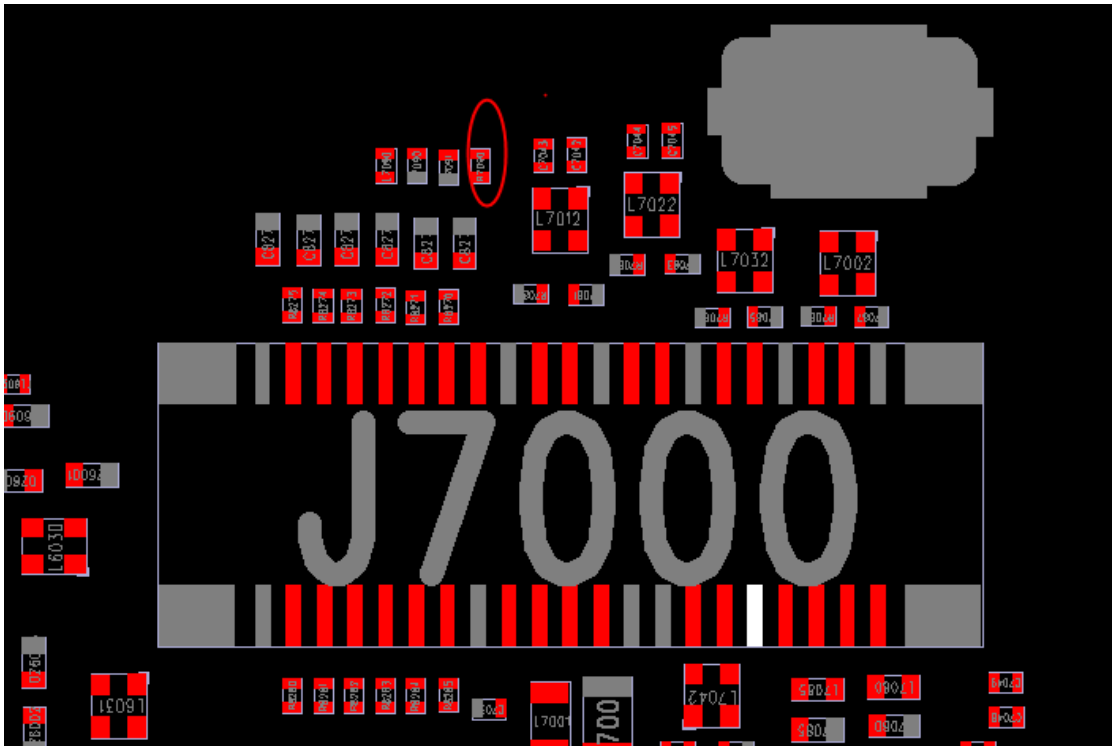
The screen is fastened, and the screen insertion detection signal is already about 1.8v, and the screen is turned on.

Thought it is already good, plug in the charging cable and see, do not charge.How can there be so many faults?

It is estimated that the initial failure of the client is not charging the battery power shortage No Power ON. It is not easy to find the replacement screen for the pick-up machine. It is reinstalled and returned to the customer. However, the screw is installed less or not, the cover is not and the bad screen connector is caused. The short circuit burns more faults.
