[Faulty model] iPad6

[Fault phenomenon] The front camera cannot be used normally.

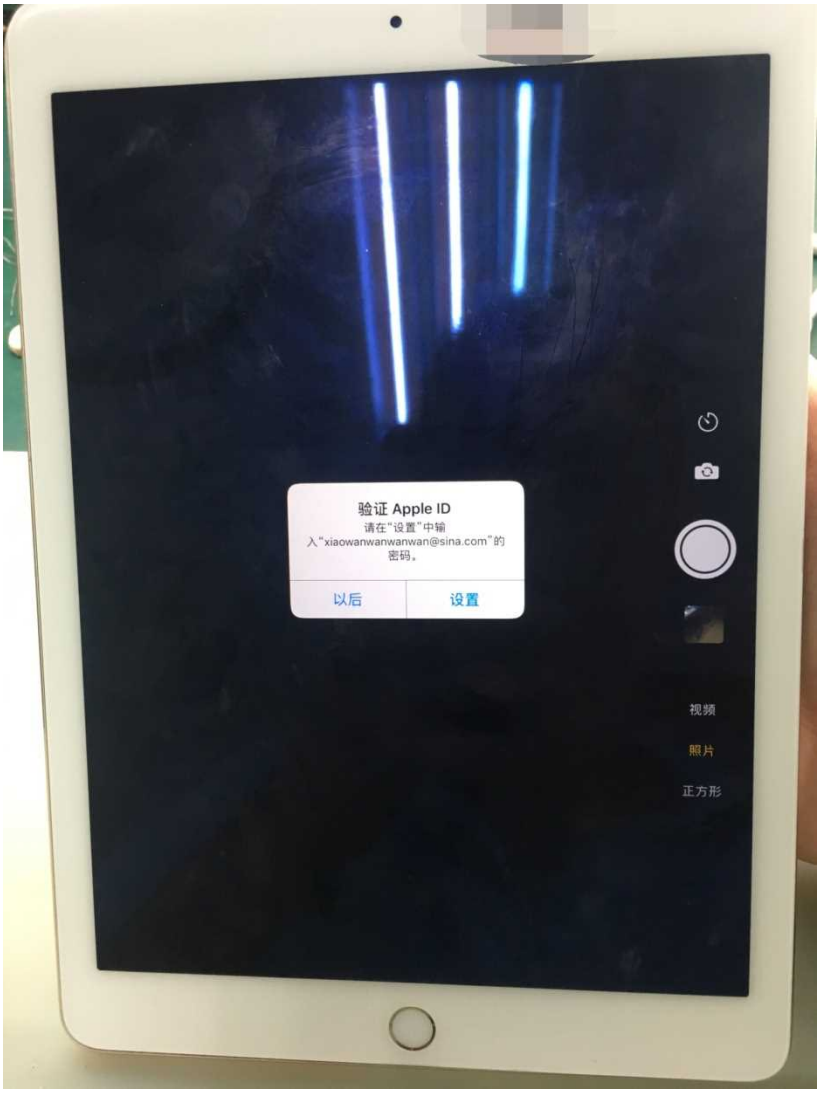
[Maintenance process] Get the device boot detection, found that the front camera can not be used, other functions are as follows:

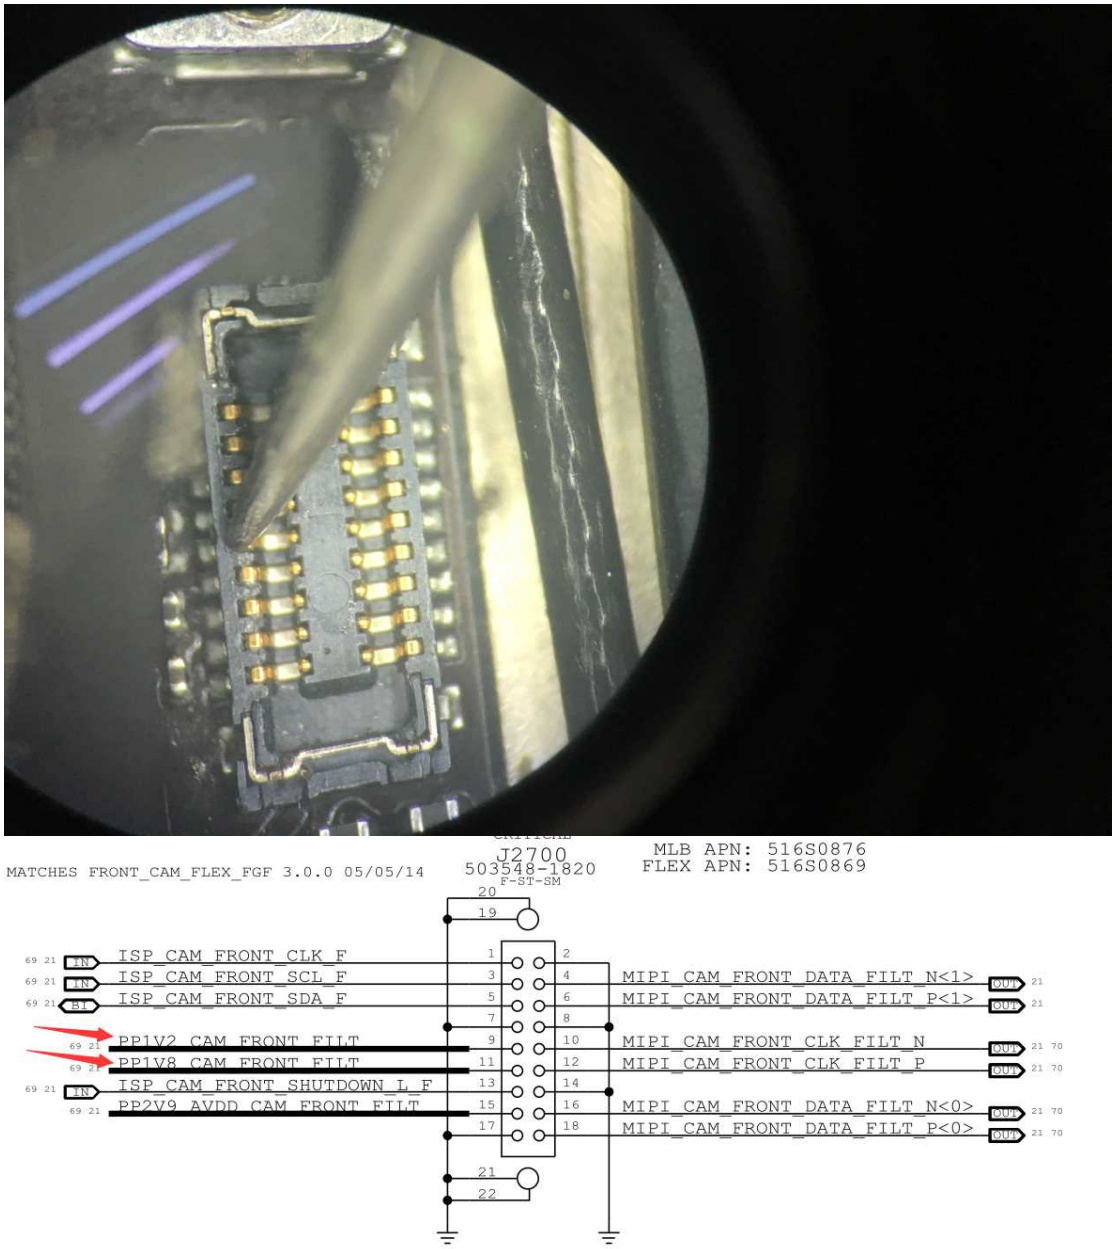
The Screen Outer Layer Glass integrated in this machine should be disassembled carefully. First measure the front camera connector diode value.

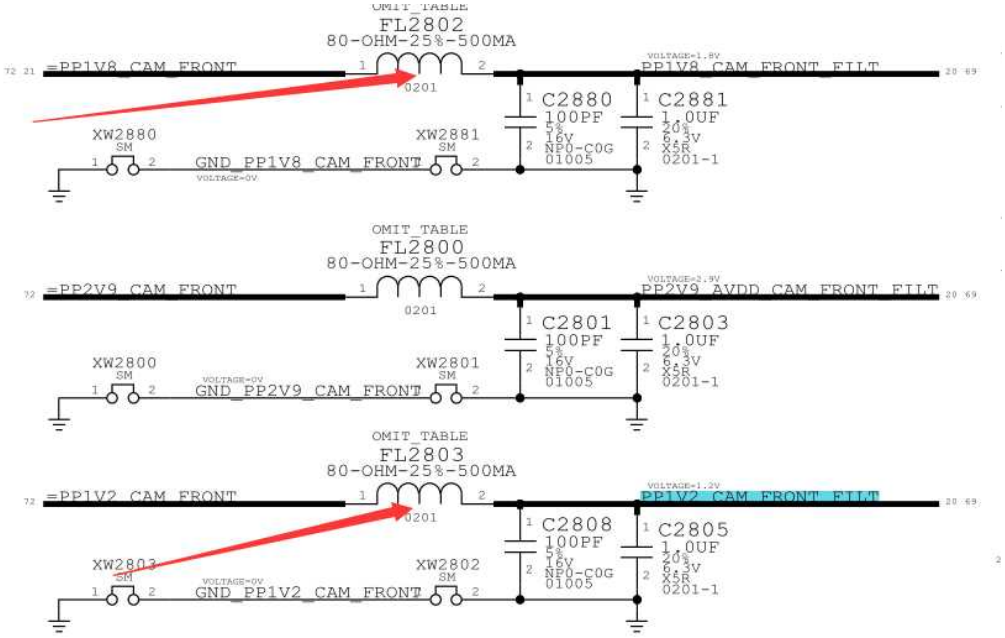
The front Camera pp1v2_CAM and pp1v8_CAM two VCC disconnected without diode value.

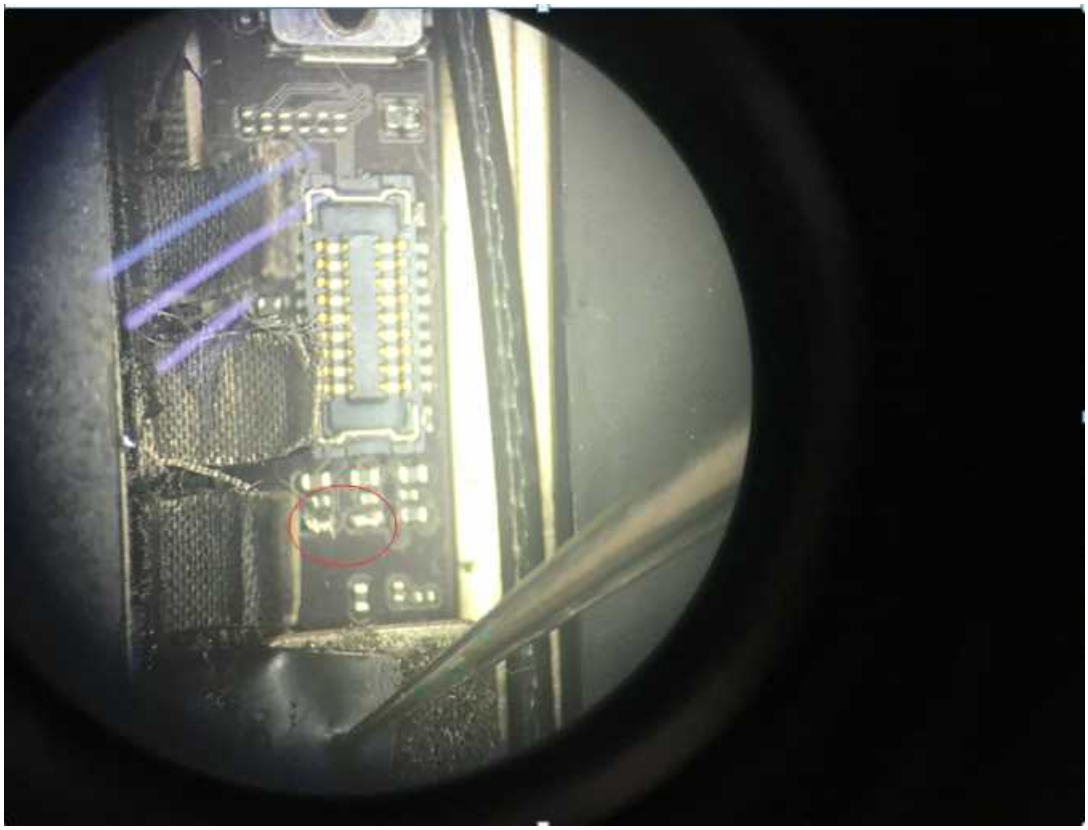
After measuring FL2802 and FL2803 respectively, Inductor is damaged and open, which can be directly connected.

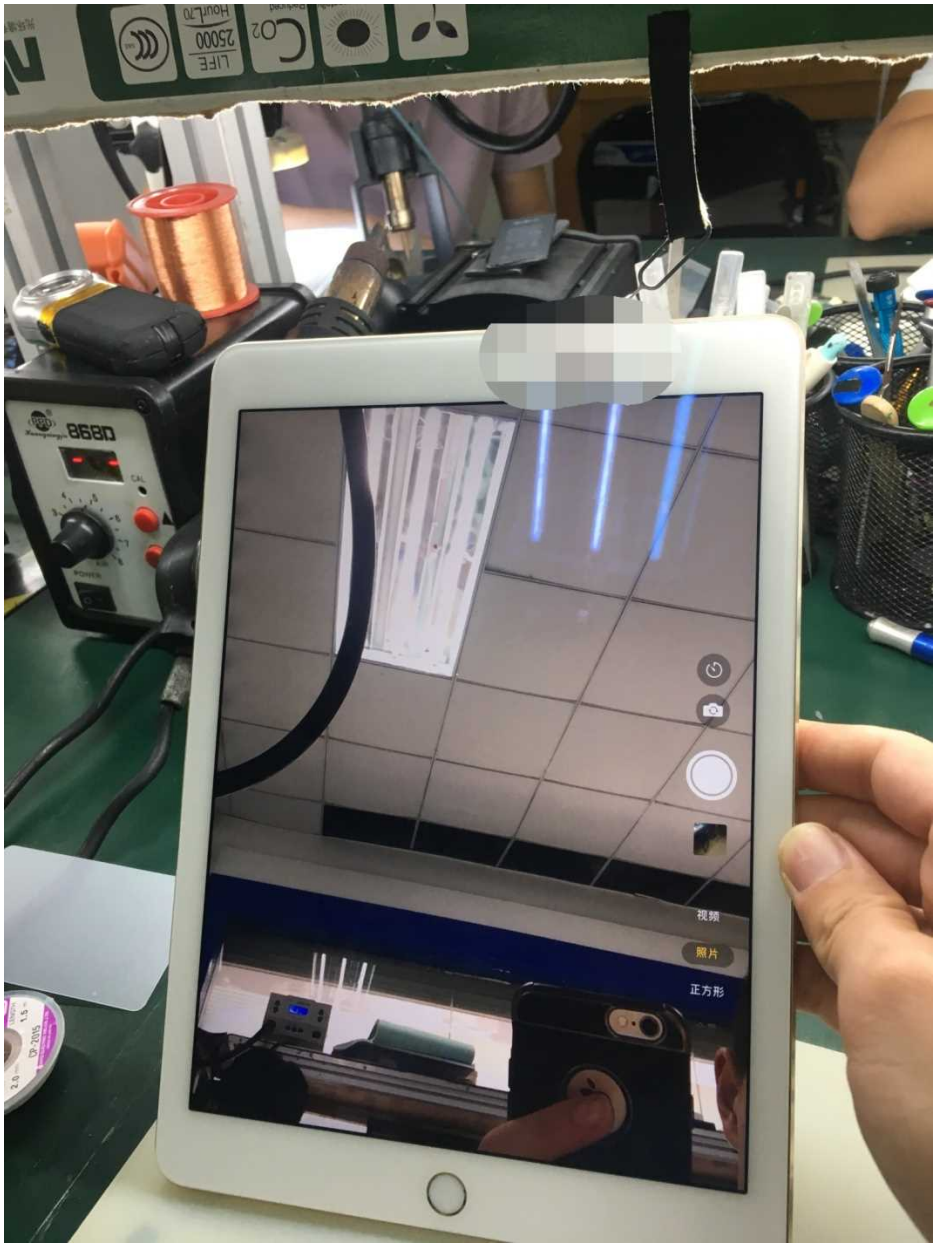
The boot test Camera is normal.
