[Faulty model] iPad 6

[Fault phenomenon] No Power ON

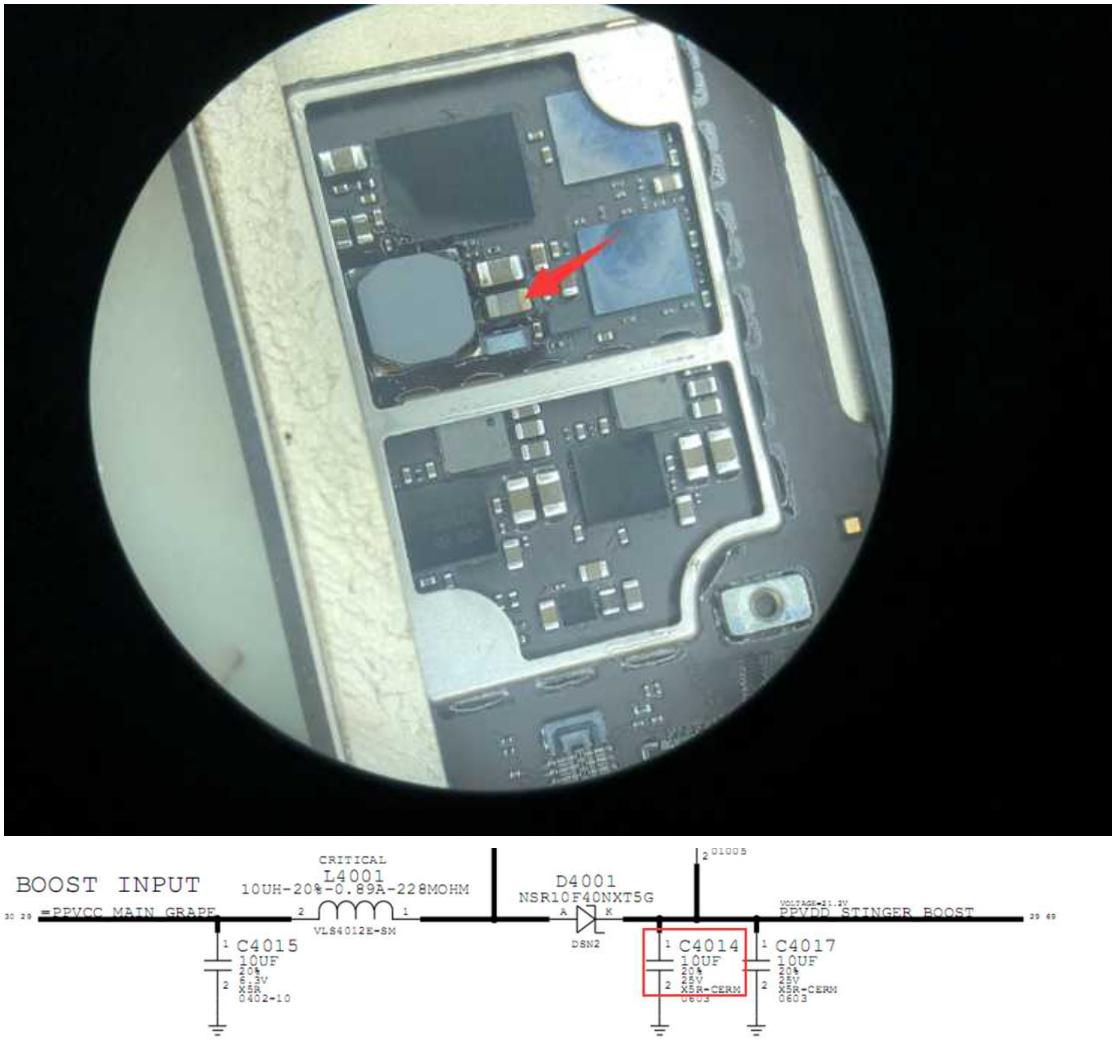
Under the microscope, it was found that the capacitor c4014 was clearly blackened.
