Three repair IPAD AIR 2no touch function

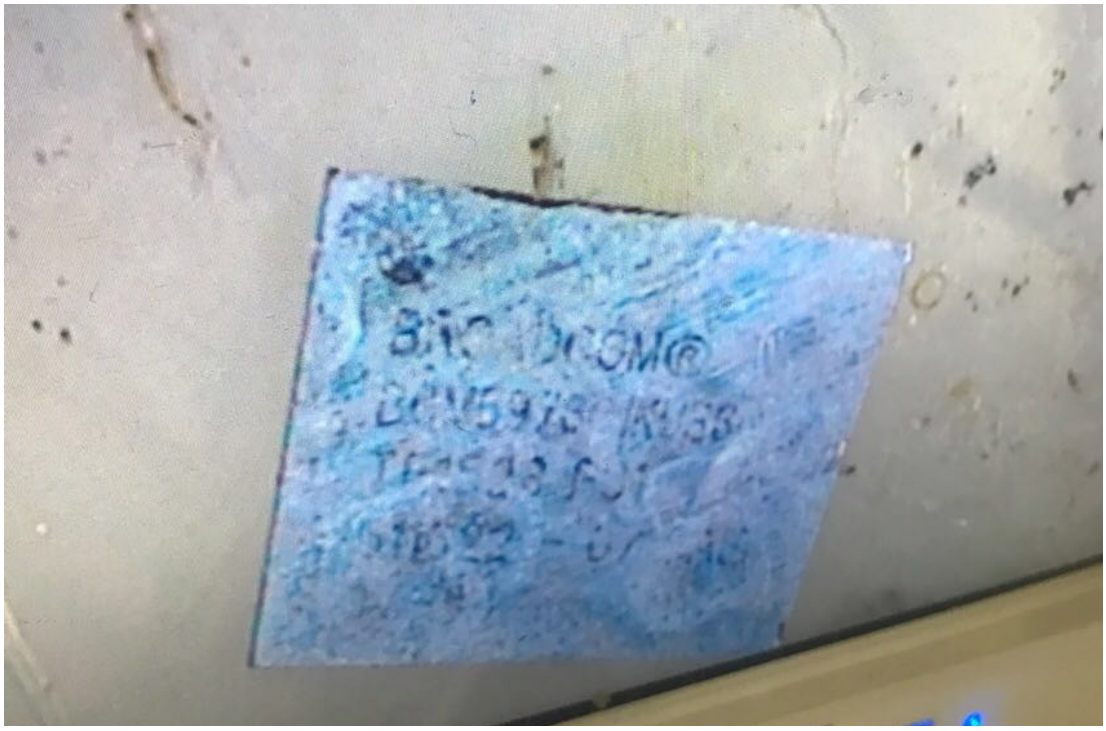
Pick-up inspection, visual inspection of the two white touch Chip are all severely damaged.The Black Touch Chip has also changed.The boost diode, the Inductor, has also been replaced.The touch screen connector is fully deformed.

The white touch Chip above is the least damaged.

So replace the two white touch Chip white touch Chip and Apple 6 universal, with a try to install the machine to try, the fault is still, I think it is not that simple.

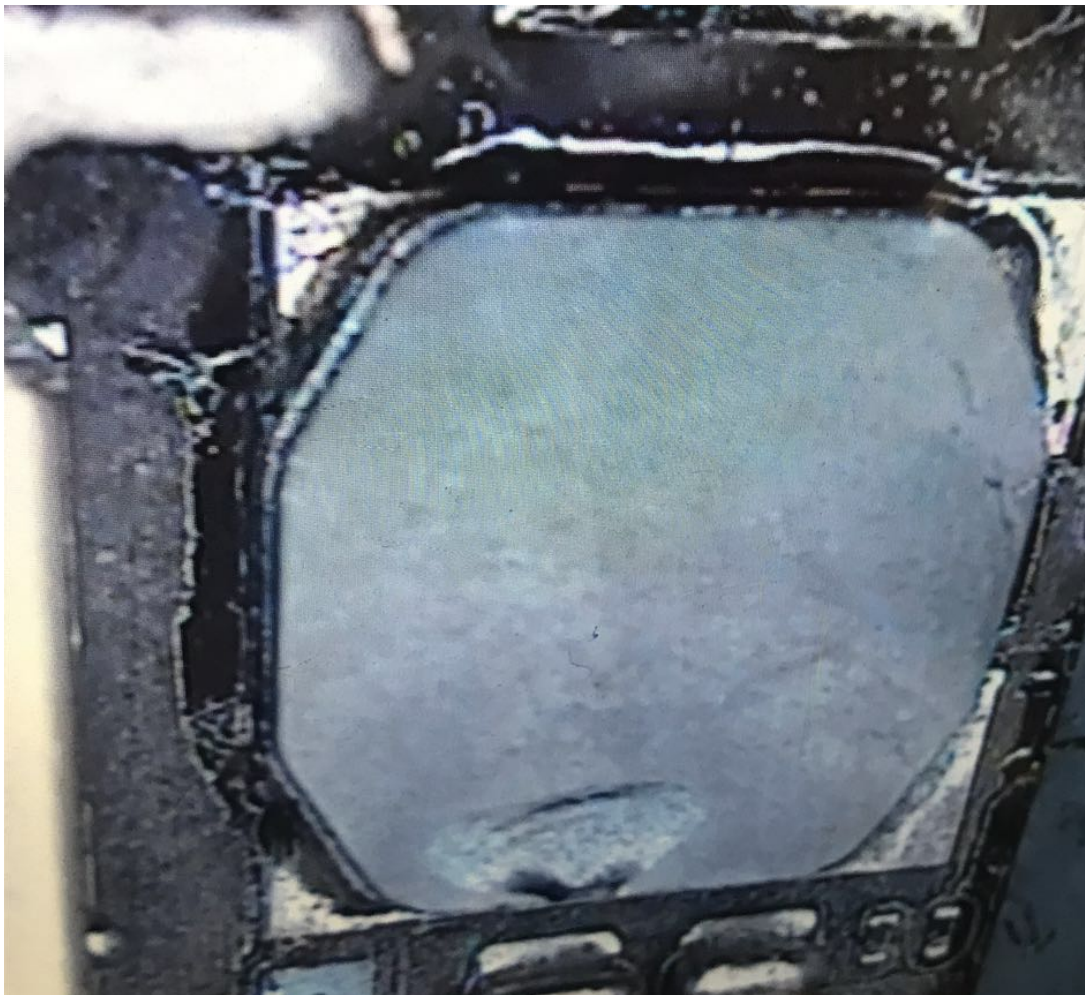
The voltage measured on the C4014 is only 2.3V. If it is not boosted, there should be a main VCC here.

Going back to test Inductor L4001 found that the voltage before and after Inductor is different.Remove the Inductor test and the Inductor is blown.

Replace the Inductor L4001.By the way, the diode D4001 was checked for damage.Try the machine again.Found that there is still no boost.The boost of this place does not have a screen and it also has a boost.

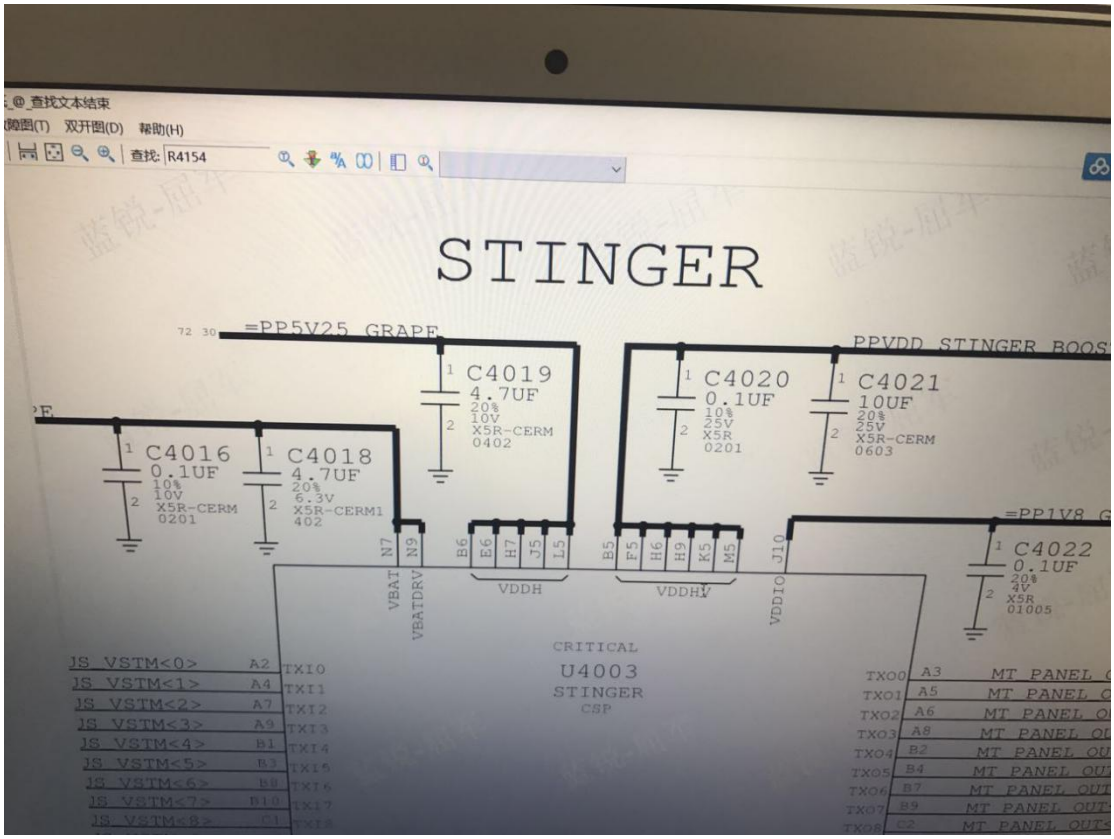
The Black Touch Chip's VCC has both 5.25V and 1.8V.

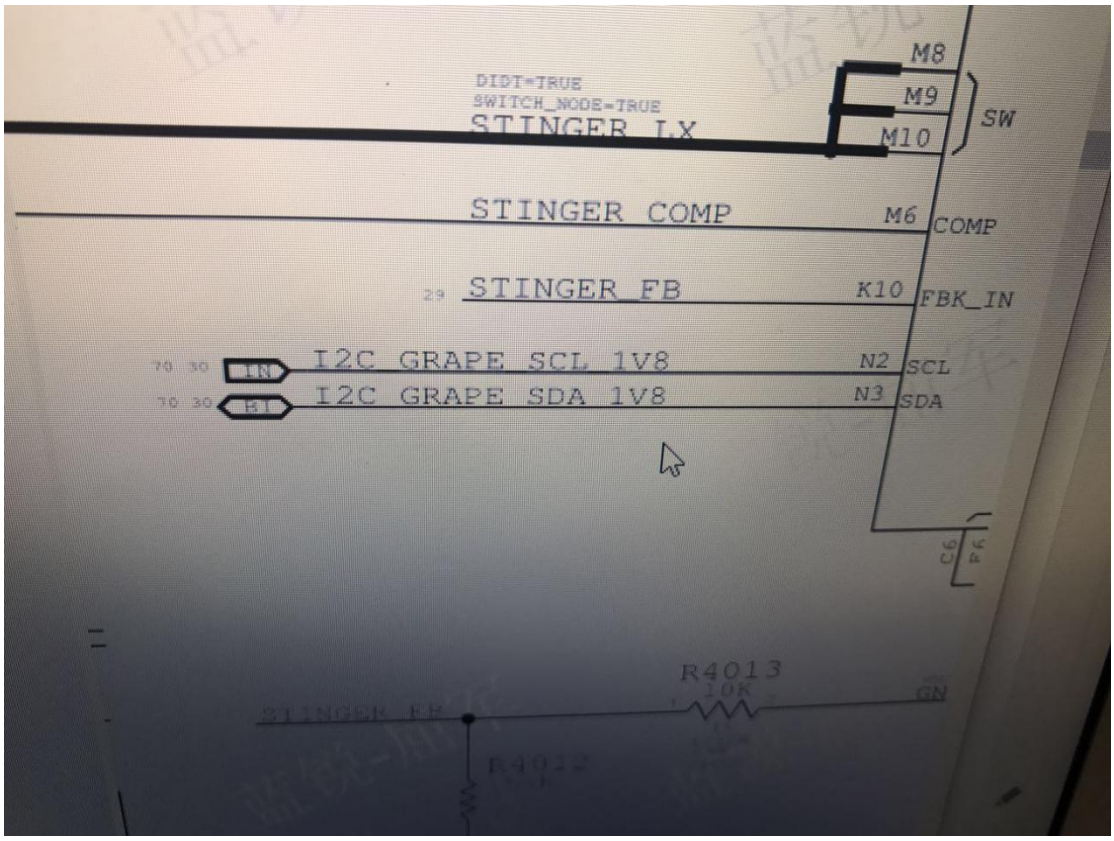
I2C total red VCC normal

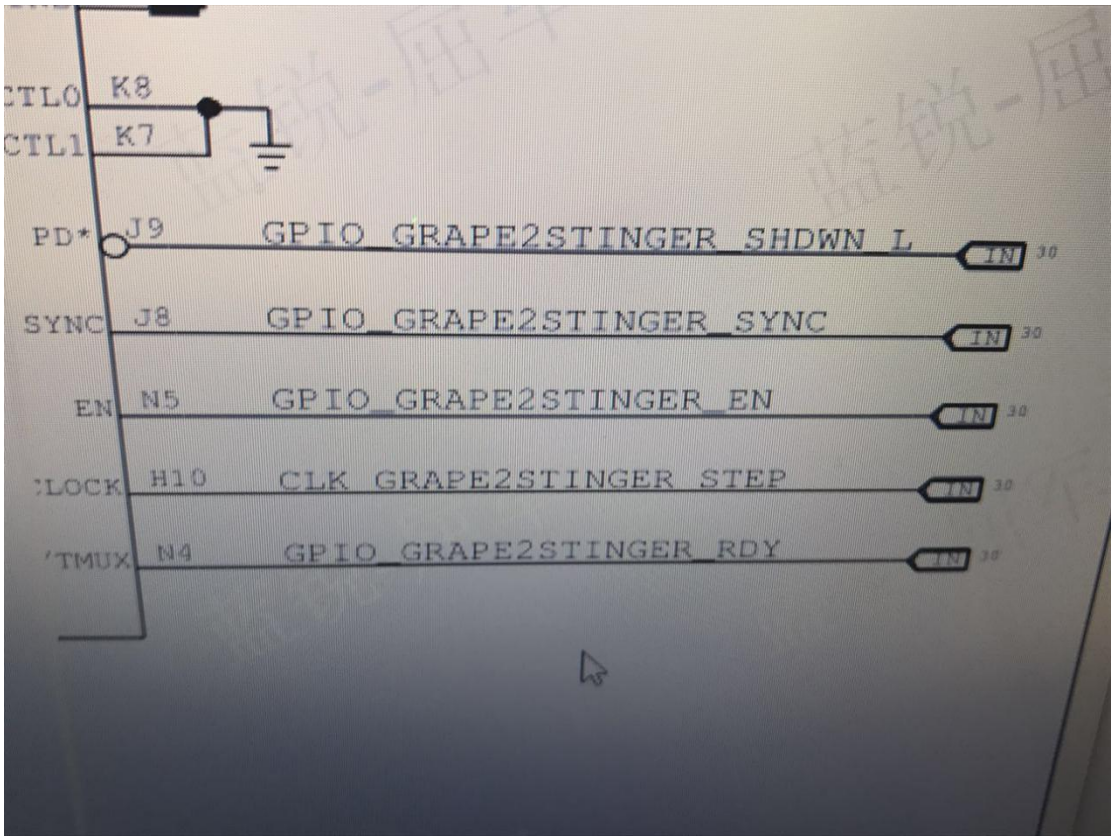
Found that the EN signal of Black Touch Chip is from white touch Chip U4150

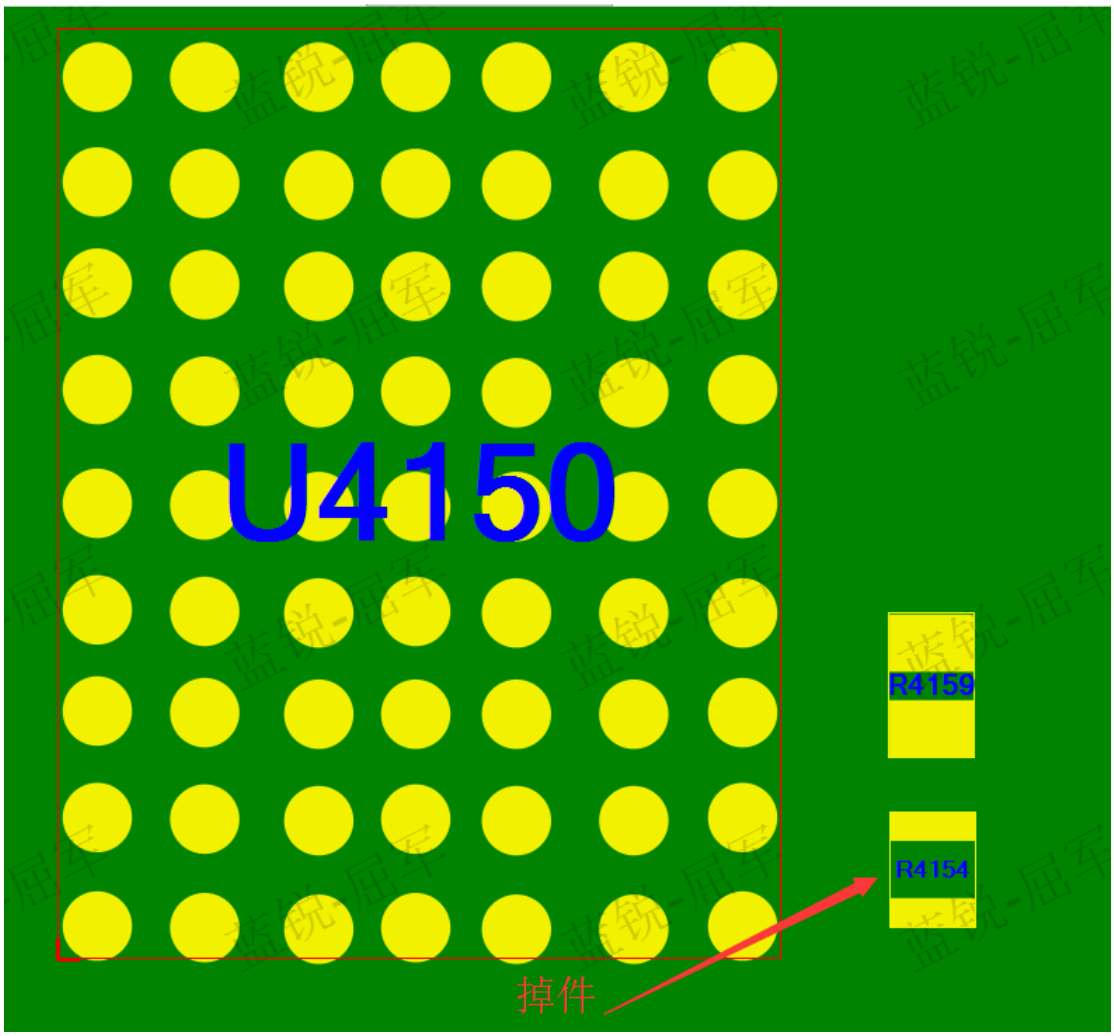
white touch Chip on the side of something (first declared that I did not get rid of), solder pad flat, there is oxidation should not be the original factory does not know what it is, look at the drawings.

Is a resistor r4154.

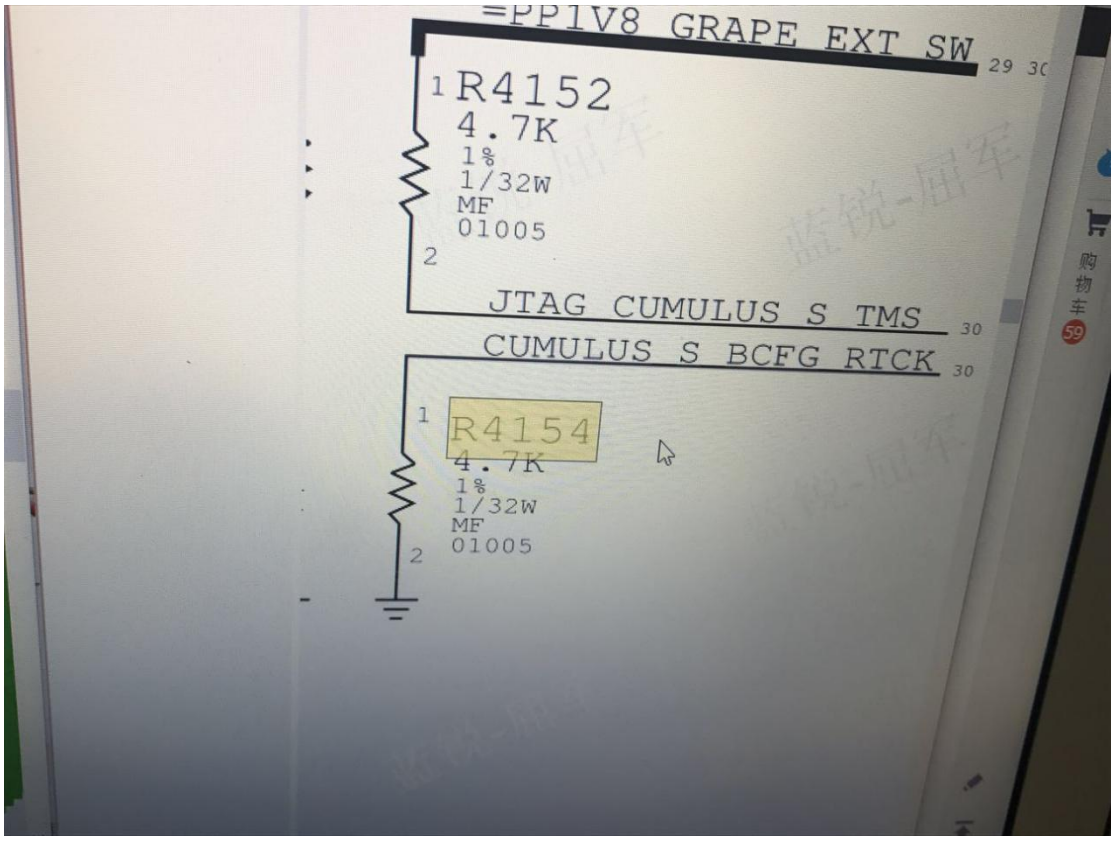
Through the original map, we can find that this r4154 is a touch-clock frequency pull-down resistor. According to the usual maintenance idea, the pull-down resistor connected to one end of the chip at one end must not be the same as the rext resistor in the iphone.

It should be that the resistance is lost, causing the white touch Chip to not work and not sending the EN signal to the Black Touch Chip, so that there is no Black Touch Chip working boost.

I found a 4.7k resistor on the Apple phone motherboard.The boot test is boosted out.18v-20v

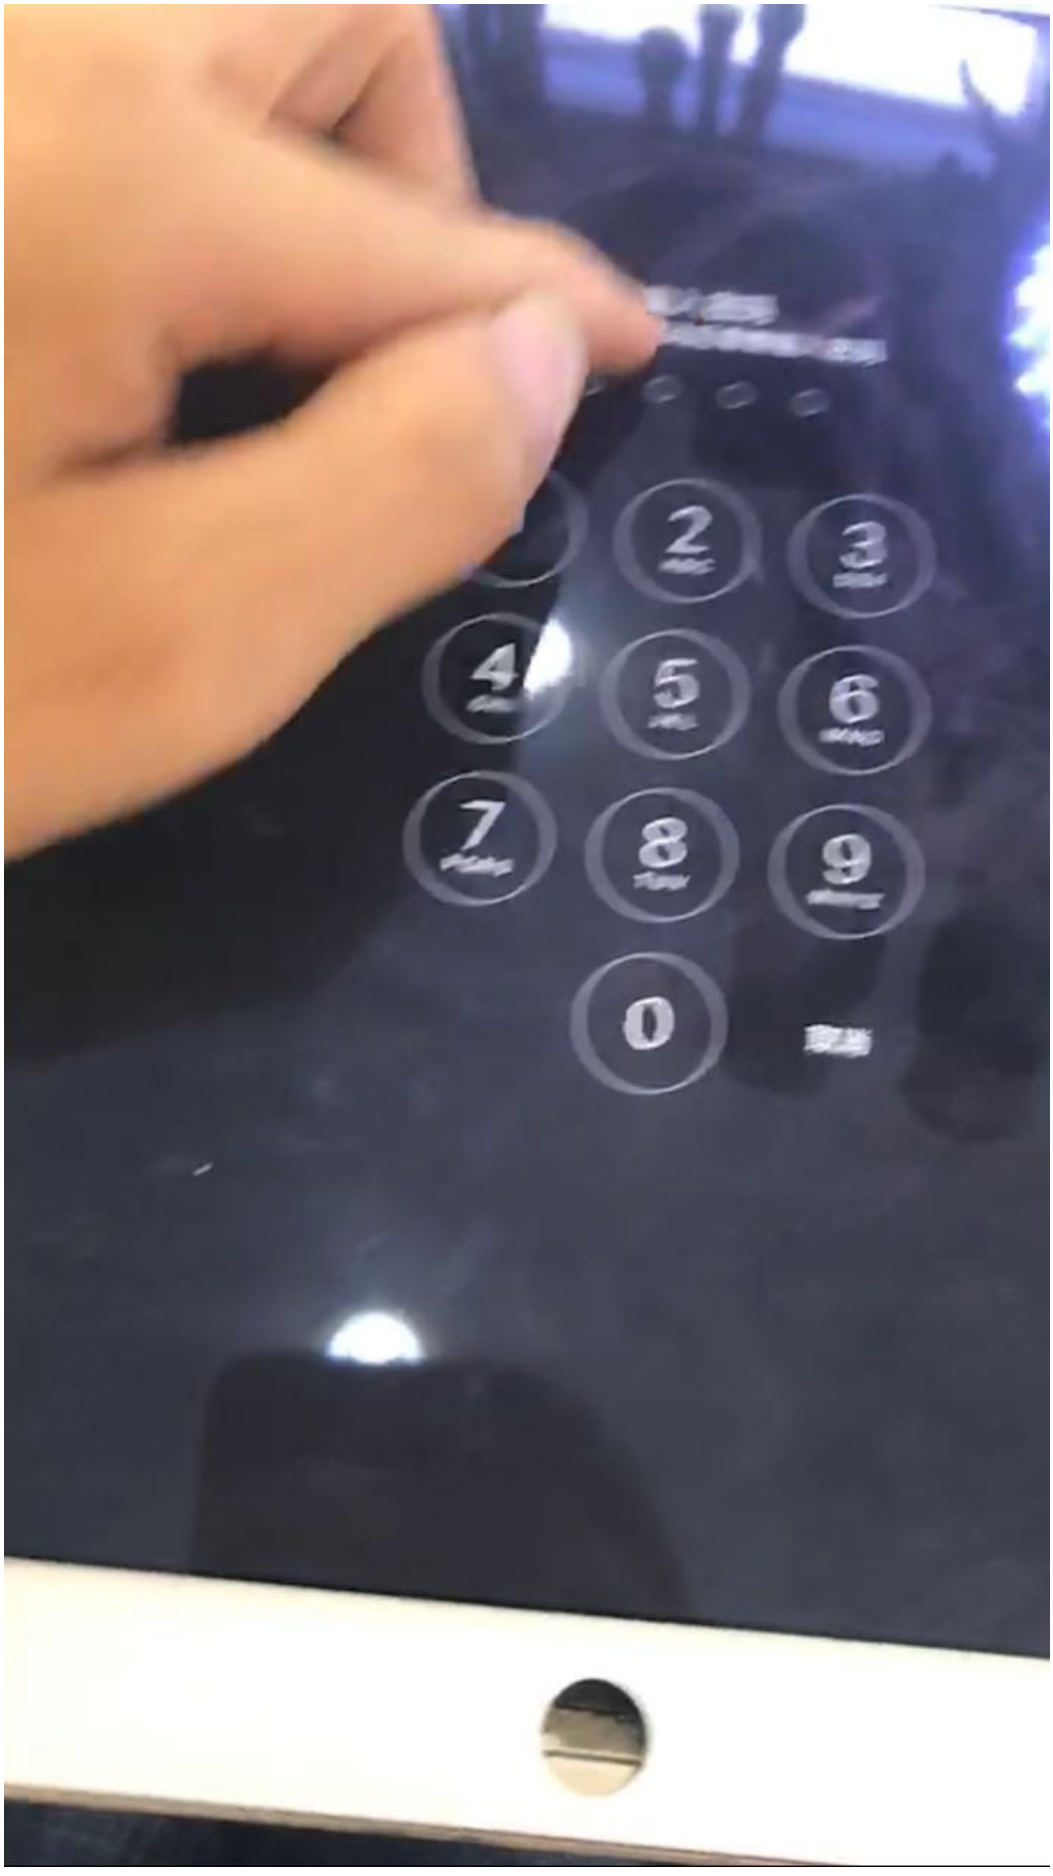
The screen test is faulty.
