iPad6no touch function repair

[Faulty model] (iPad Air2 64GB)

[Fault phenomenon] Touch no response after booting

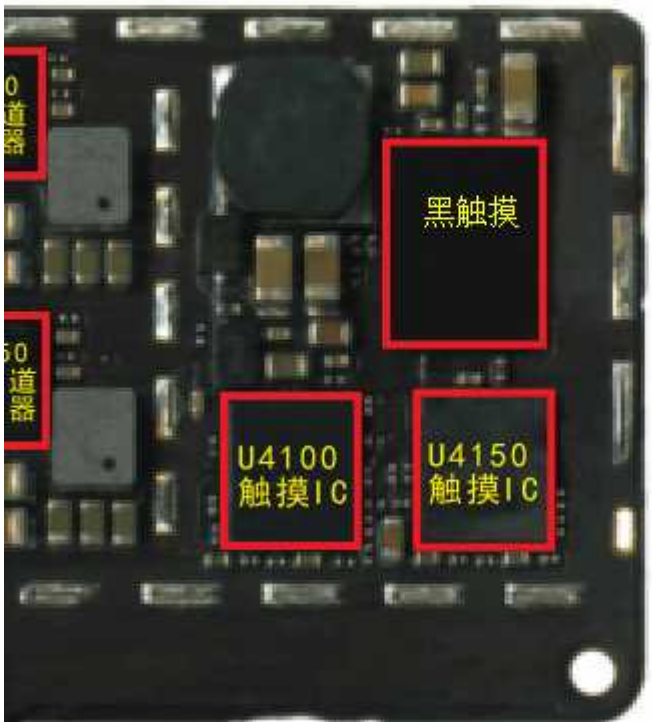
First look at the touch circuit

The core of the iPad6 touch circuit consists of two white touch Chip s and one Black Touch Chip.

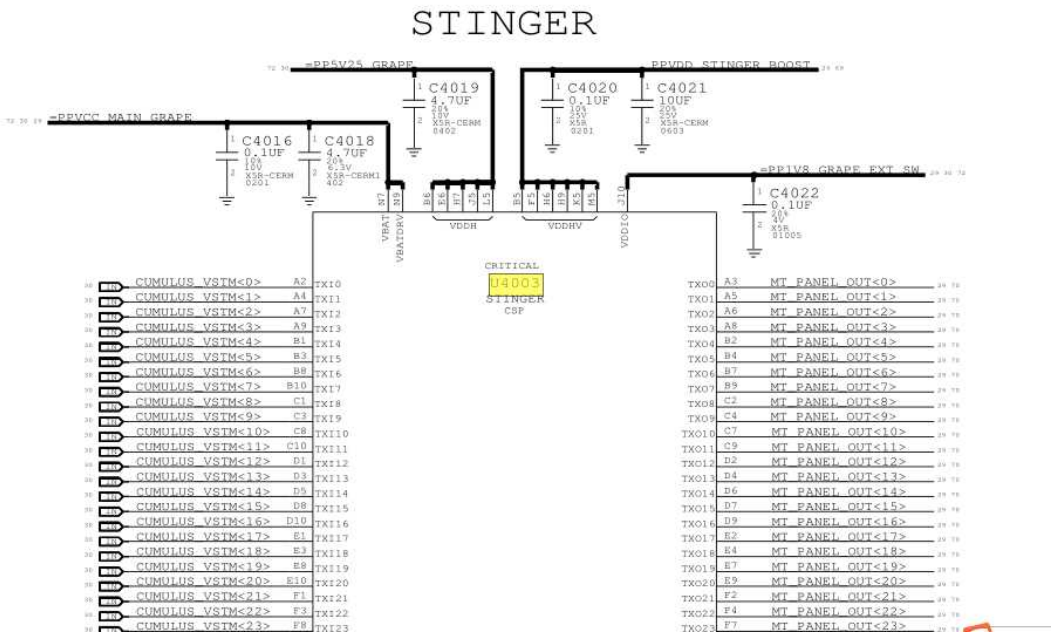
There is no 5.25VVCC on the Black Touch Chip side.And this 5.25VVCC is provided by the main power supply.The main power supply is troublesome to replace, and the cost is not low. VCC, you can borrow it, the key is to find out who to borrow.In order to do the experiment, I first borrowed the main VCC PP_VCC_MAN.After borrowing, the touch can be used, but the touch is intermittent, and the measurement PP_VCC_MAN is only 4.44V.It still seems that the requirements of the Black

Touch Chip cannot be met.Then we are looking for it.

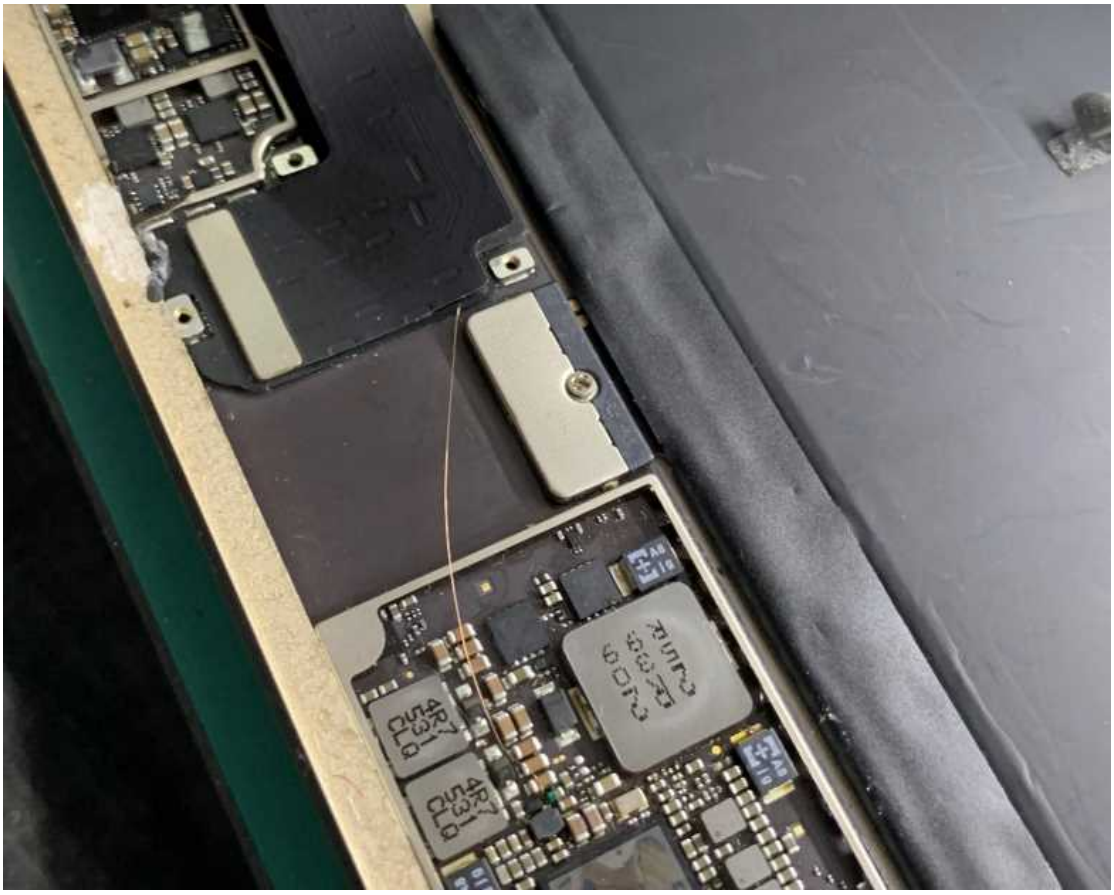
At this time we found a PP6V0_LCM_VBOOST, which is 6VVCC, slightly higher than the 5.25V requirement.

This picture flies a bit far, with a 5.25v capacitor on the side.

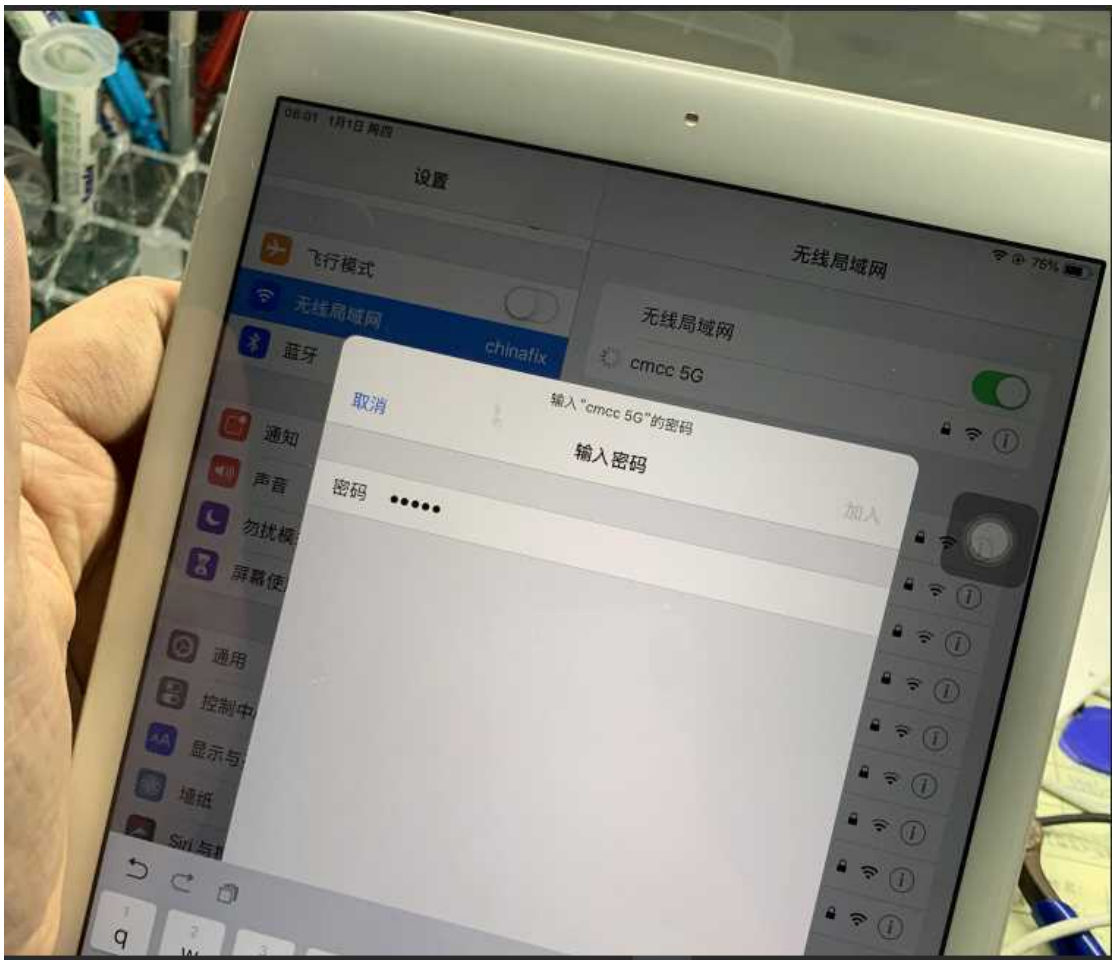
Touching everything is normal.

Installed test
