iPad AirNAND solder dot dropped repair

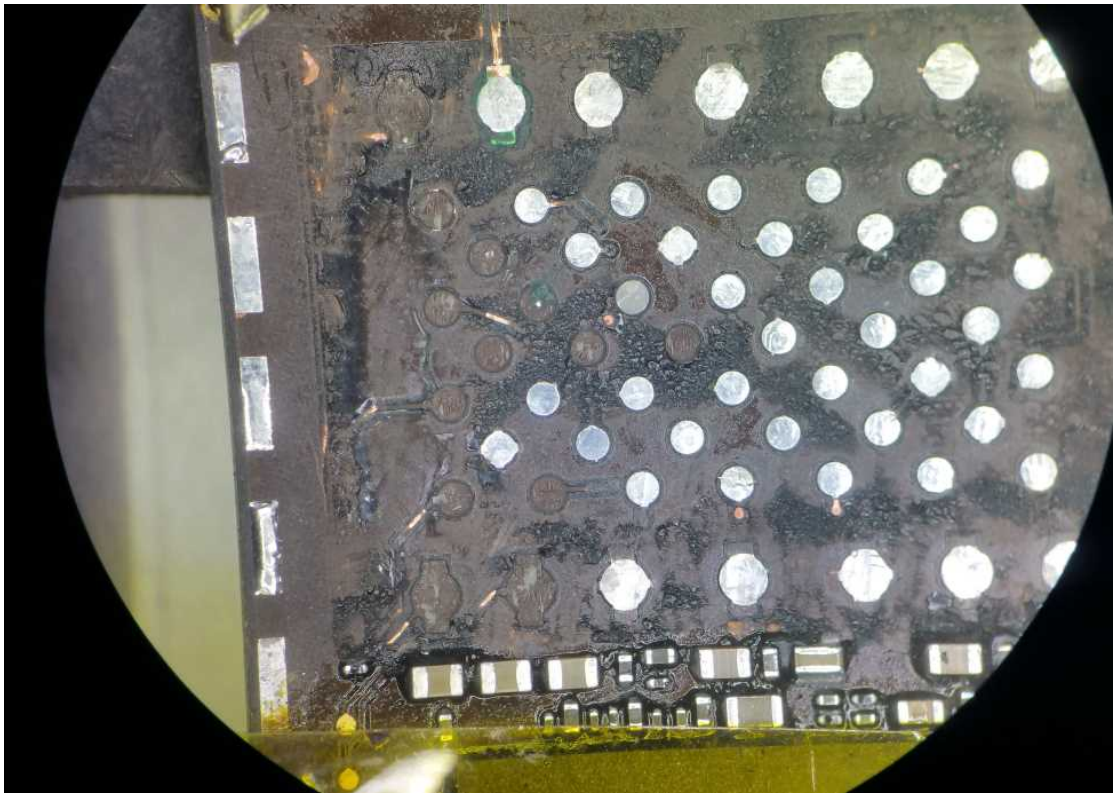
The solution ID causes the NAND solder dot dropped.

The customer hard-solved ID temperature is too low to cause the NAND solder pad solder dot dropped.There are several solder pad's intermediate layers that can't be repaired.The Add tin and weld handles the solder pad after the hole is scraped out of the middle trace.

Dig out two solder pad from the bad board and make up the motherboard of the solder dot dropped.

After the solder pad is repaired and the Test Diode Value(Multimeter uses diode gear, red pen connect GND, black measurement test point) is confirmed to be normal, the NAND is installed.

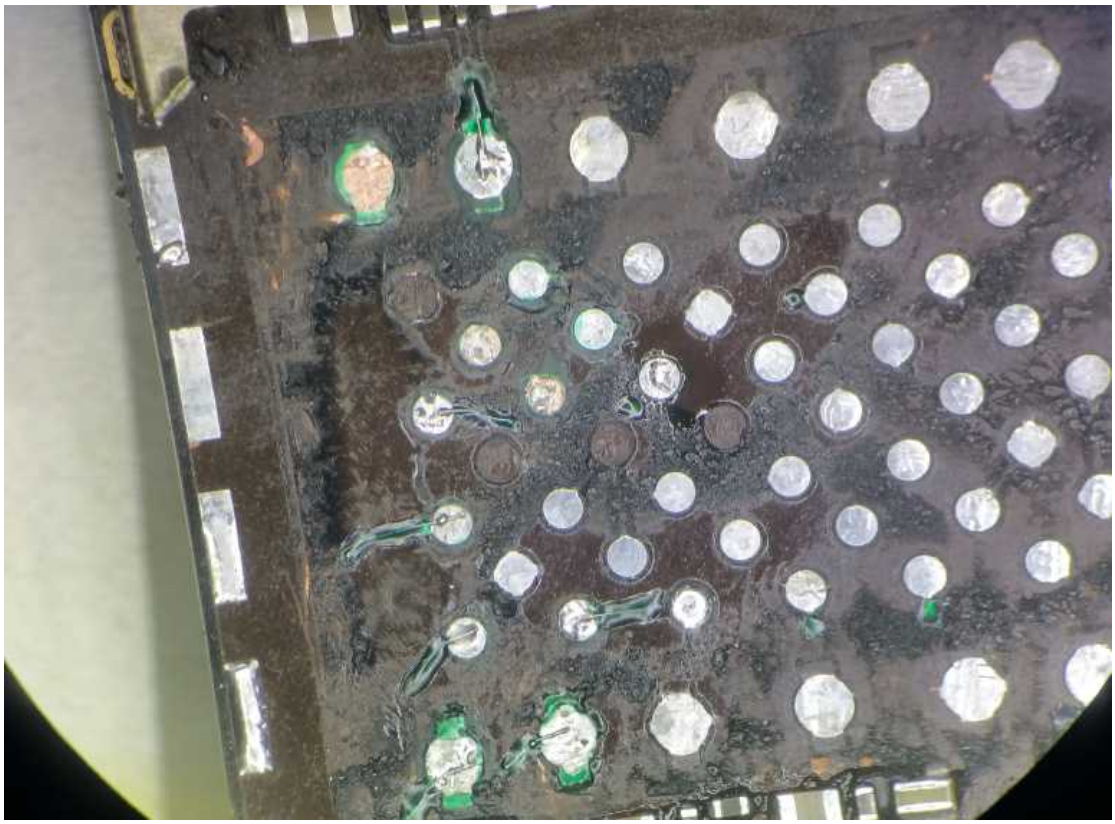
Boot test failure repair.
