[Faulty model]: iPad Air

[Fault phenomenon]: no charging

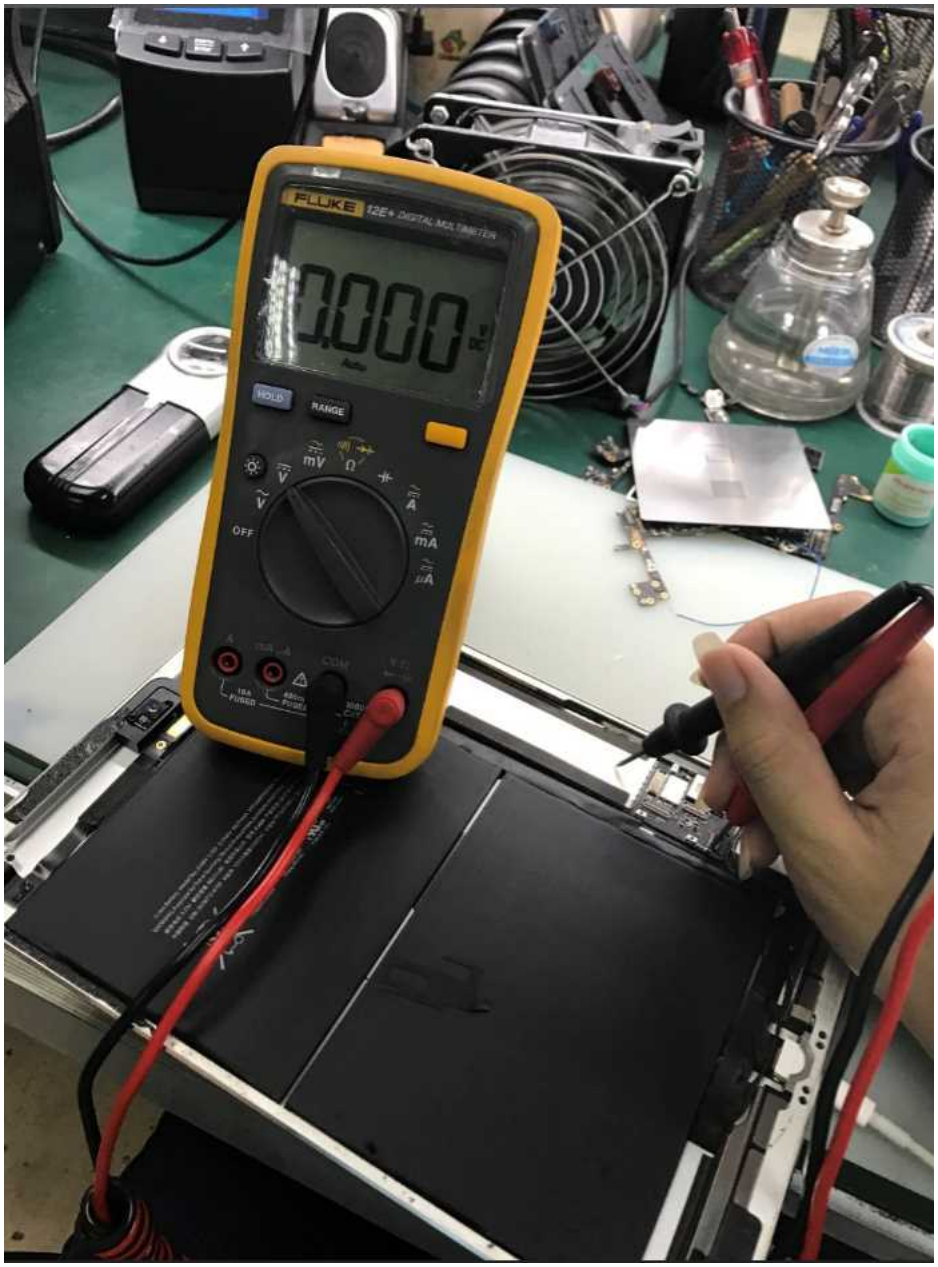
Disassemble the tablet, plug in the charger, and measure whether there is a charging voltage of 5v on the motherboard.The measurement found no voltage on the motherboard.

Actually, there is no voltage coming up. It seems that there is a problem with the charging connector and it is broken.

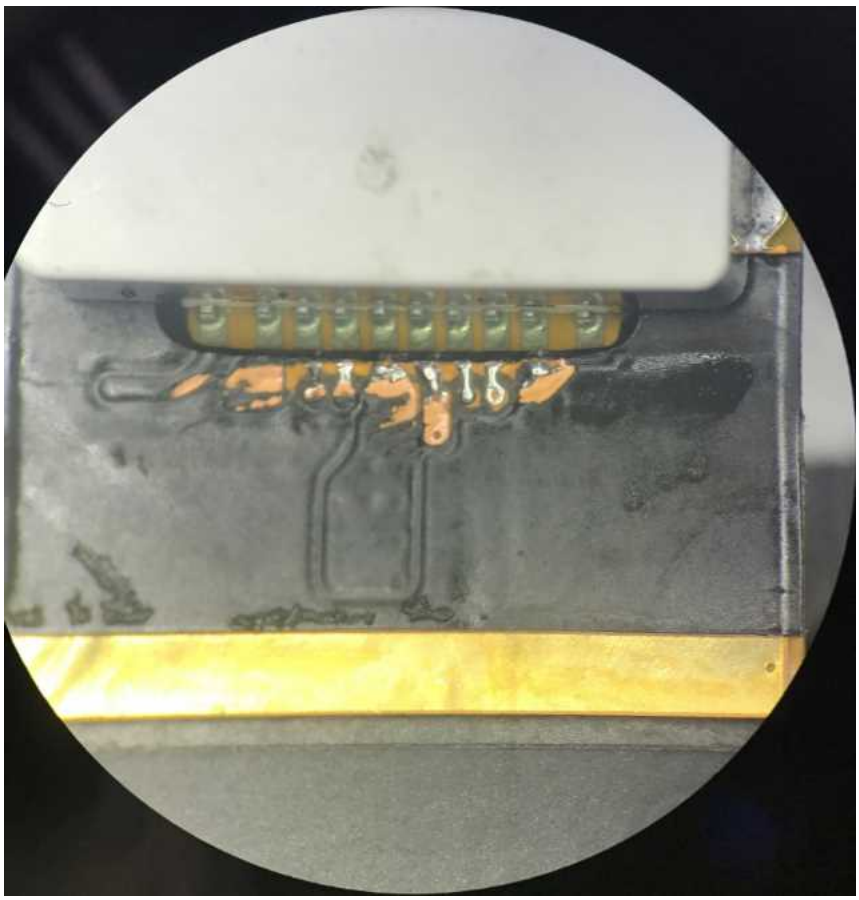
Observed under the microscope, it was found that there was a crack in the charging connector interface line. No wonder that no voltage came to the main board, and the cracked area was scraped open and repaired.

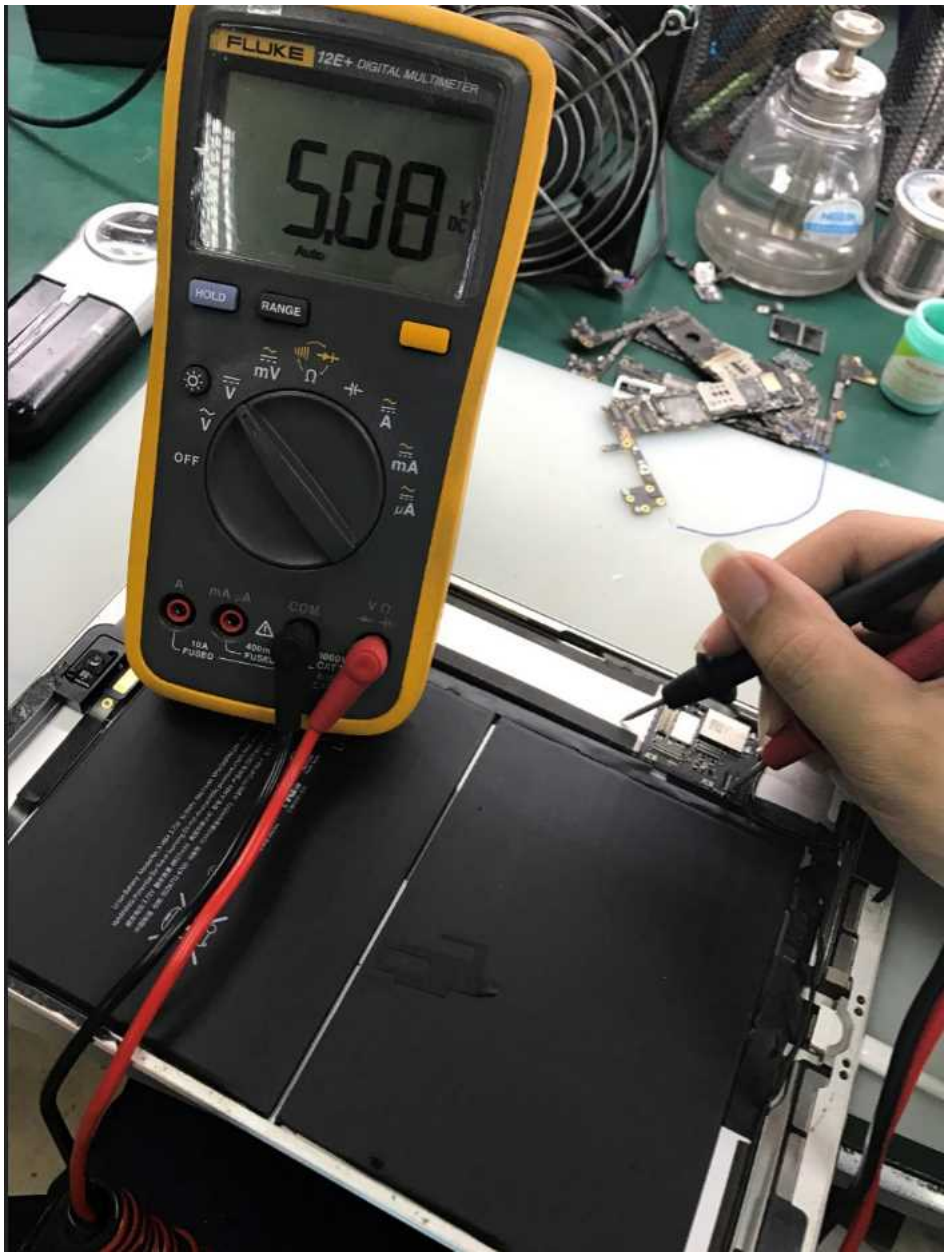
Plug in the charging cable and measure the charging voltage of the motherboard to return to normal.

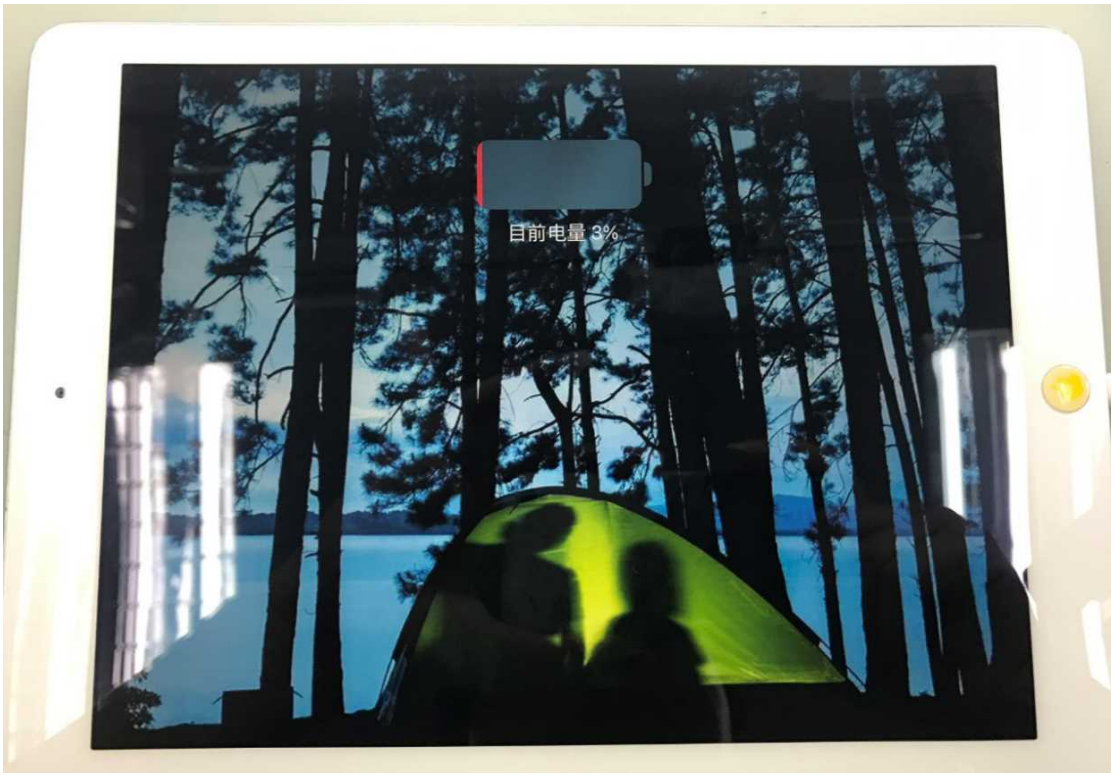
Installation test, the charging is back to normal, and the repair is over.This fault is caused by the charging connector splitting and disconnecting the charger.
