IPAD AIR2 Inlet Water No Power ON

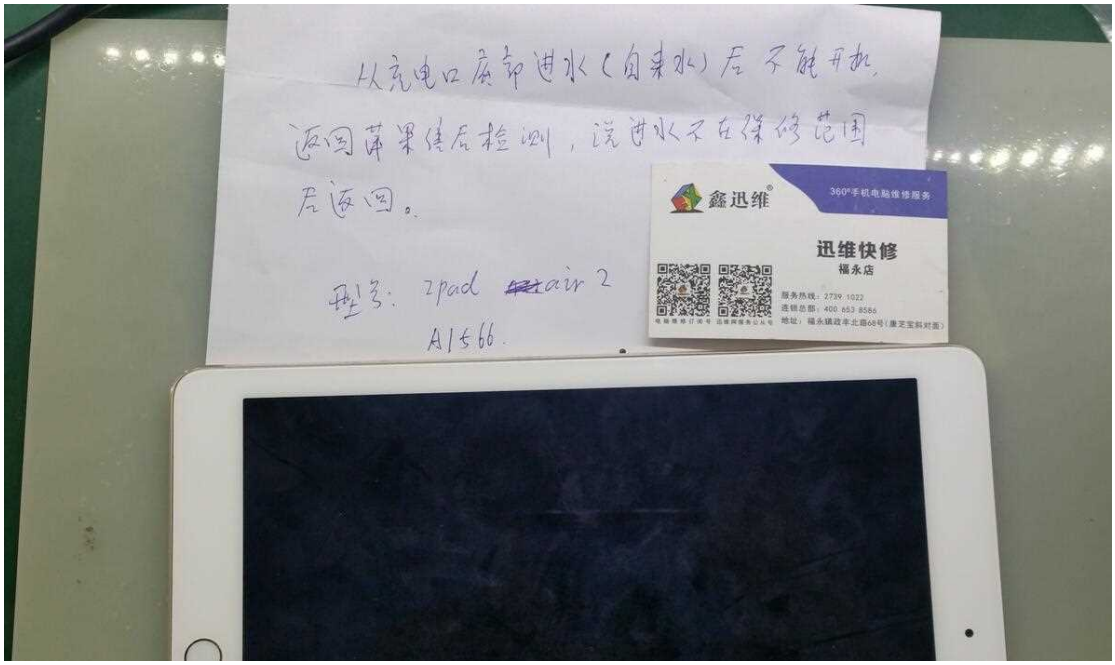
The customer described that the ipad charging port could not be turned on after entering the water, and the Apple refused to protect after sale.

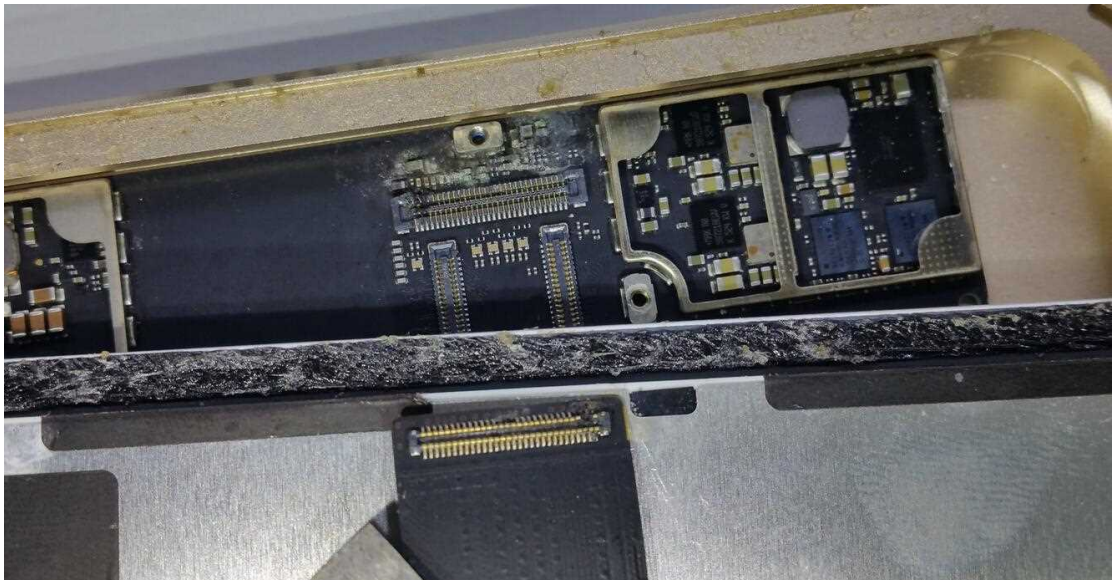
After the disassemble, the screen interface was found to be burnt.

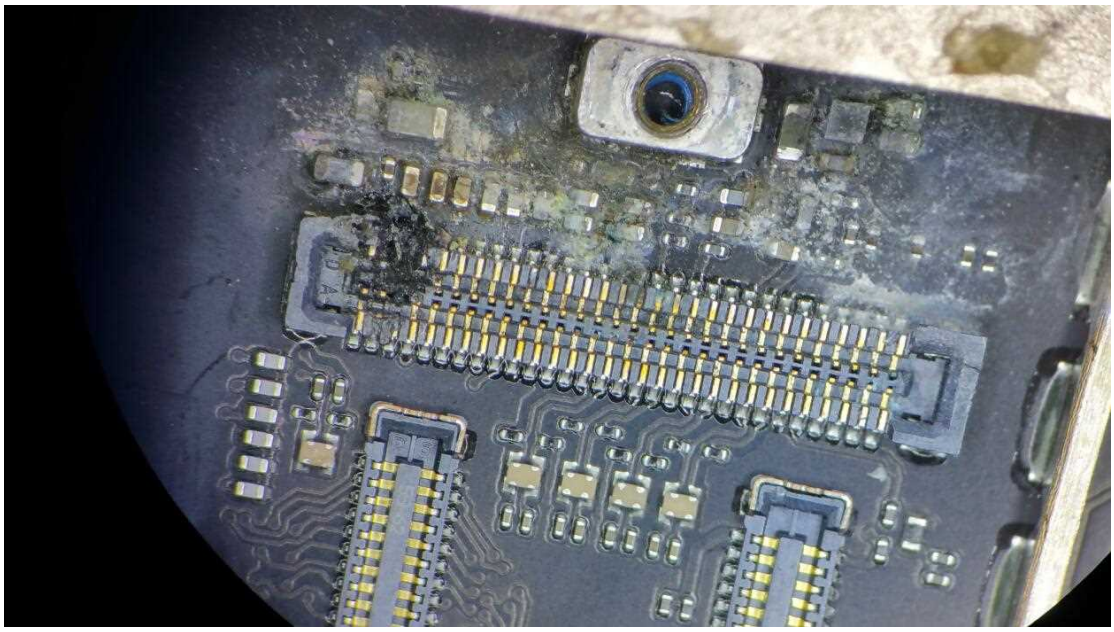
The motherboard screen interface is burnt and has serious signs of water ingress.

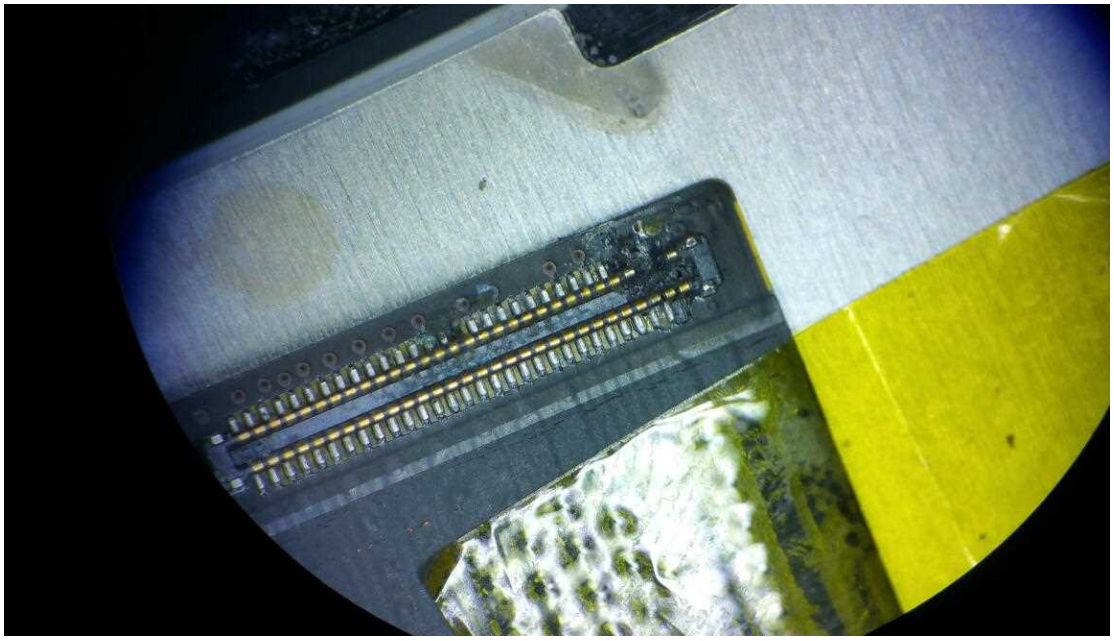
The screen line interface has also been burned out.

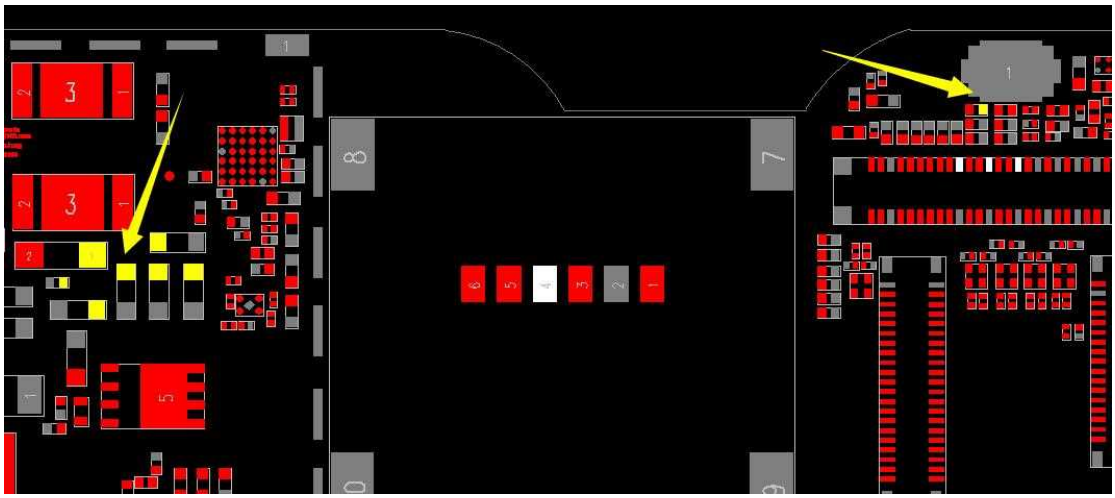
There is no problem with the screen to start repairing the motherboard. After the motherboard is cleaned, a lot of components have been lost. Several solder pad s have also been burned out. After the patch is repaired, the PPLED_BACK_REG_A is found to be worthless.PPLED_BACK_REG_A is connected to D8428 after Inductor.

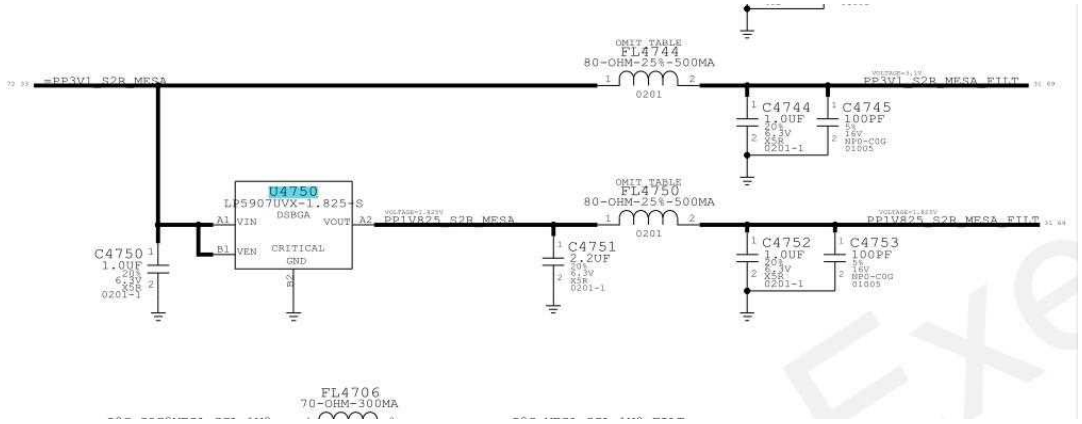
After the screen line interface circuit is processed, the next step is to process another. The map shows that the U4750 has also been moldy damaged, and the solder pad has fallen off and cannot be soldered.The U4750 is a 1.825VVCC that is converted to the fingerprint on the screen.

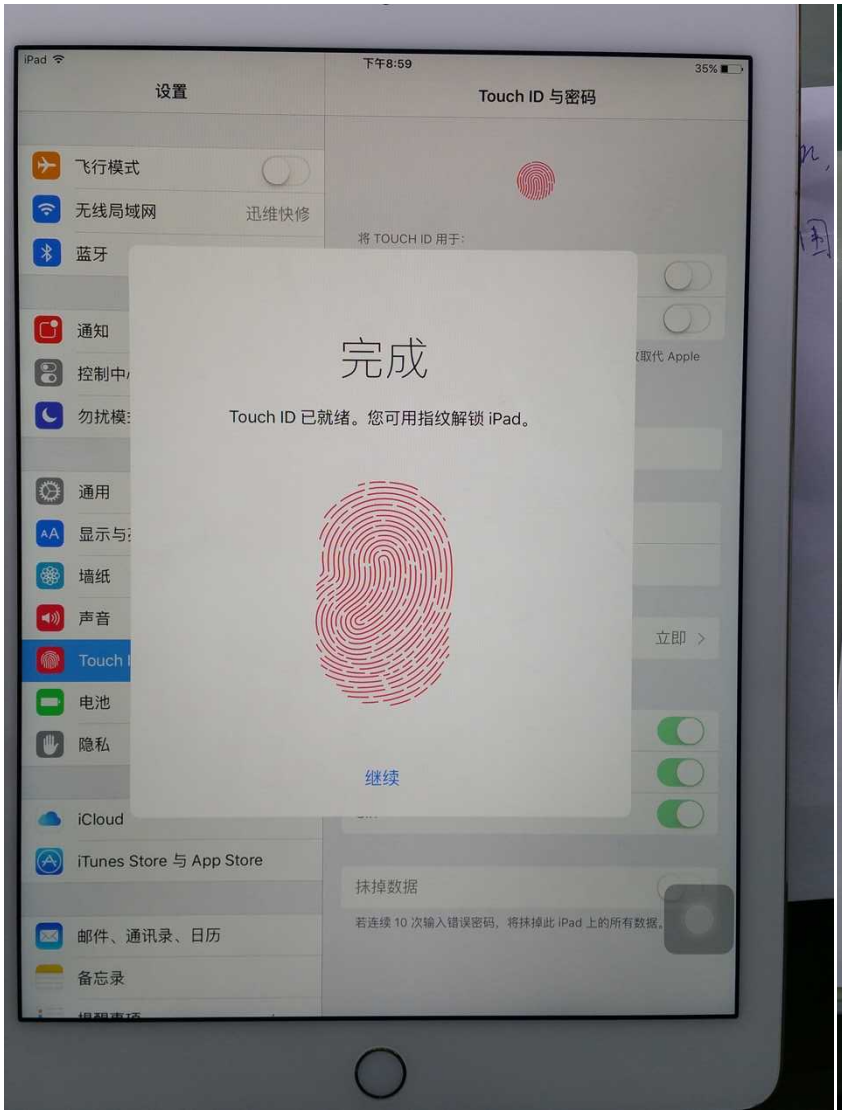
After processing, the screen is turned on and the test is normal, and the fingerprint is used normally.
