[Faulty model]: iPad Air2

[Fault phenomenon]: Inlet water No Power ON

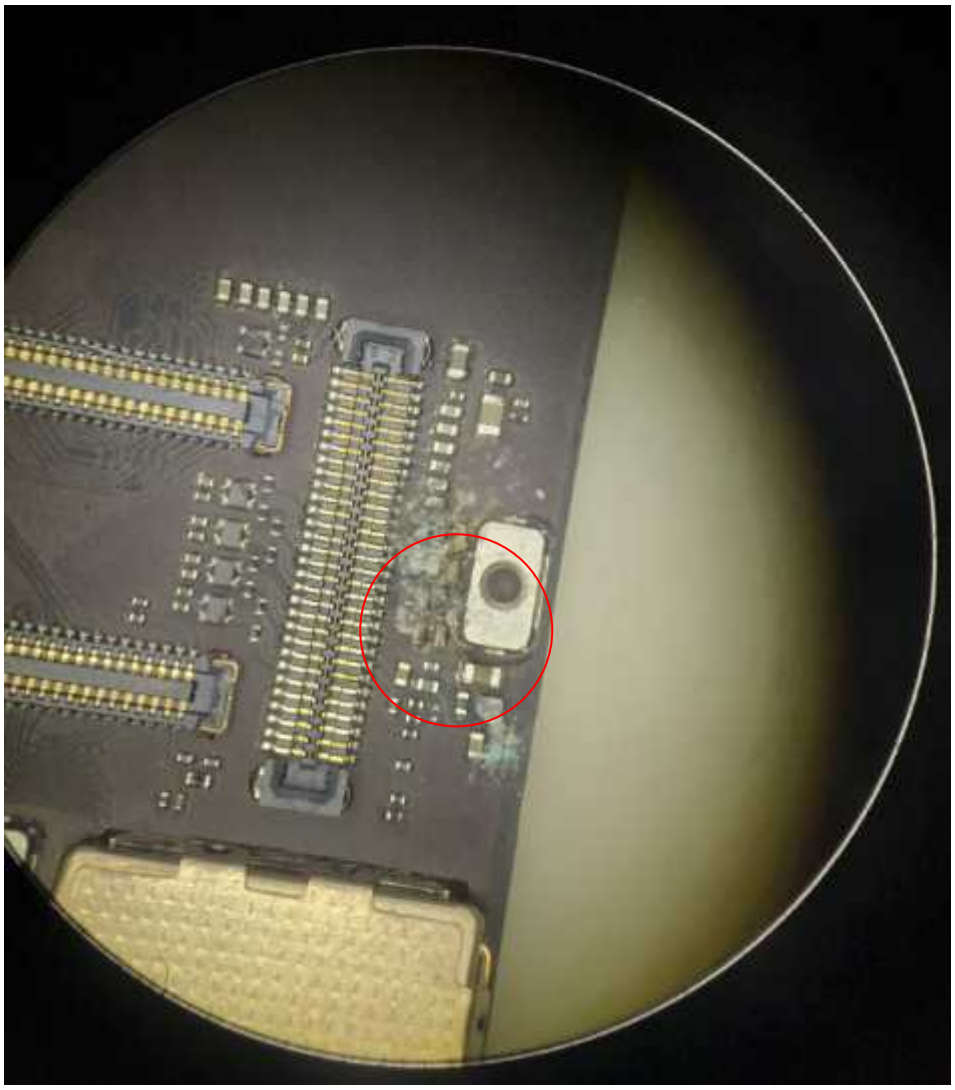
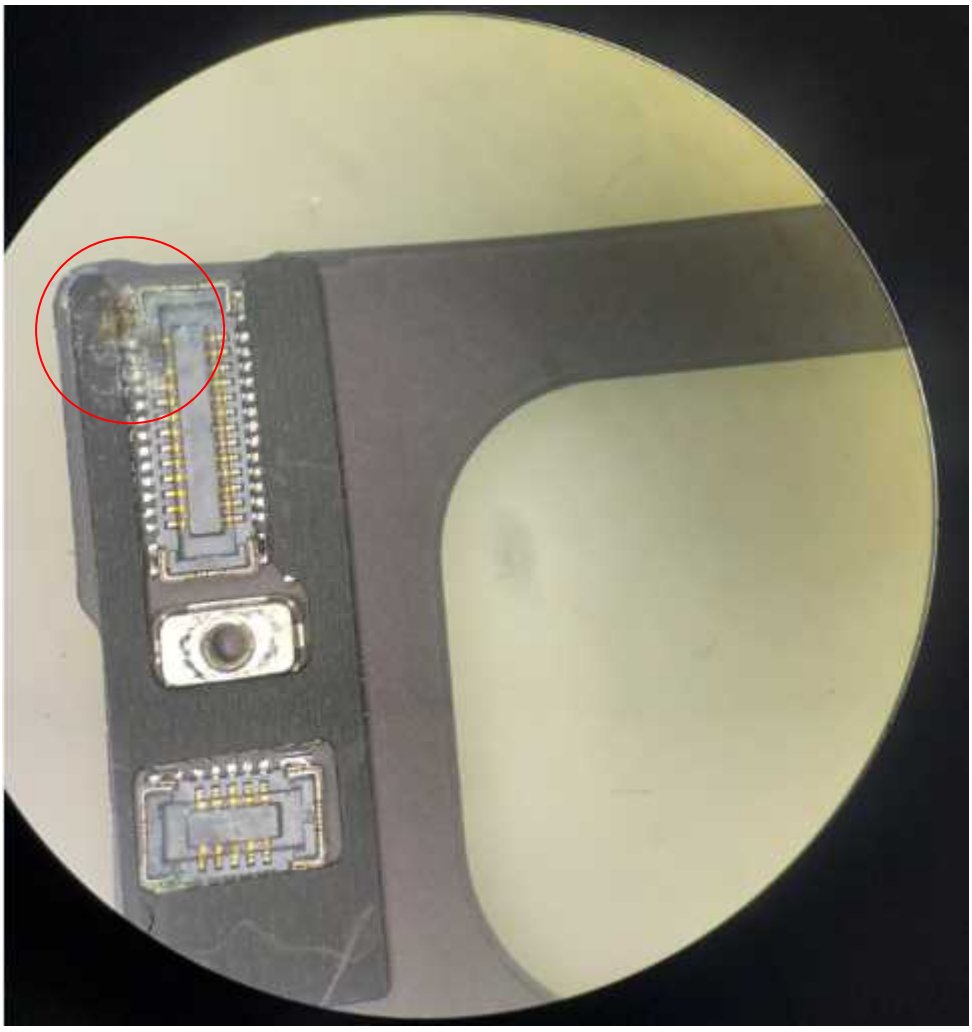
Get the machine, take apart the screen, take off the motherboard, and find traces of water corrosion.

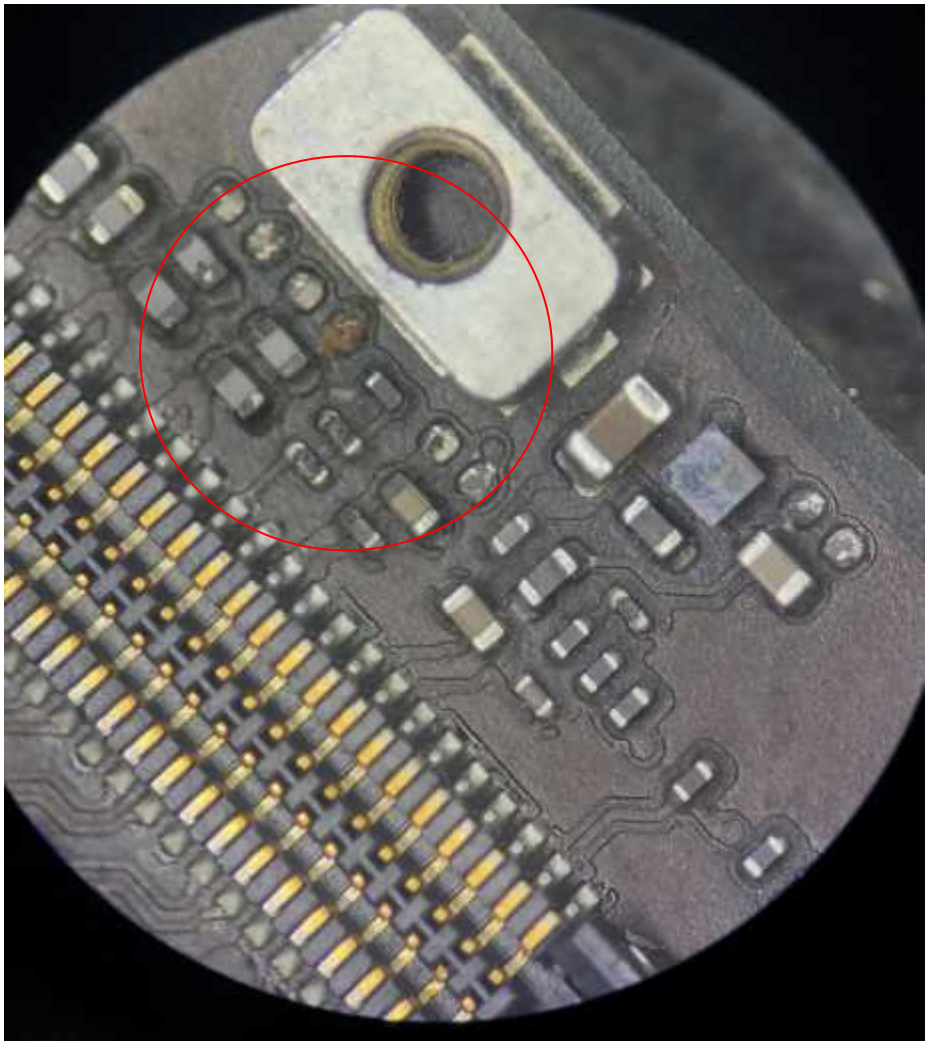
Clean up the place where the water is corroded, and show the corroded capacitor on the side of the connector.

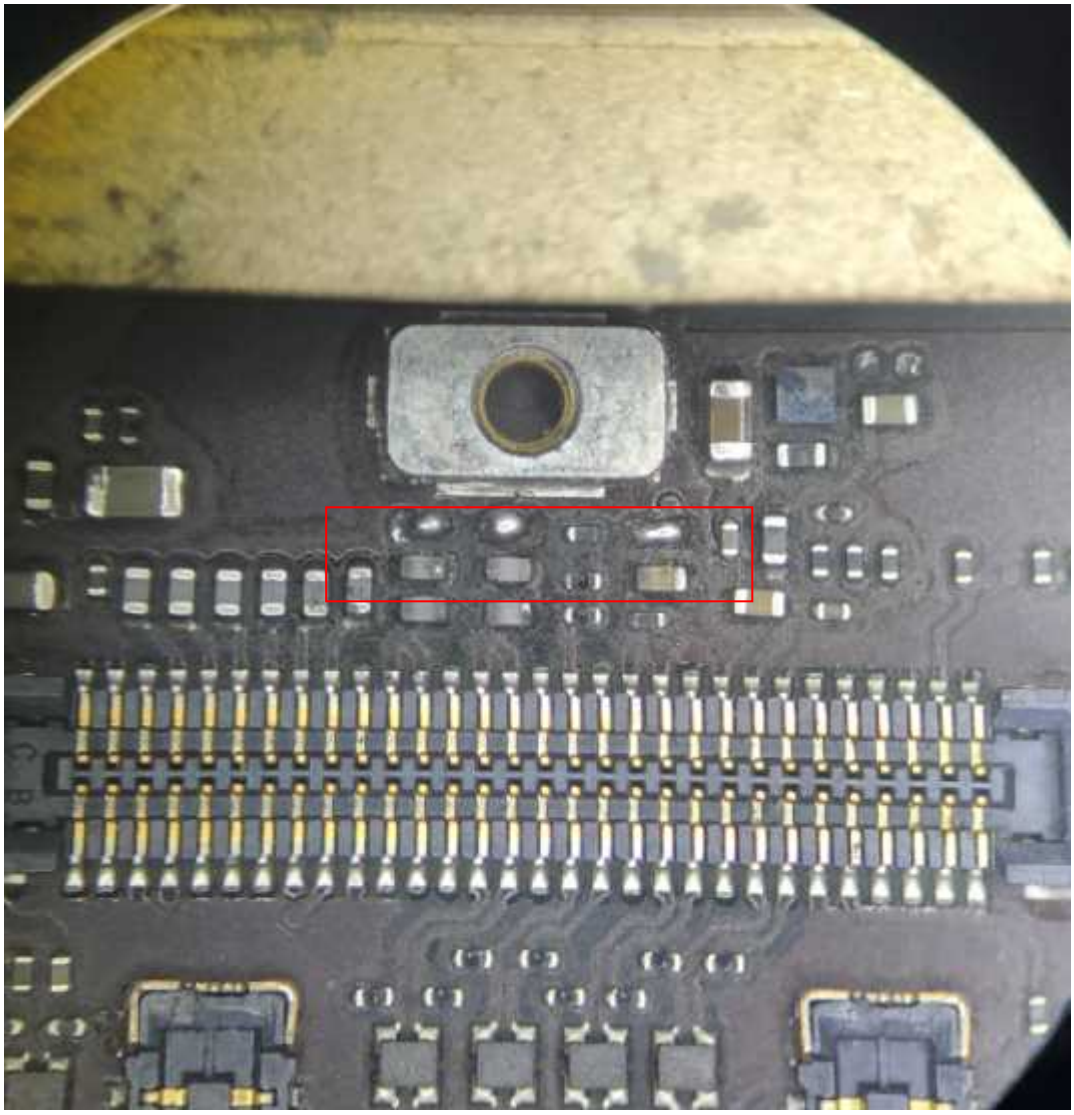
The corroded Inductor is shorted.

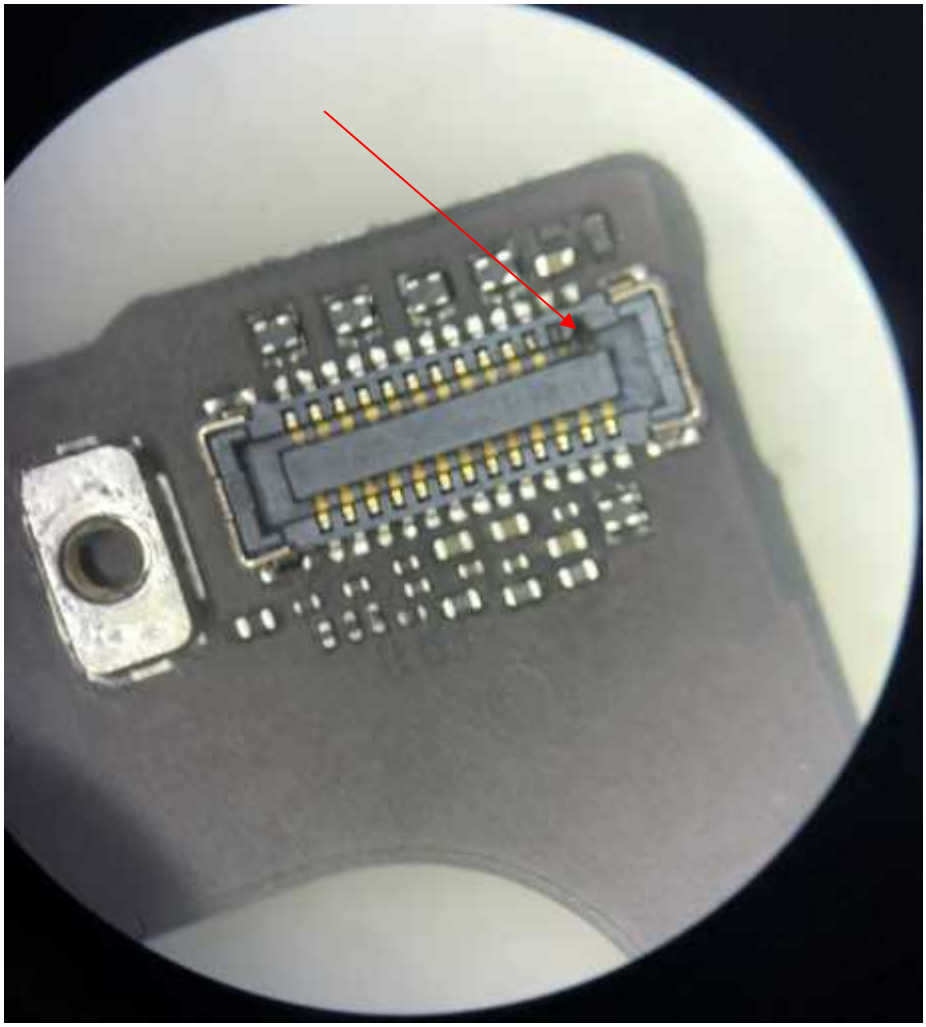
After cleaning the position of the Camera connector.It was found that the foot has been eroded and replaced directly with a rear Camera connector.

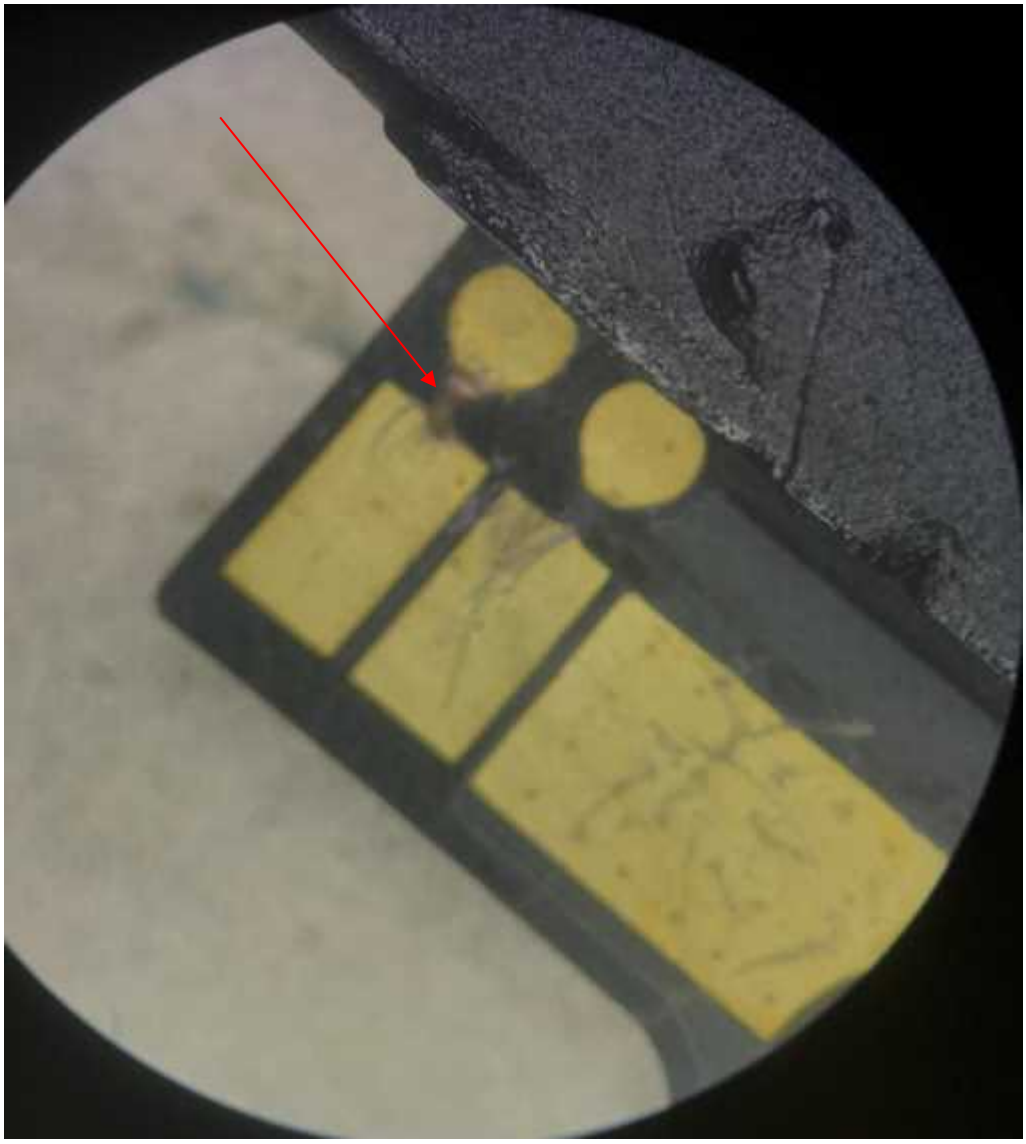
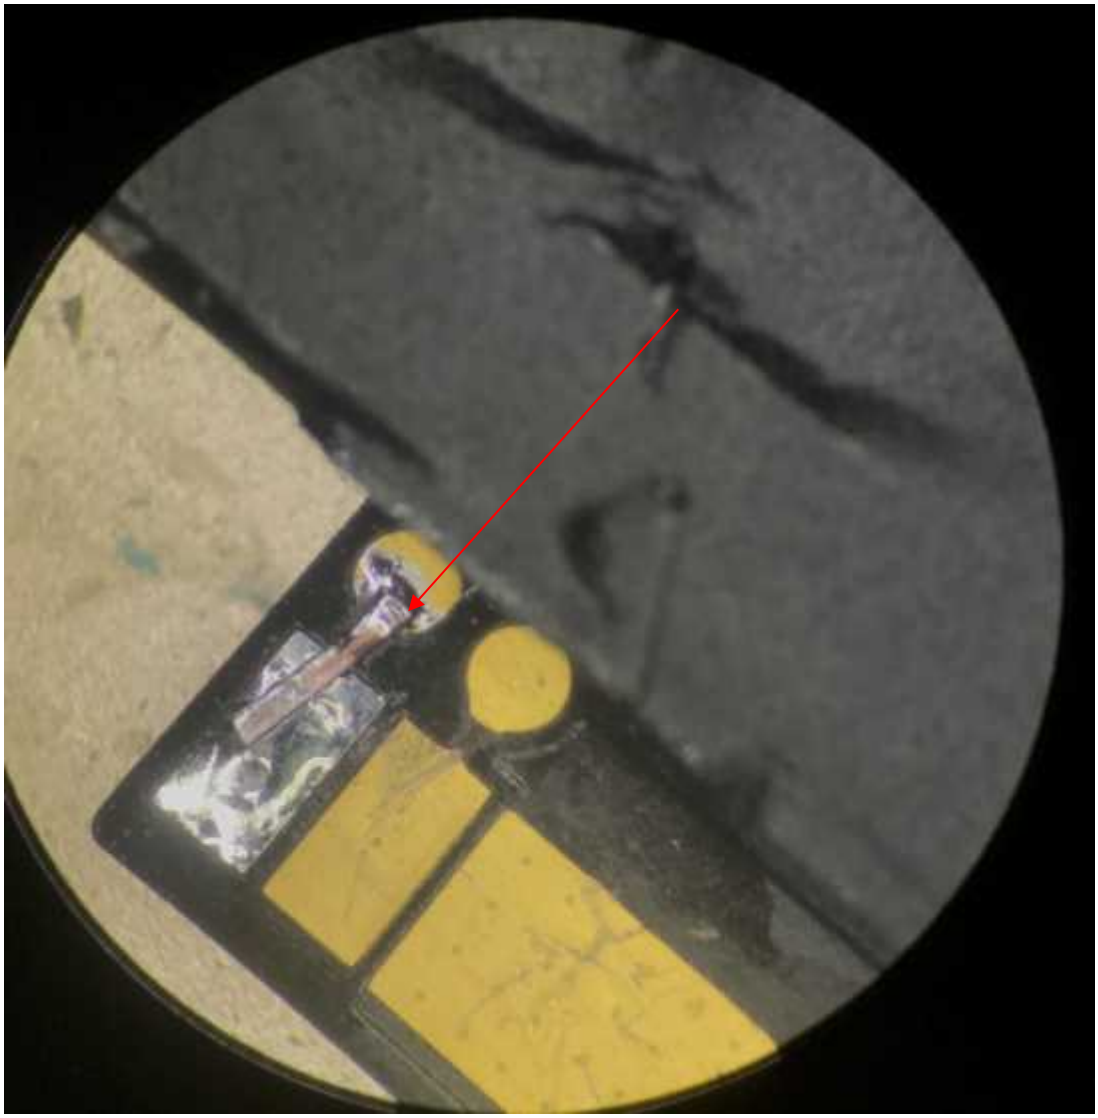
The installation found that it can be turned on, but it is not charged. The test found that the data pin on the battery was corroded and broken, and it was directly processed by Flying wire (connecting two solder joints with thin insulated wires).
