[Faulty model]: iPad Air2

[Fault phenomenon]: no charging

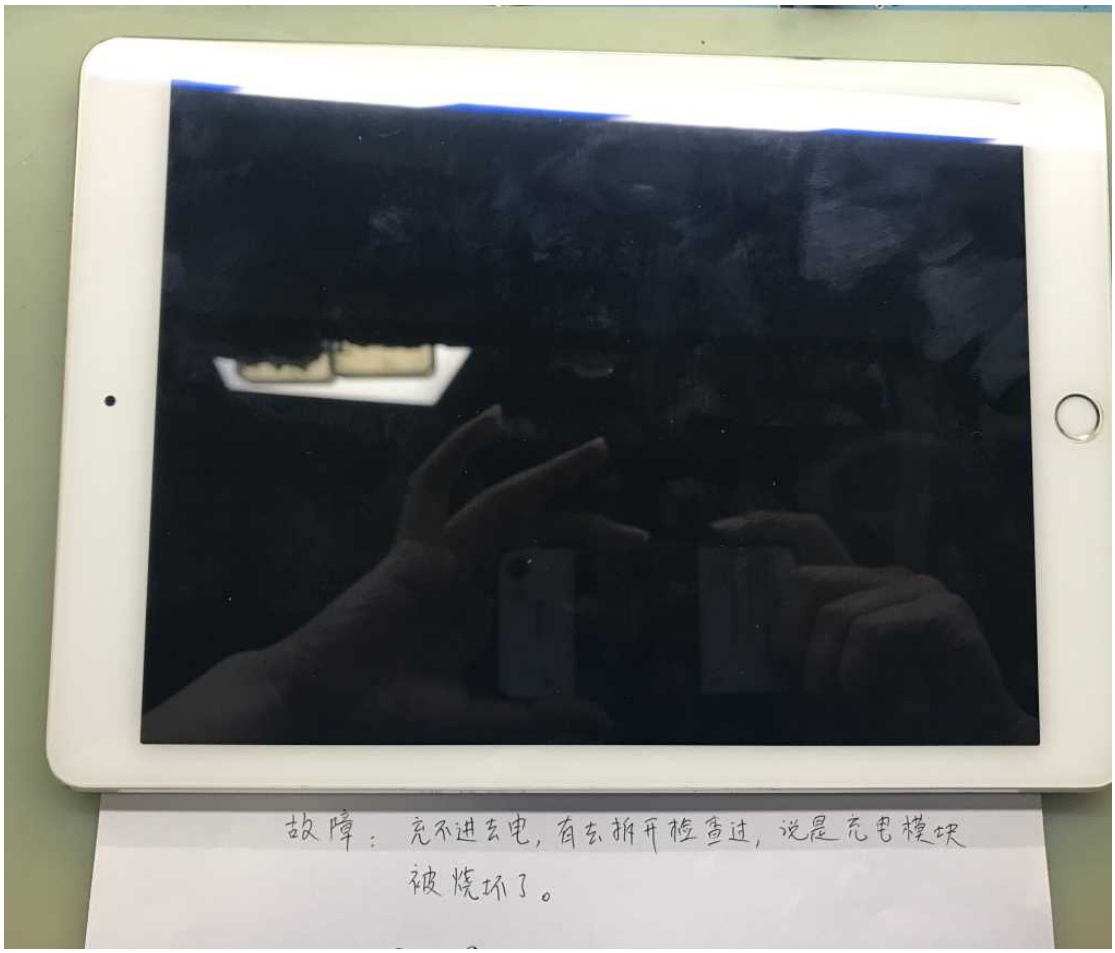
The customer described that the machine was not charged, and it was removed and tested, saying that the charging module was burned out.

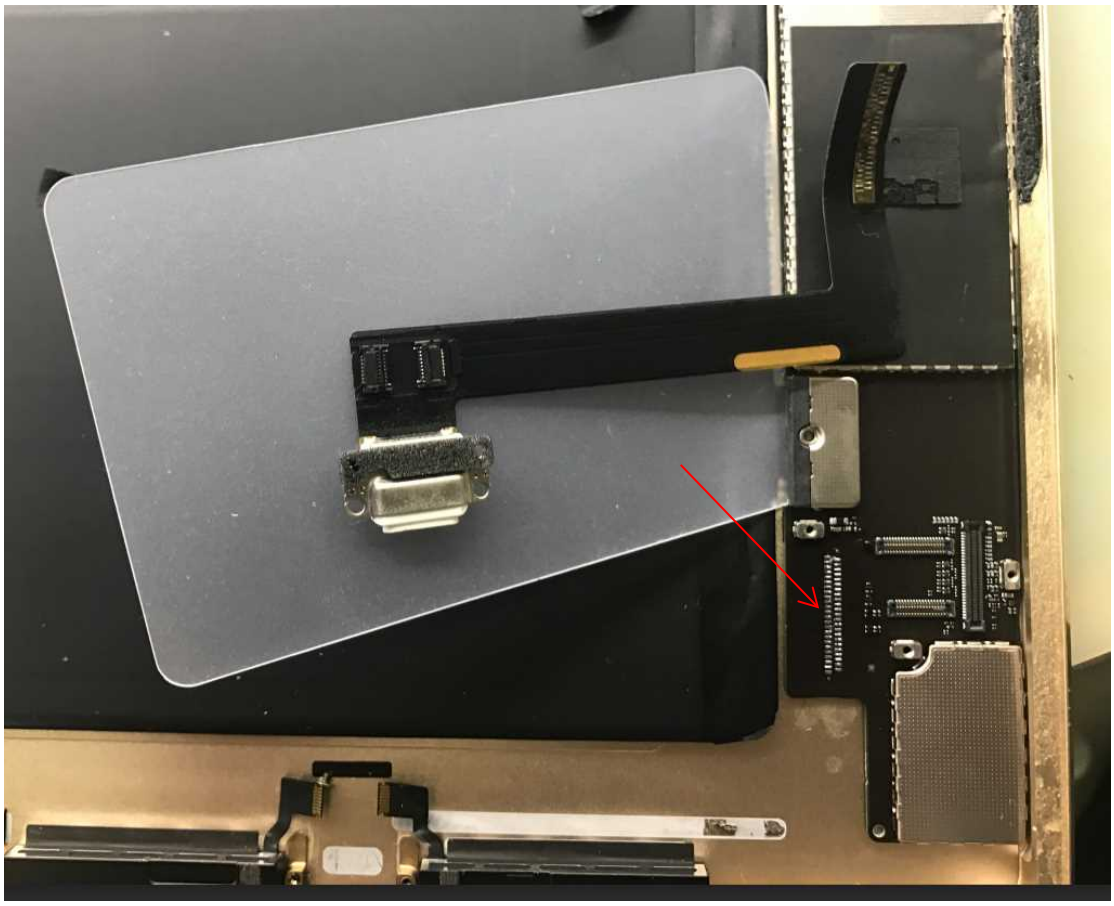
There is no response when the receiver is connected to the charger, and the charging cable is loose. It is likely that the charging connector is damaged.

Remove the switch and remove the charging connector.

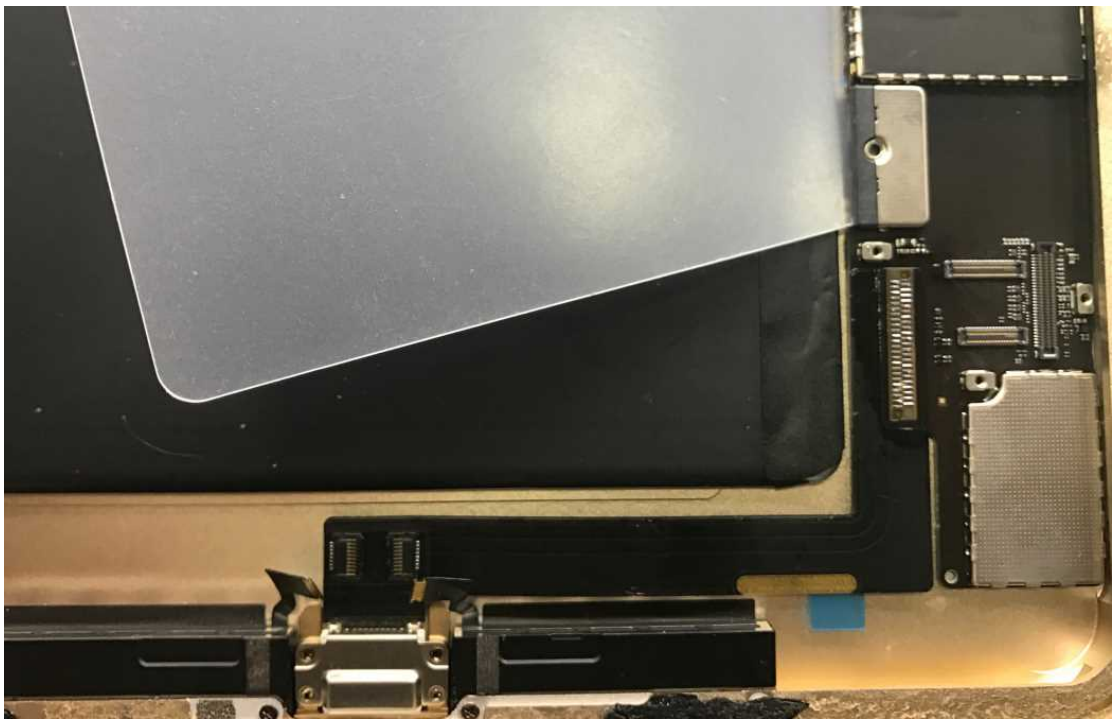
The charger can be charged, the test function is normal, and the repair is over. This fault is caused by the charging connector damage.

Solder the new charging connector back.
