[Faulty model] iPad Air 2

[Fault phenomenon] No Power ON

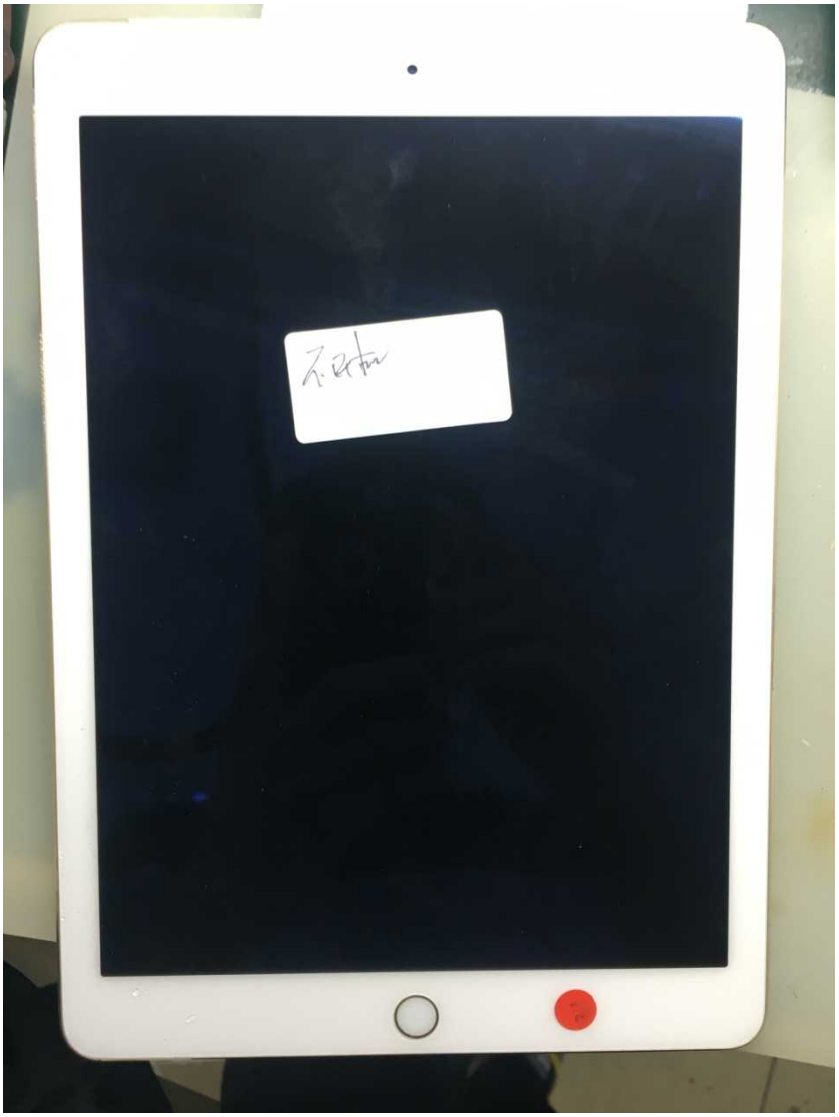
[Maintenance process] The customer described an iPad6 on the second day of charging, No Power ON sent over the inspection and repair as shown:

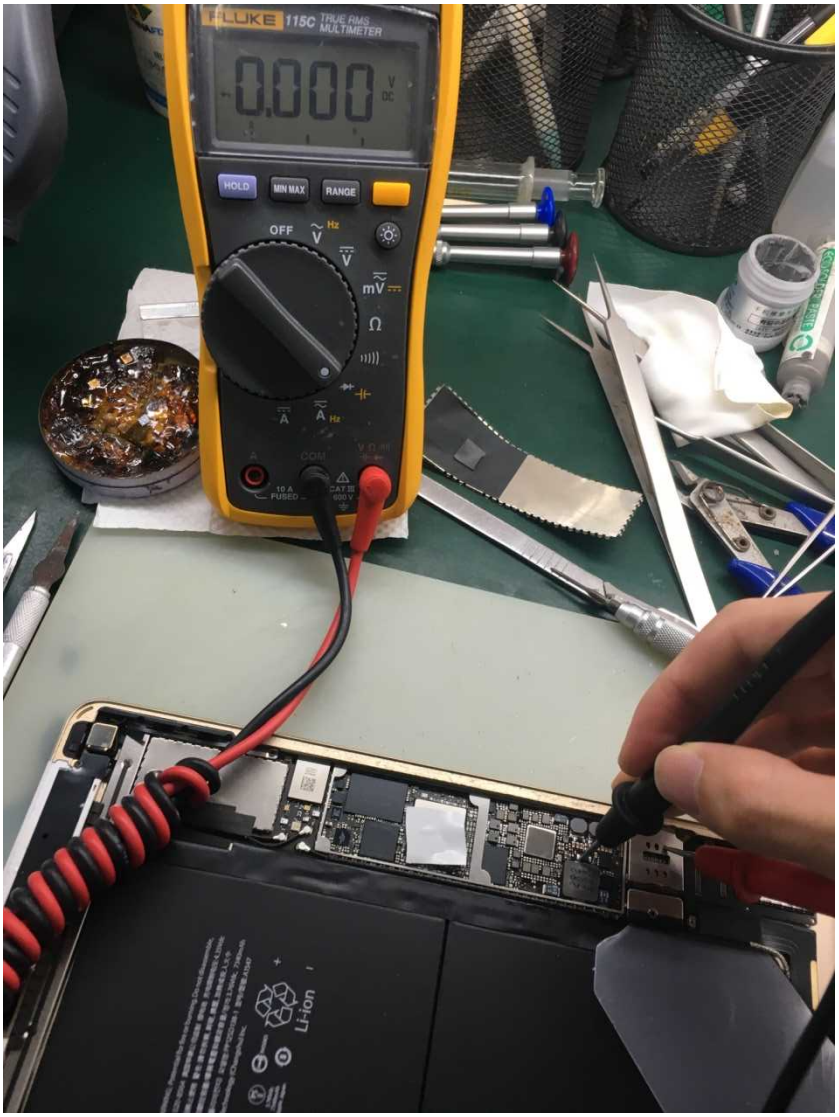
Send it to the heating platform and slowly remove the screen assembly, observe that the motherboard has no obvious charred black originals, and then start measuring the Inductor to the ground diode

value found abnormalities as shown:

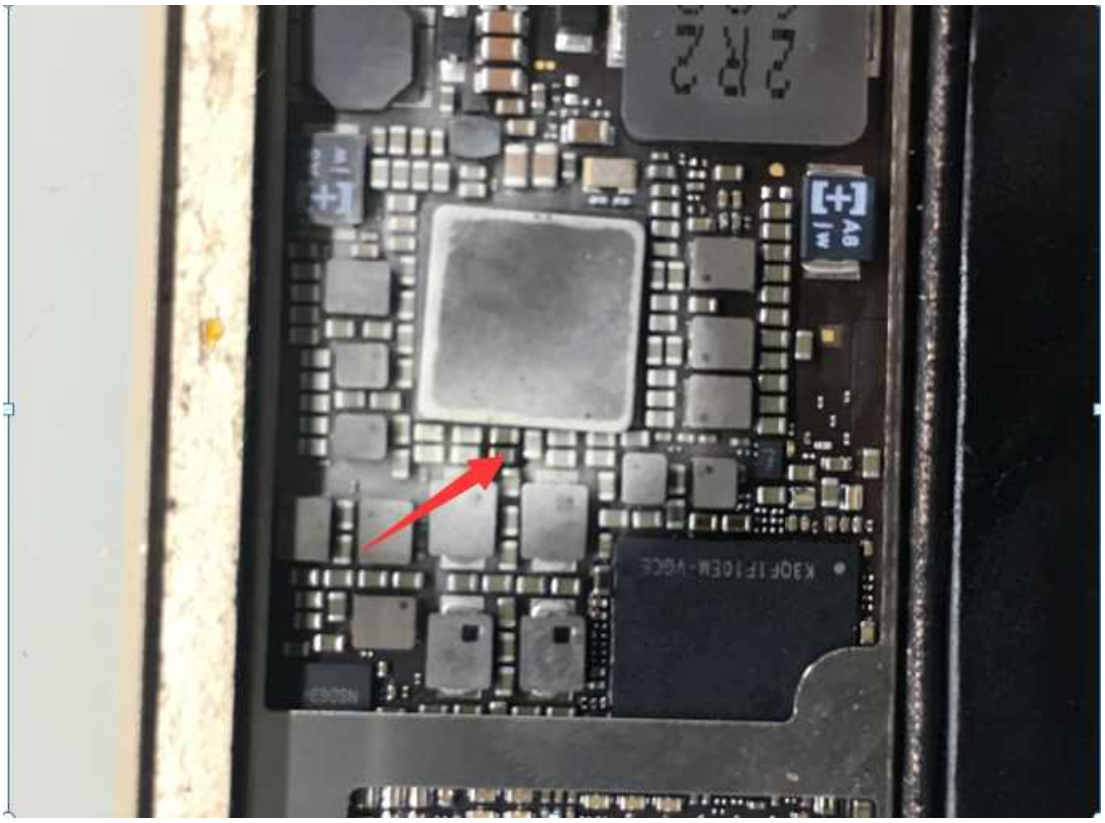
The main VCC PPVCC_MAIN is short-circuited to the ground, using the artifact, the whole board is smoked on the Colophony (Solder) and the fault is as follows:

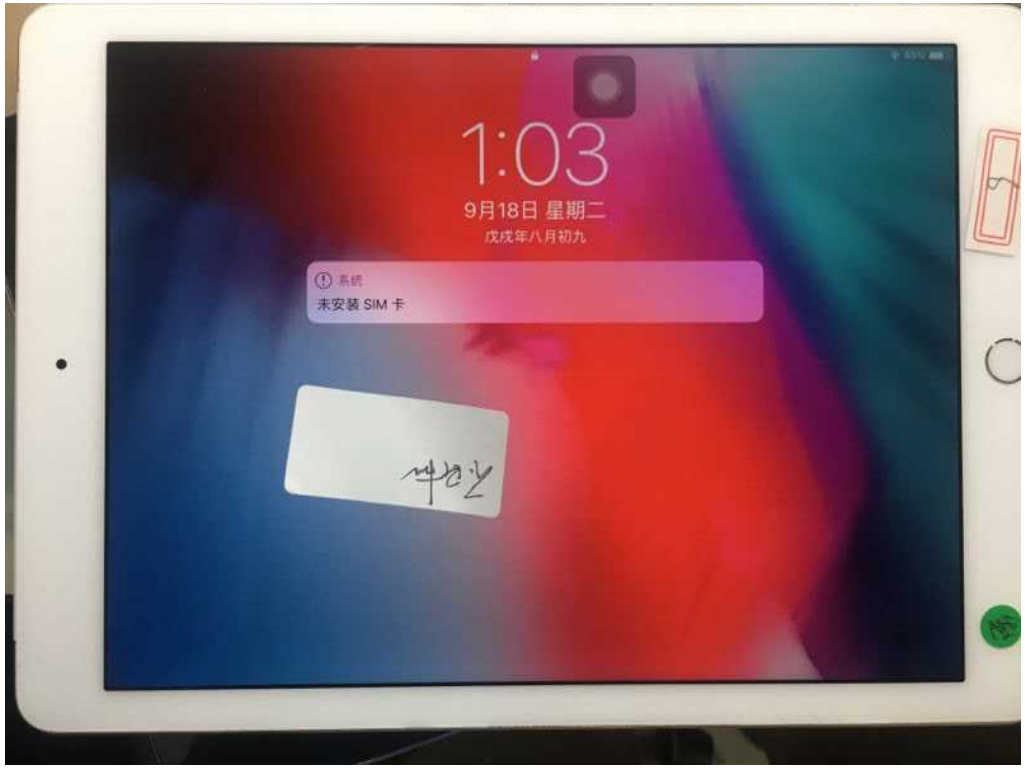
The short-circuited filter capacitor first melts and heats up, decisively deducting the installed detector.
