Air2no touch function repair

Fault model: ipad air2

Symptom: Complete no touch function

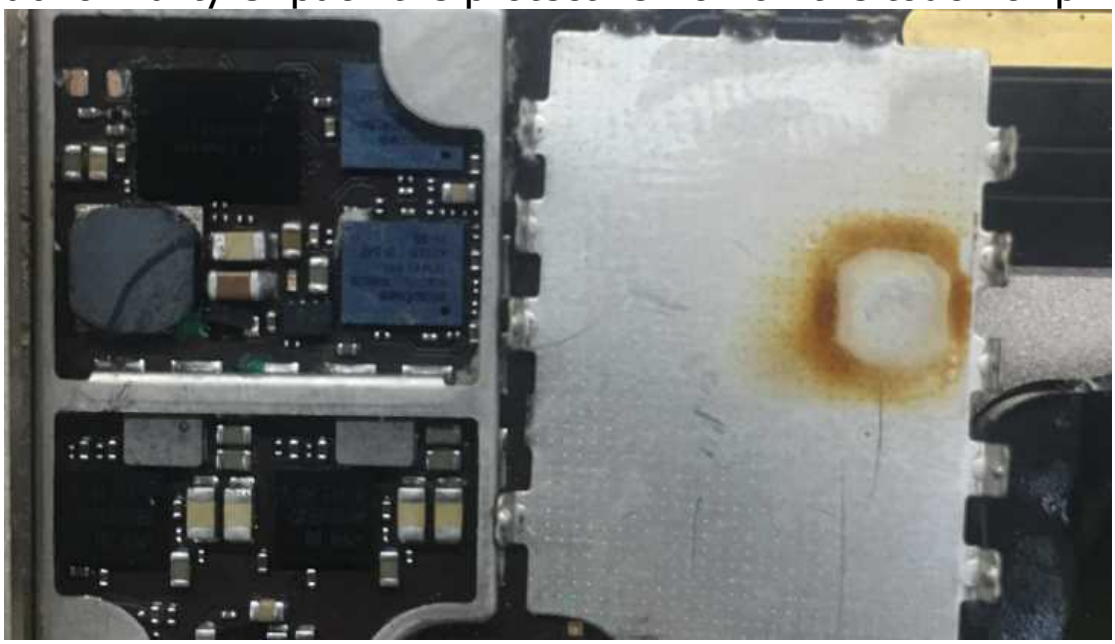
According to the maintenance idea of repairing the touch of the mobile phone in the past, the touch connector is first measured on the ground value, and there is no abnormality.Unpack the protective iron on the touch chip.

It was found that there were burnt marks on the protective iron sheet. It was visually observed that the motherboard had already moved all three touch chips, as well as the Inductor and the diode.The Boardview and the circuit diagram Inductor and the diode are both boost

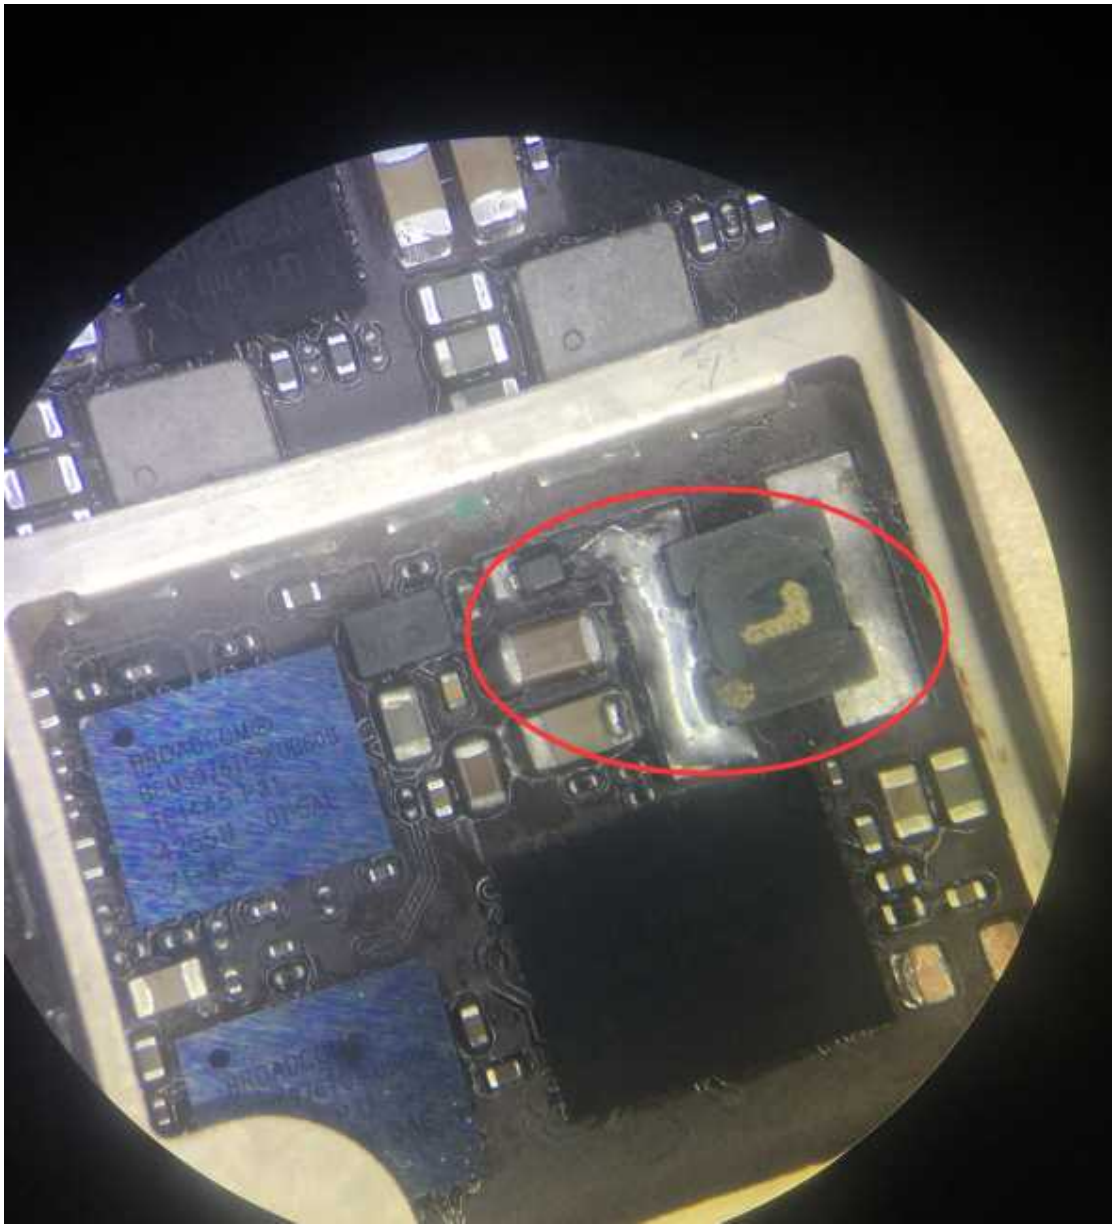
Removing the boost Inductor measurement found that the Inductor has been opened.Replace the Inductor with the diode.

Repair result: After the replacement is completed, the system test is repaired.
