iPad Air2no touch function

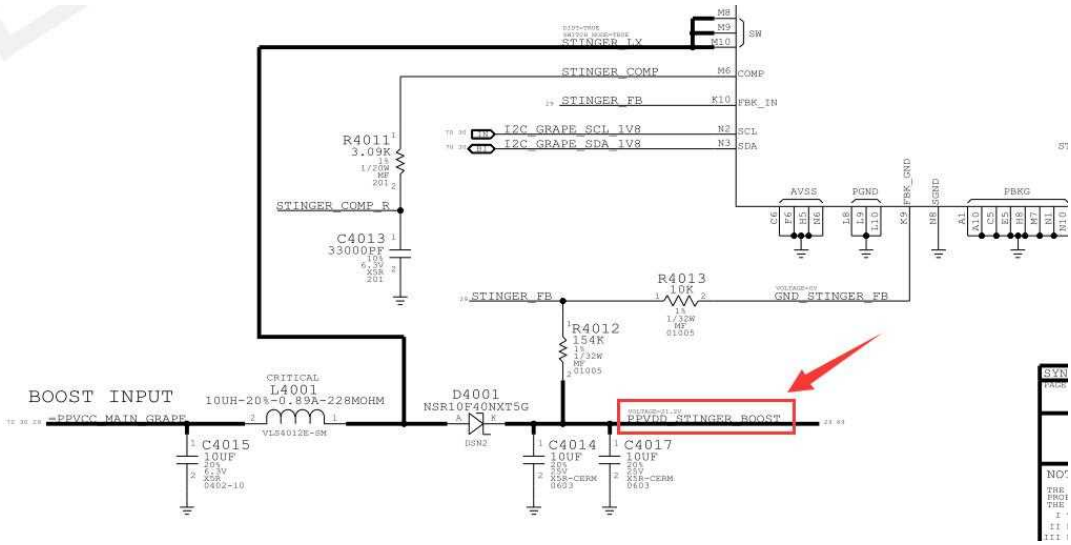
Measuring the touch VCC is found that the PPVDD_STINGER_BOOST voltage is not.

PPVDD_STINGER_BOOST voltage Boardview position

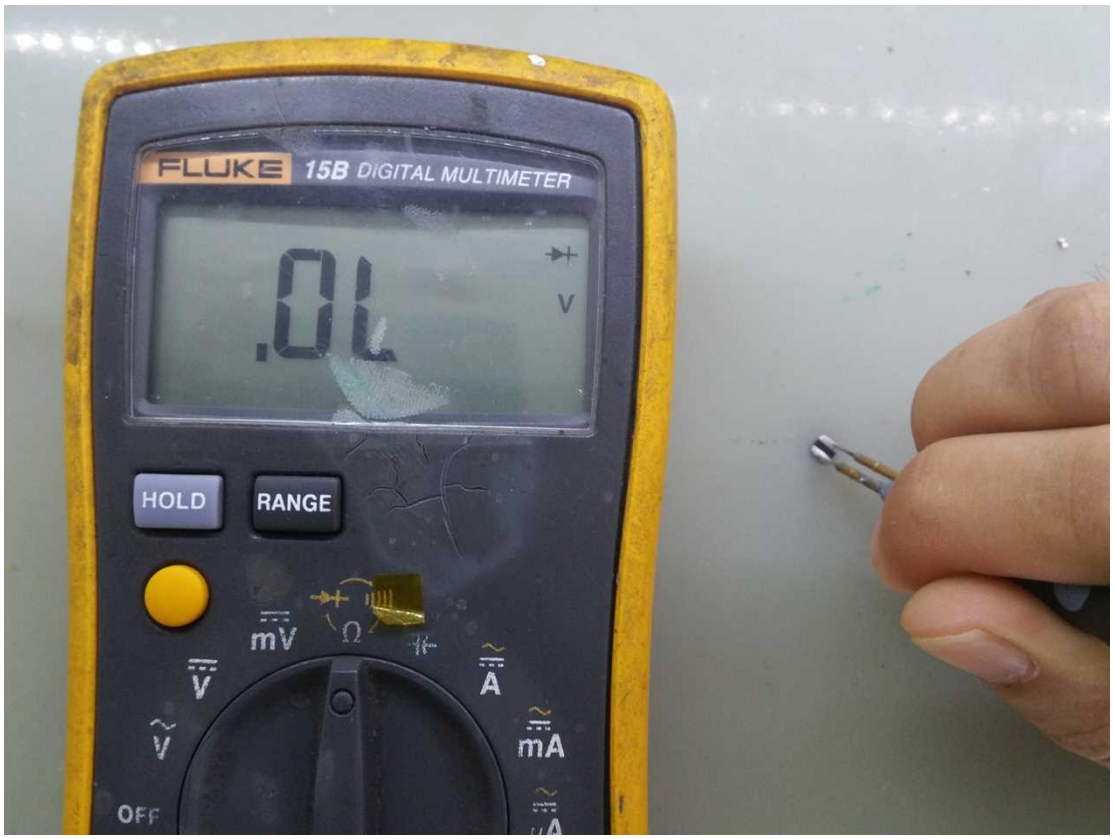
Ppvdd_stinger_boost schematic location

When measured, it was found that L4001Inductor has no dipole value.

In order to ensure that the machine is used to replace the l4001 stably, replace the d4001, c4014 and c4017 by the way.
