Ipad mini break repair

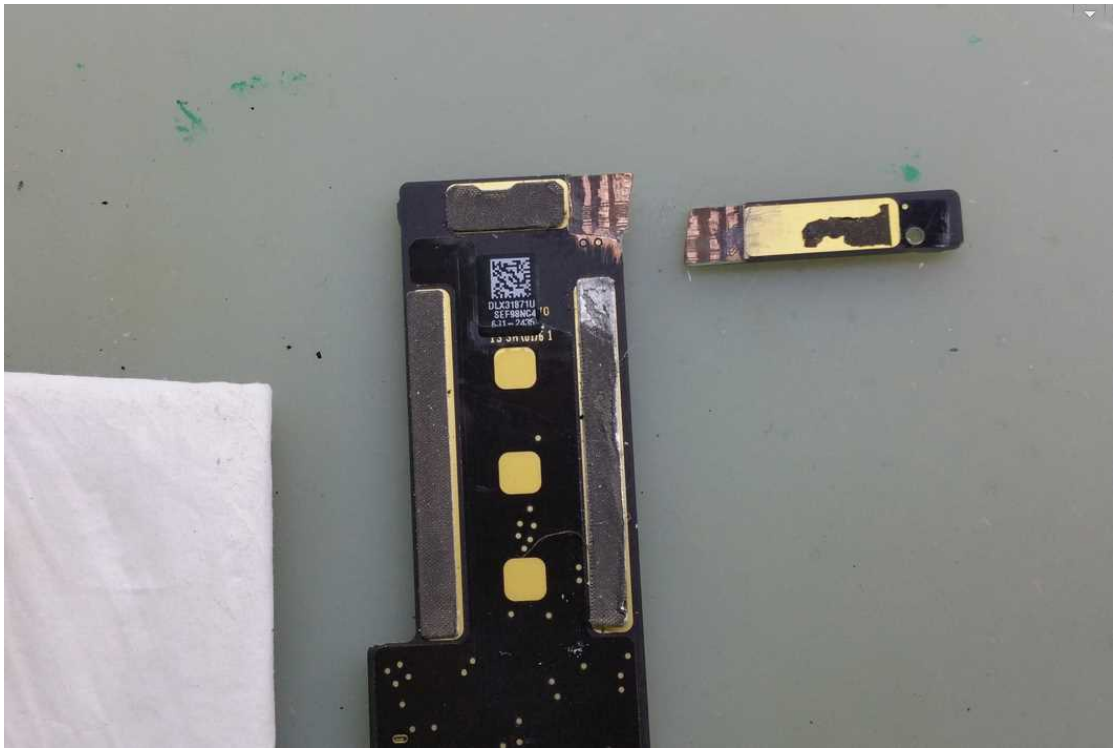
The ipad mini front camera and headphone plug connector head were cut off.

The broken head can be repaired by scraping the PCB layer one by one. The following is the scraped PCB layer. The IPAD MINI main board should be scraped off from the back because the front three layers are all GND.

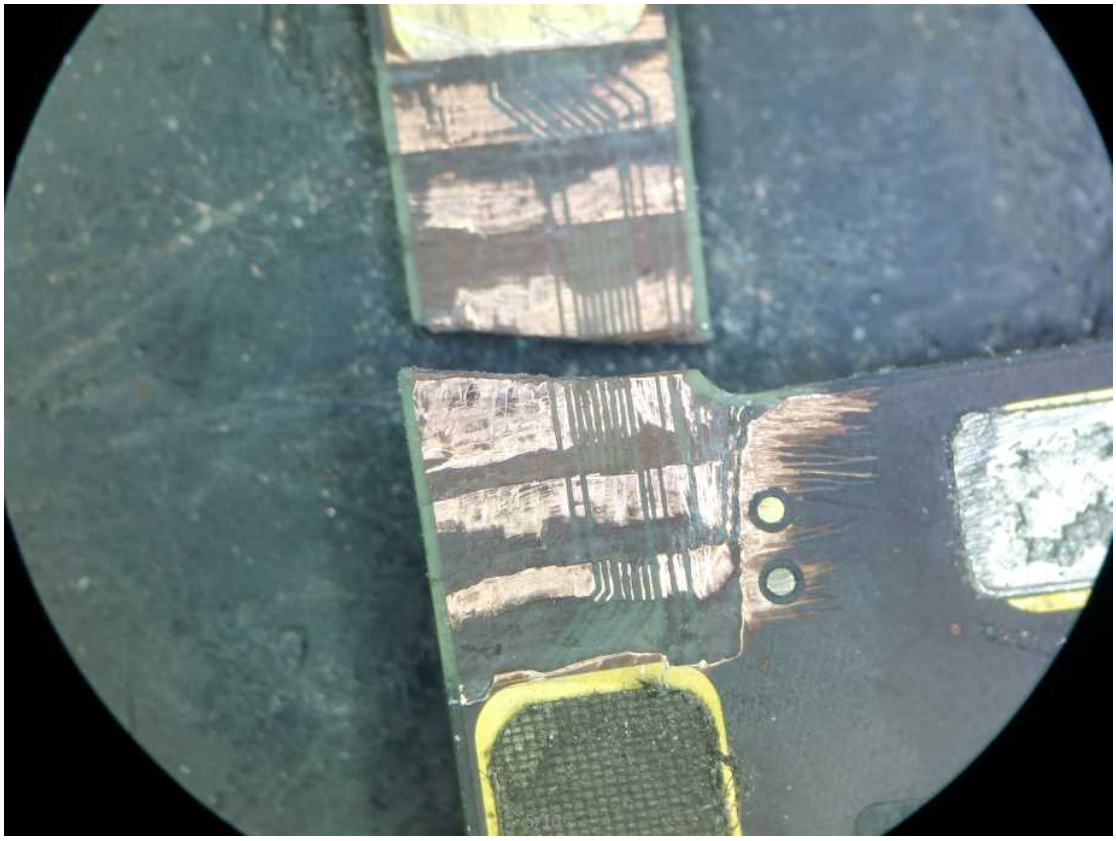
After the ipad mini is scraped open, only three layers have data lines, and the other layers are all ground. It is easier to repair, and the position is neatly arranged after scraping.

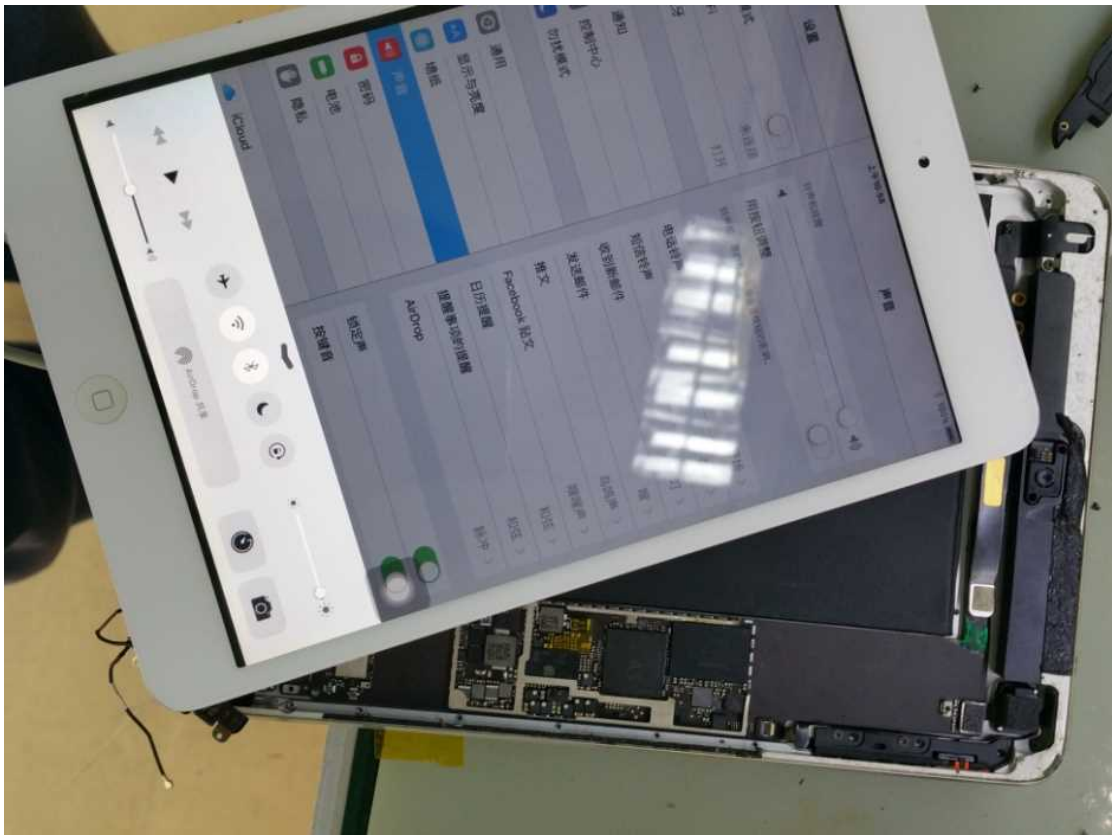
After the patch is completed, the front camera is tested normally.

The test is normal.

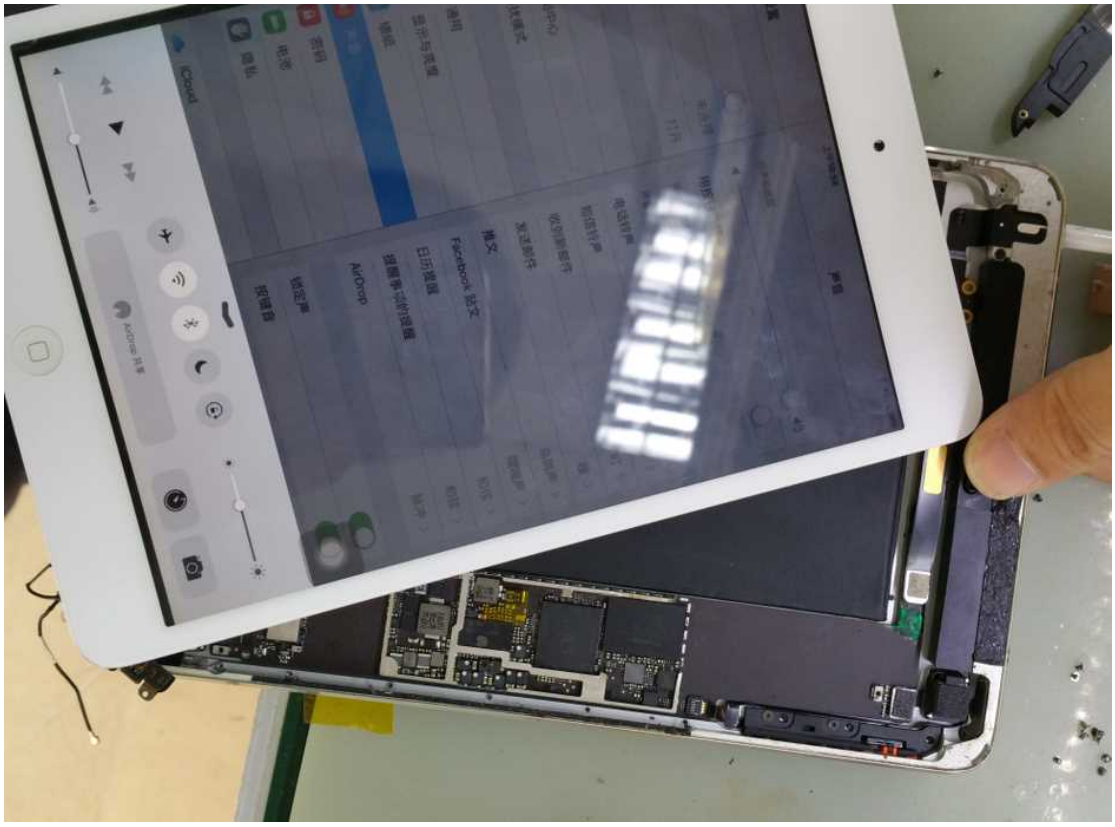
The headset test is also normal and fixes this fault.
