[Fault phenomenon]

Take a repair customer ipad mini specific fault description as shown in the figure,

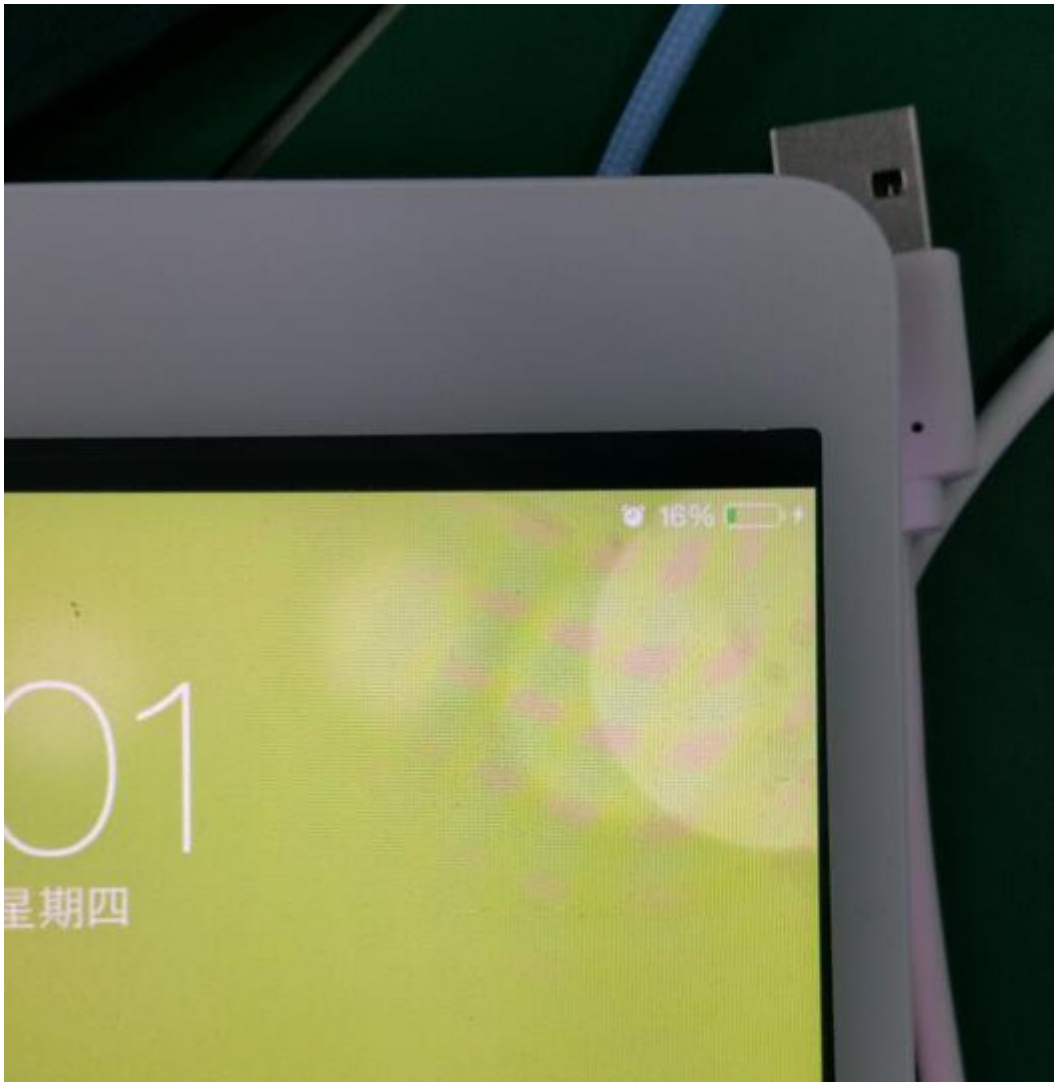
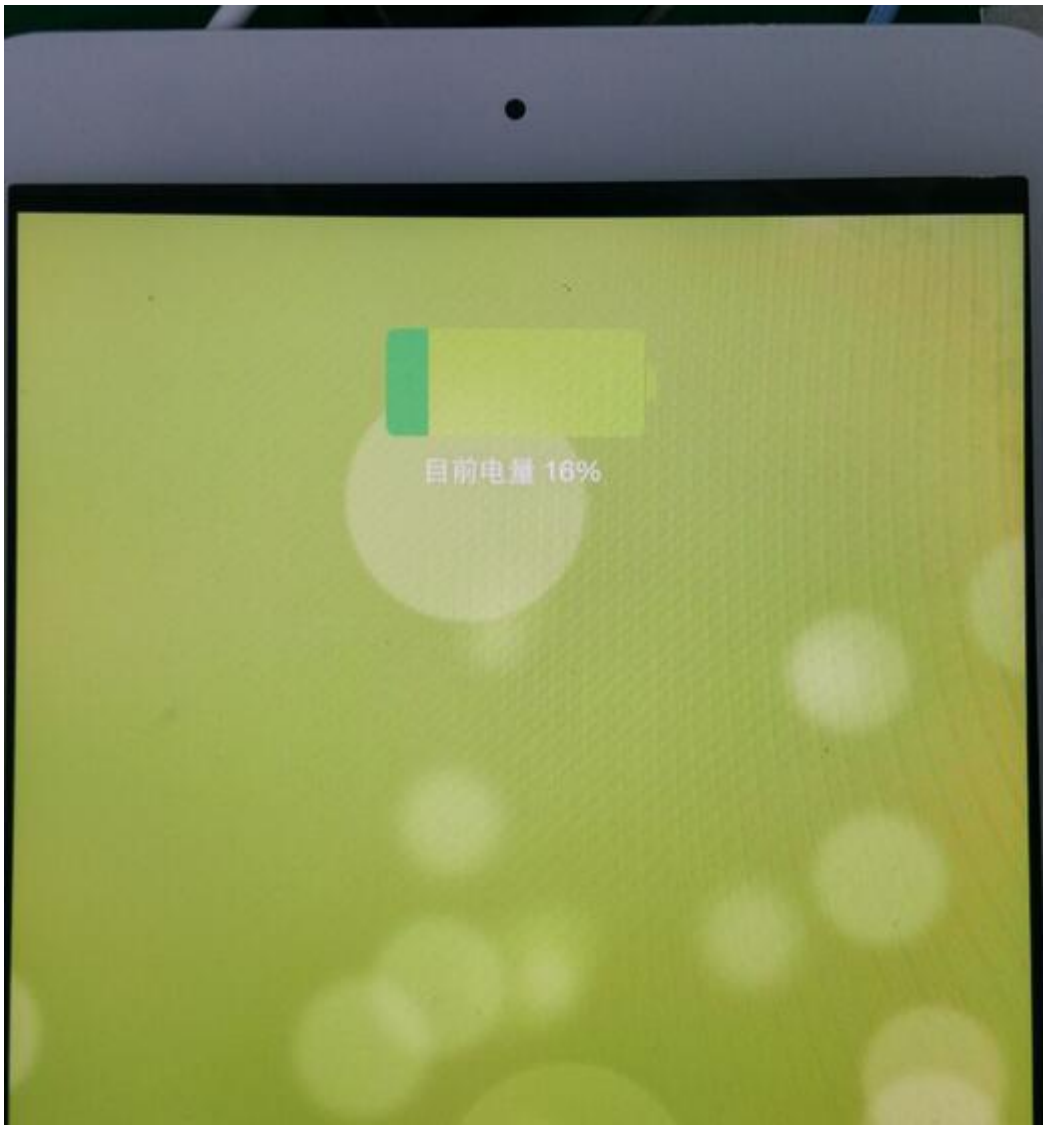
The customer repairs the broken charging connector cable.

After the power-on test, the data cable can be connected and charged normally after the data line is inserted. It is initially determined that the charging connector has no problem and continues to test other functions.

After processing the solder pad, re-solder the good charging connector cable.

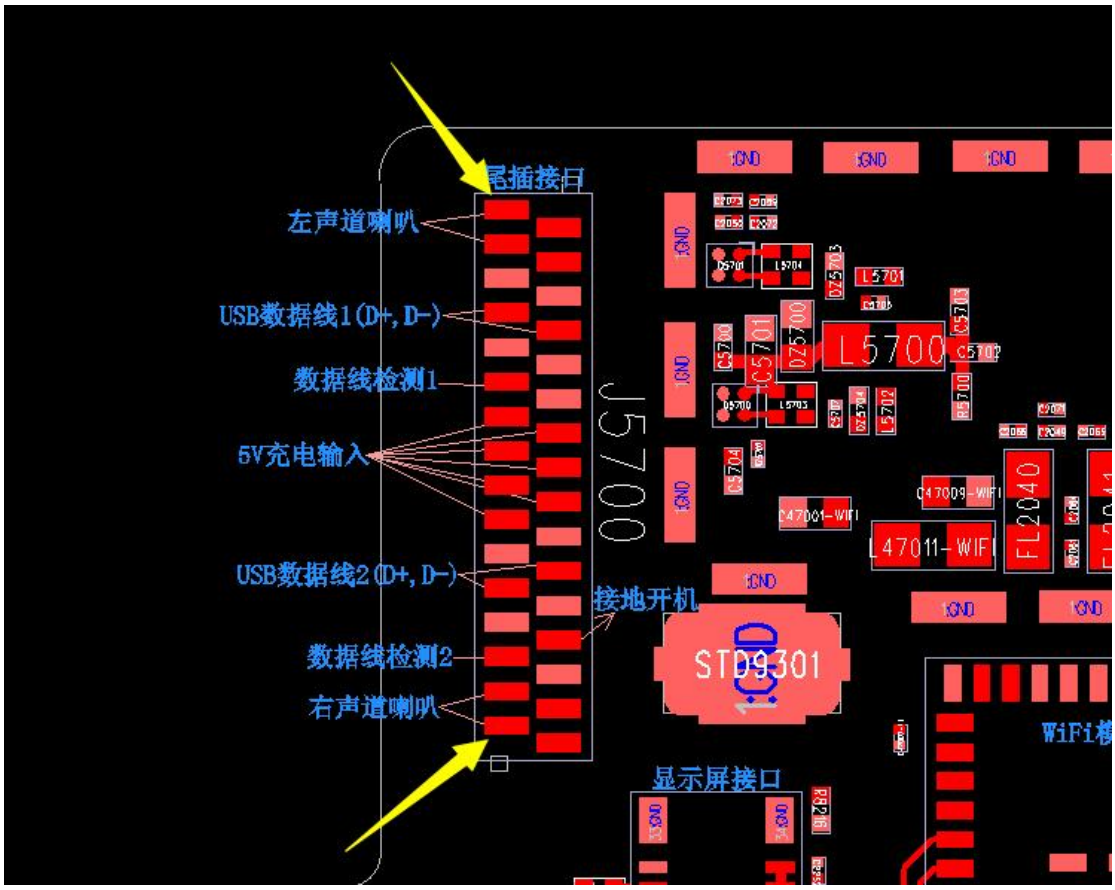
The customer's IPAD is unable to enter the system with a lock screen password, call the customer, and enter the system after going to the lock screen password.When testing each function, there was no sound from the left speaker.Use a multimeter to measure the ground value of the charging connector left and right speakers.

Charging connector has no problem, then it may be a problem with the speaker, because the machine has been in the water before, the speaker has been moldy, so I found a new speaker to replace it, but after the replacement, the left speaker also has no sound, put the speaker to other The test on the machine is normal, indicating that there is no problem with the speaker.

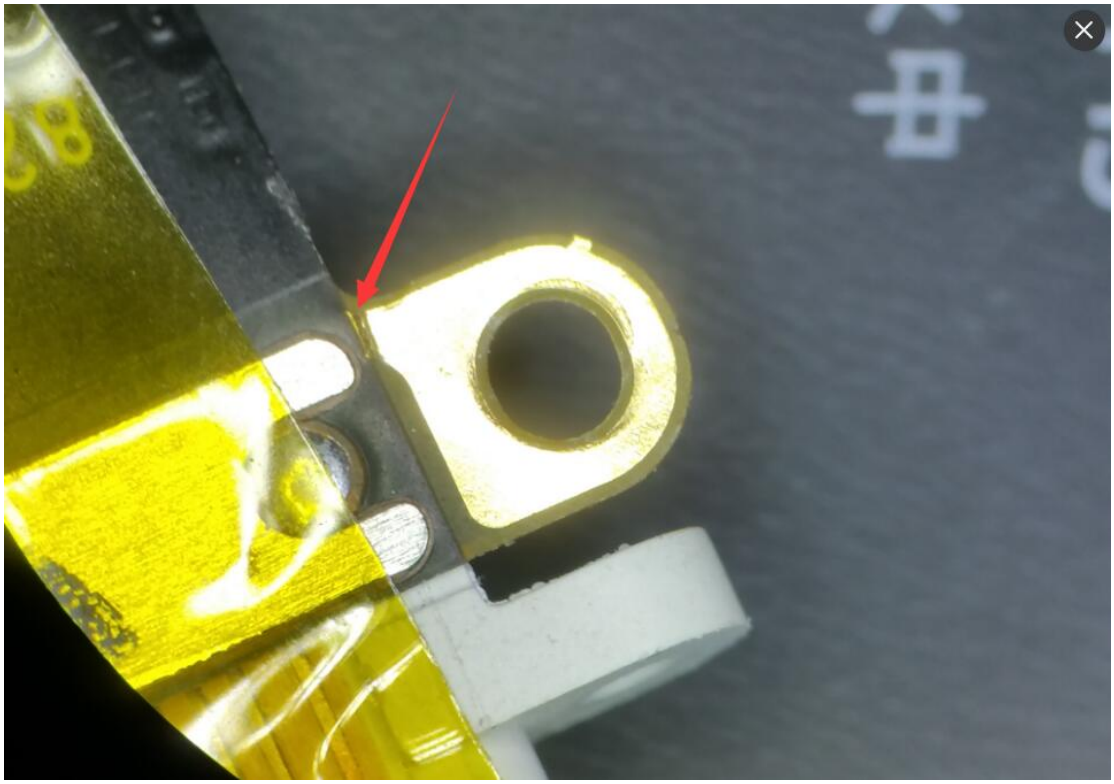
When the charging connector interface is removed and the ground value of the speaker cable contact is measured, it is found that there is no value in the face.Under the microscope, it was found that the contact and the wire were disconnected.

After the repair circuit line is soldered, the fault is repaired.
