Ipadmini has no backlight

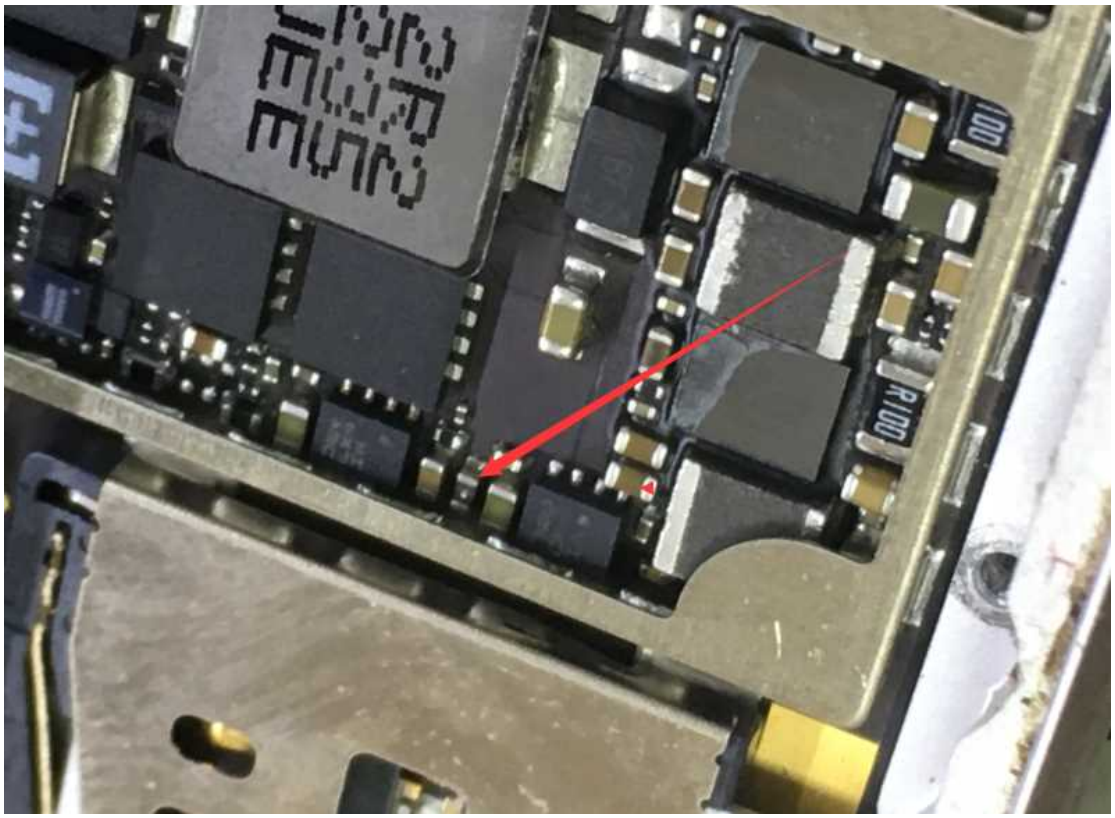
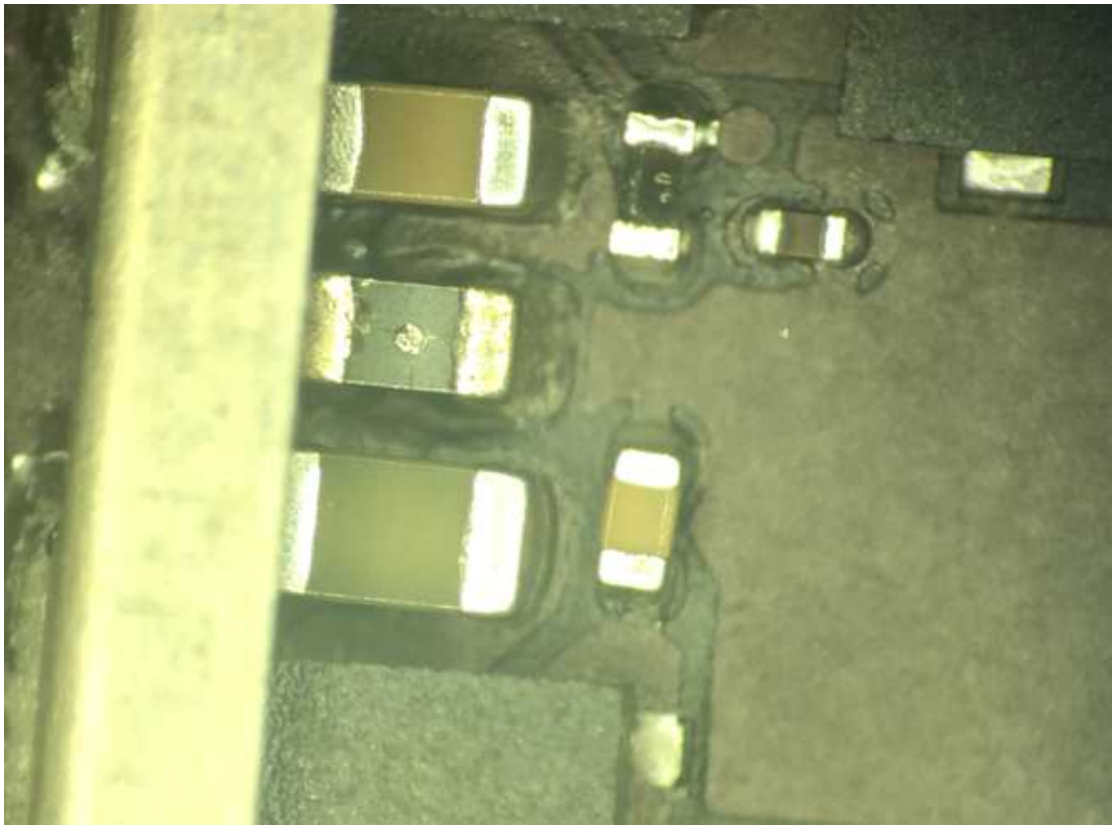
After repairing a customer's iPadmini generation machine, the customer described the fault as the touch screen was broken. When changing the screen, the battery was not burned.
Disassemble the machine to the display panel Test Diode Value(Multimeter uses diode gear, red pen connect GND, black measurement test point) and find that the backlight VCC has an infinity value.Looking for the connection insurance Inductor L2200 along the row of seats, the end of the Test Diode Value(Multimeter uses diode gear, red pen connect GND, black measurement test point) Inductor has a value of infinity.Placed under the microscope to observe that the Inductor has been burned, and the three feet diode value on the Inductor Test Diode Value(Multimeter uses diode gear, red pen connect GND, black measurement test point) row seat are replaced.Connect screen power-on test, fault repair.

Li-ion
0.325
V
DC
RANGE
MIN MAX
HOLD
