MINIno touch function repair

Fault model: mini1

Symptom: Complete no touch function

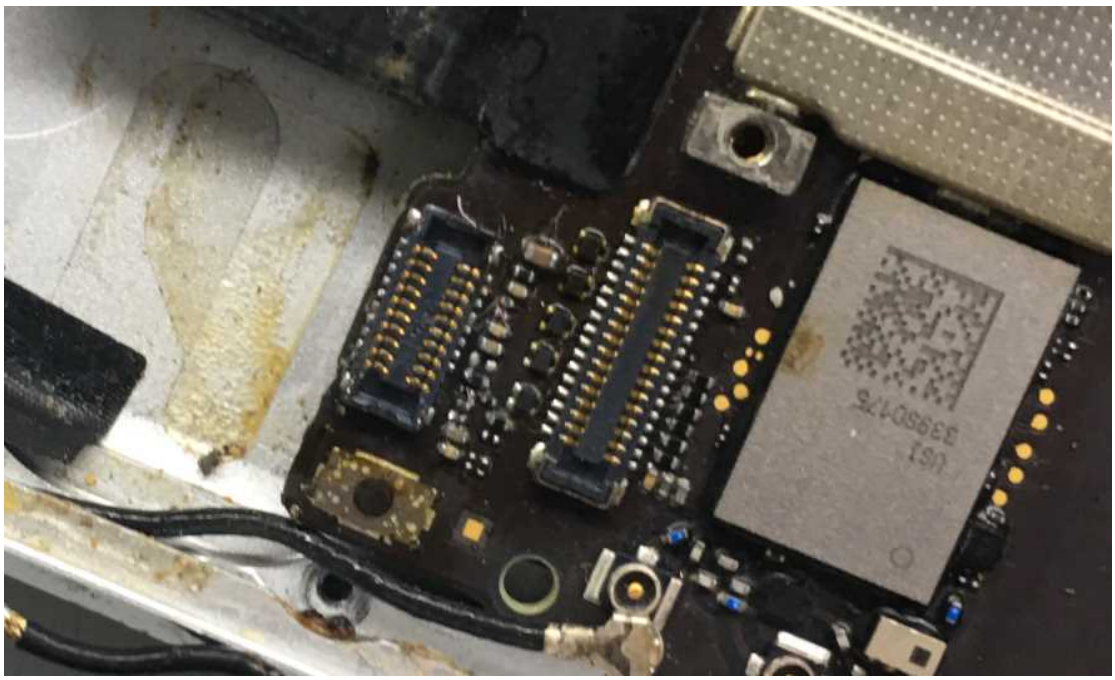
Maintenance process: The disassemble test found that the touch connector has repaired traces.

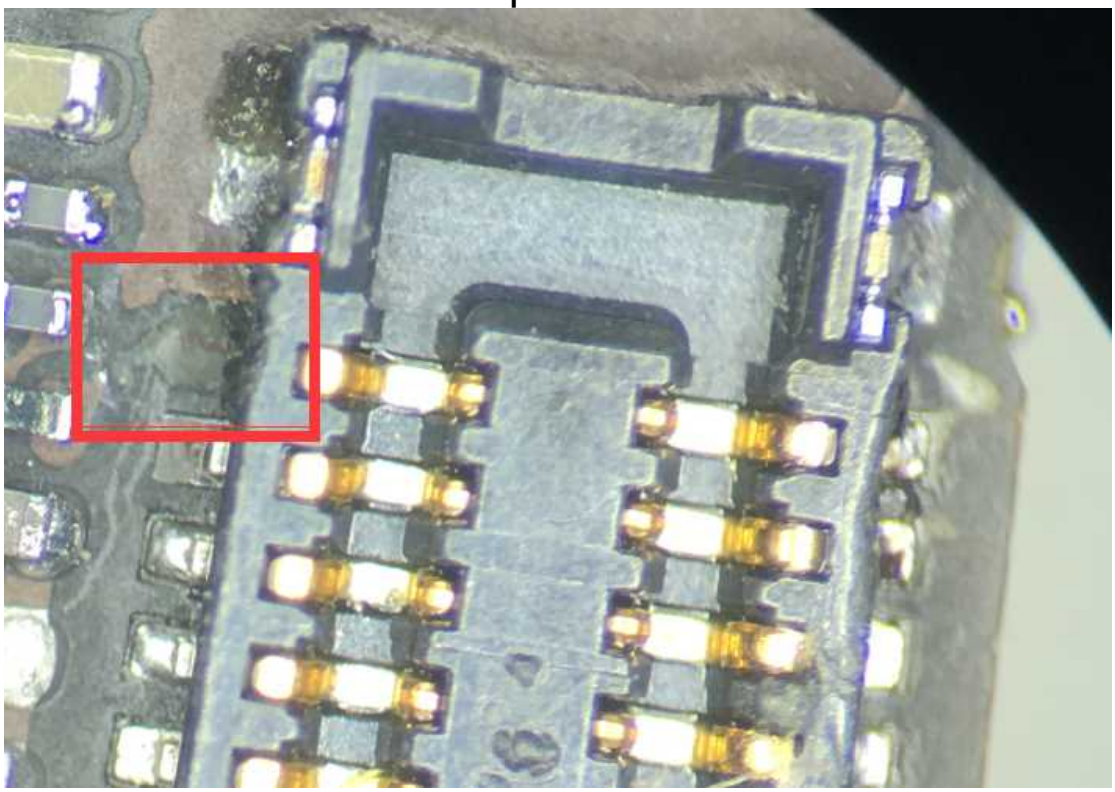
Fault analysis: MINI1 and MINI2 touch connector is easy to break.

Under the microscope, the connector was touched and it was found that one solder pad had fallen.
