Mini1 changes the screen by itself, causing no charging and no touch

[Faulty model]: Apple mini1

[Fault phenomenon]: changing the screen causes no charging and no touch

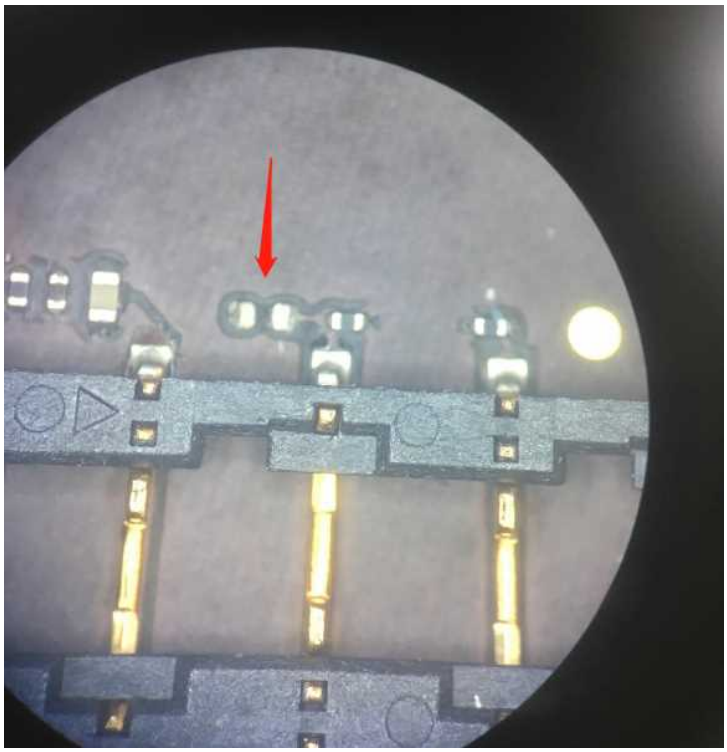
[Maintenance process]: Received a MINI1 tablet from the customer, the fault description touch screen connector is damaged and charged abnormally.It is already obvious that the customer does not charge and does not touch the touch screen.Disassemble the screen and see that there is a noticeable drop in the side of the motherboard battery connector, and the connector has lost four feet.

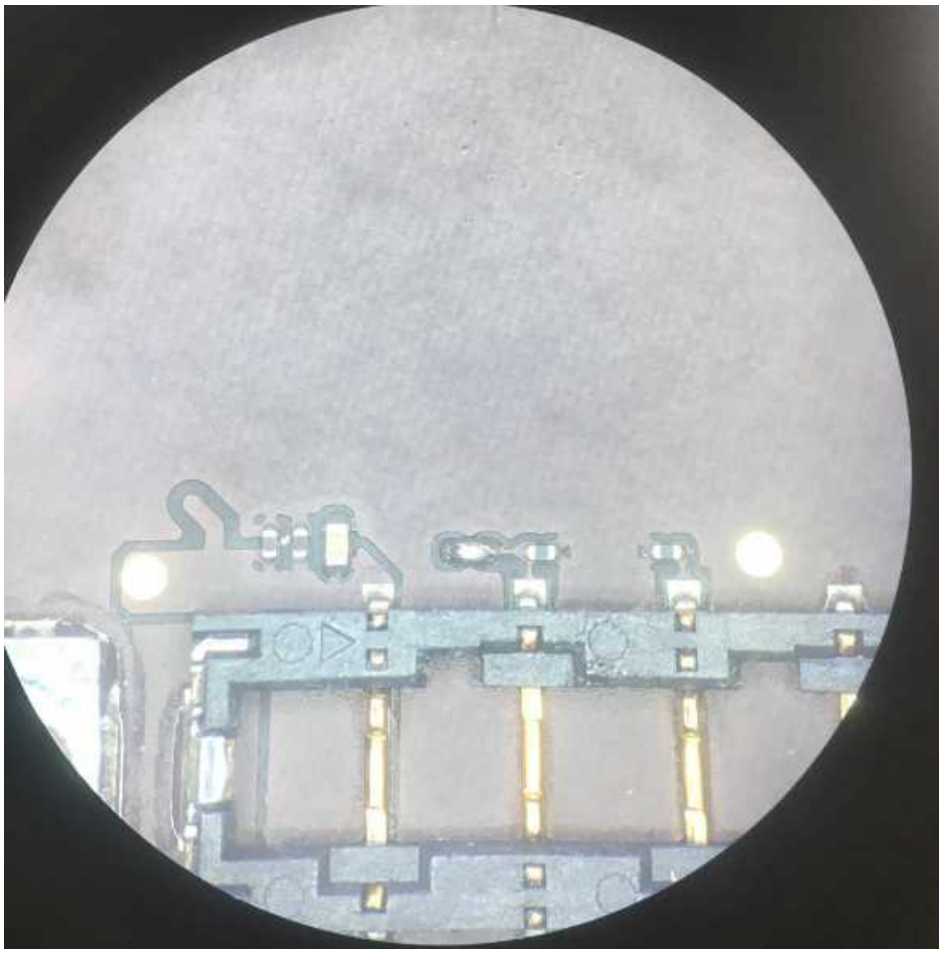
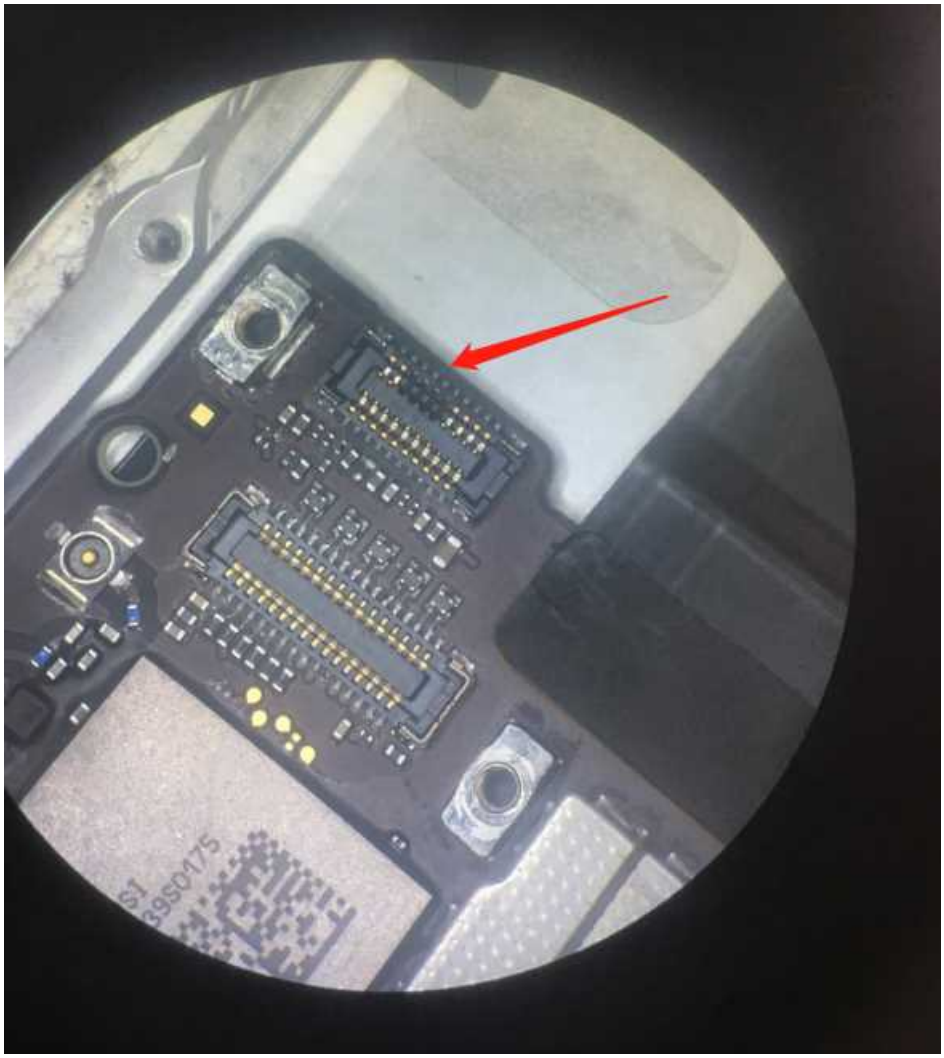
Direct short-circuit insurance Inductor

Since the touch connector has lost its foot, only the connector can be replaced.

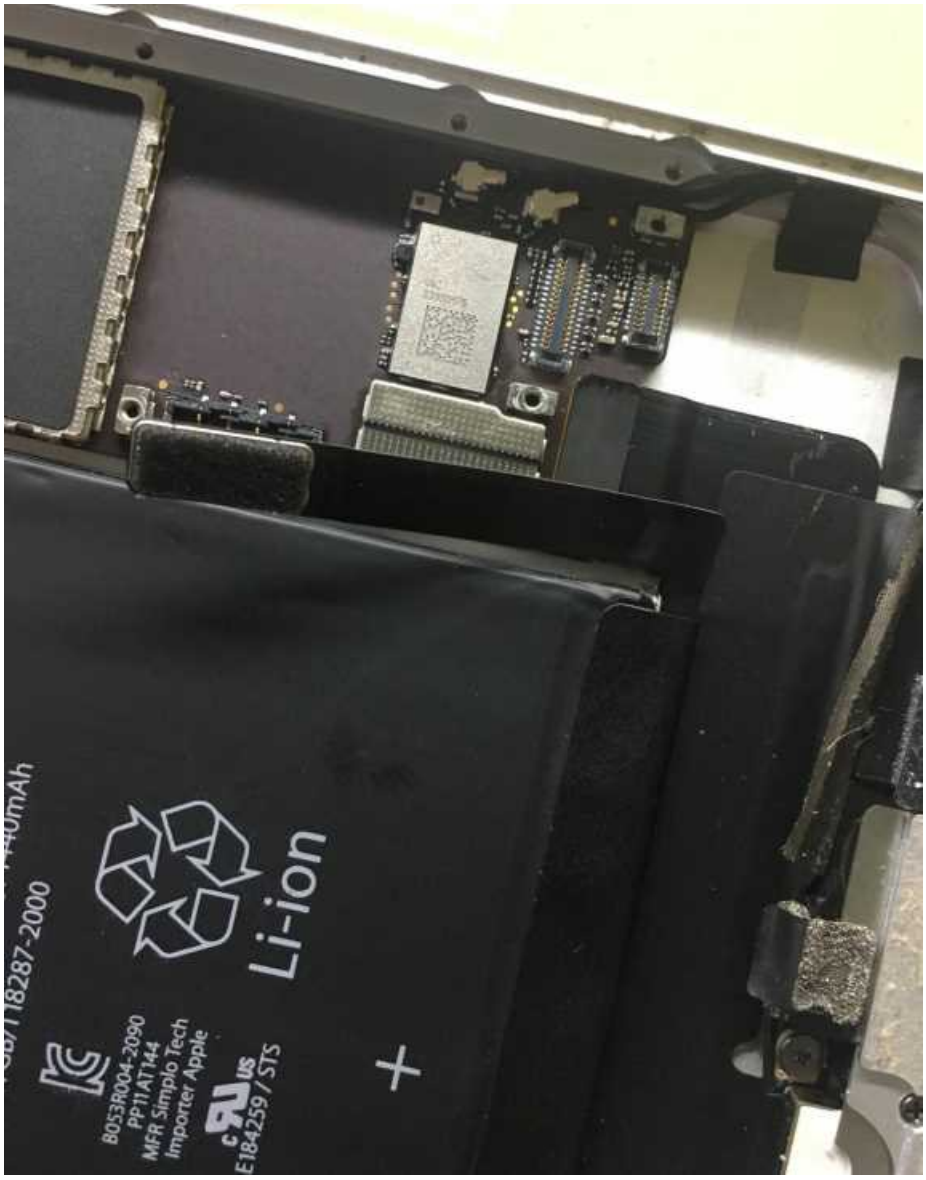
After the connector is replaced, the installation test

The function is all normal, the repair ends here.
