Ipad mini1 tablet does not display fault repair

One of the customer's ipad mini1, the fault is not displayed when booting.

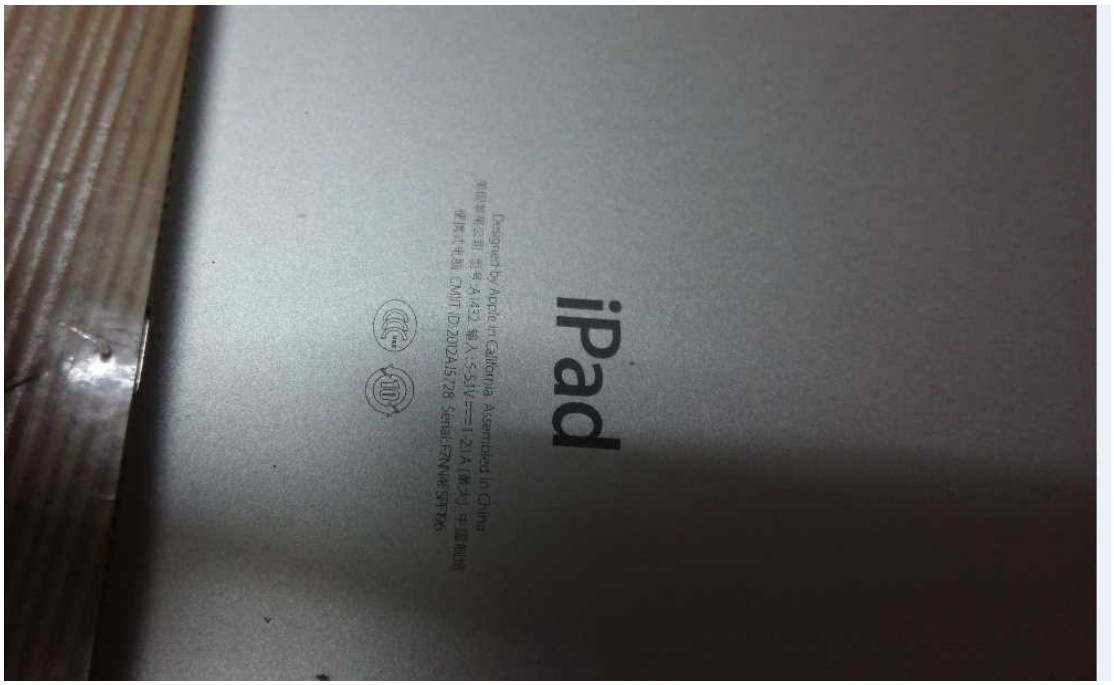
got the machine and the screen was broken. The customer said that the good machine suddenly fell to the ground, and the screen did not show up after the screen was broken.Pictured:

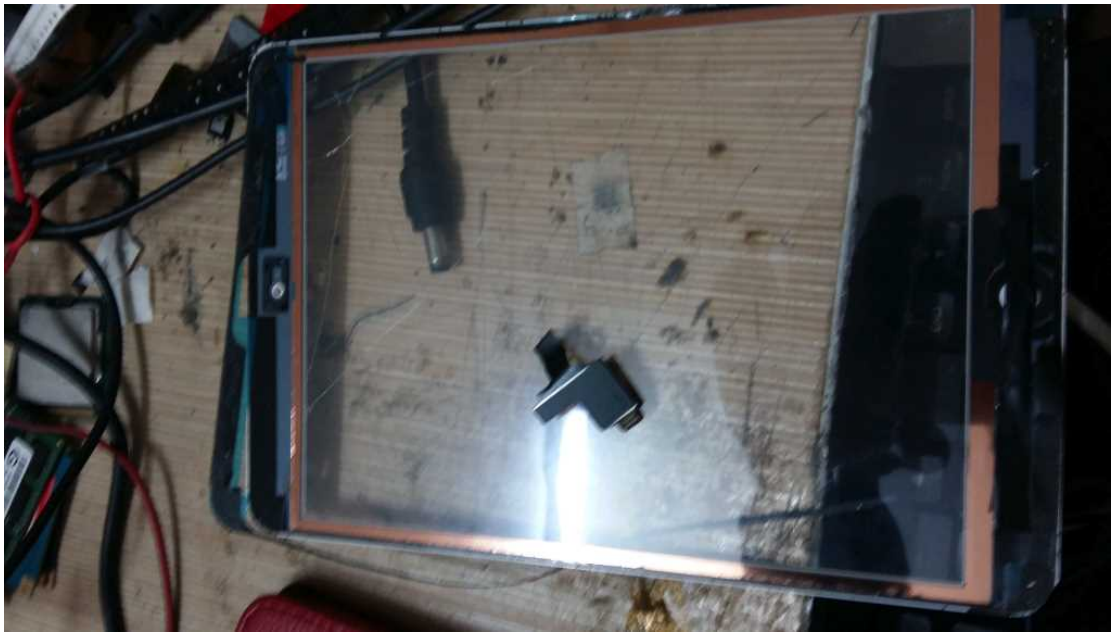
First use the Adjustable Power supply to boot and see the current can run normally and have a jump.The

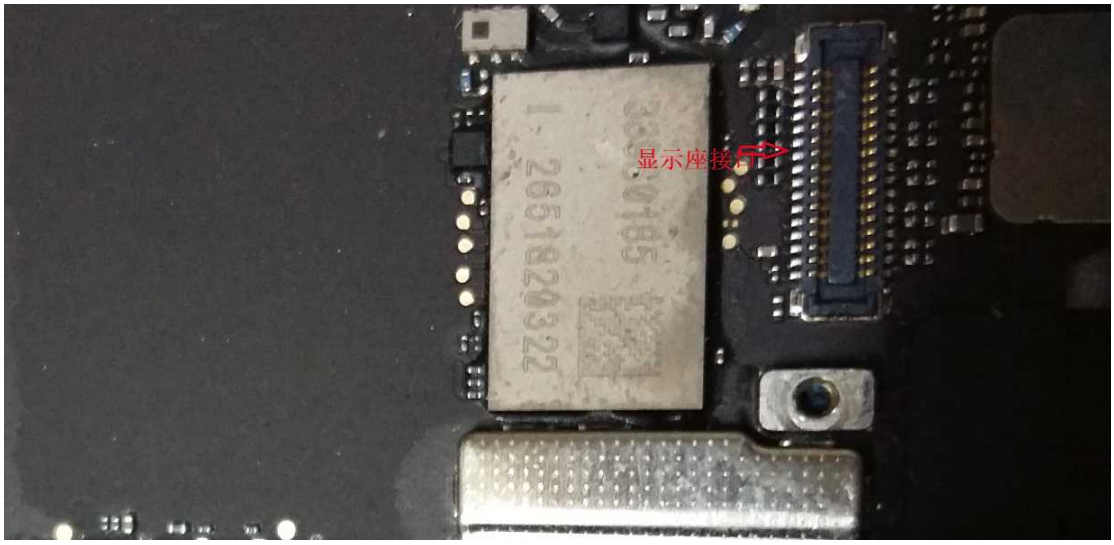
visual inspection board display interface, no obvious missing parts occurred.

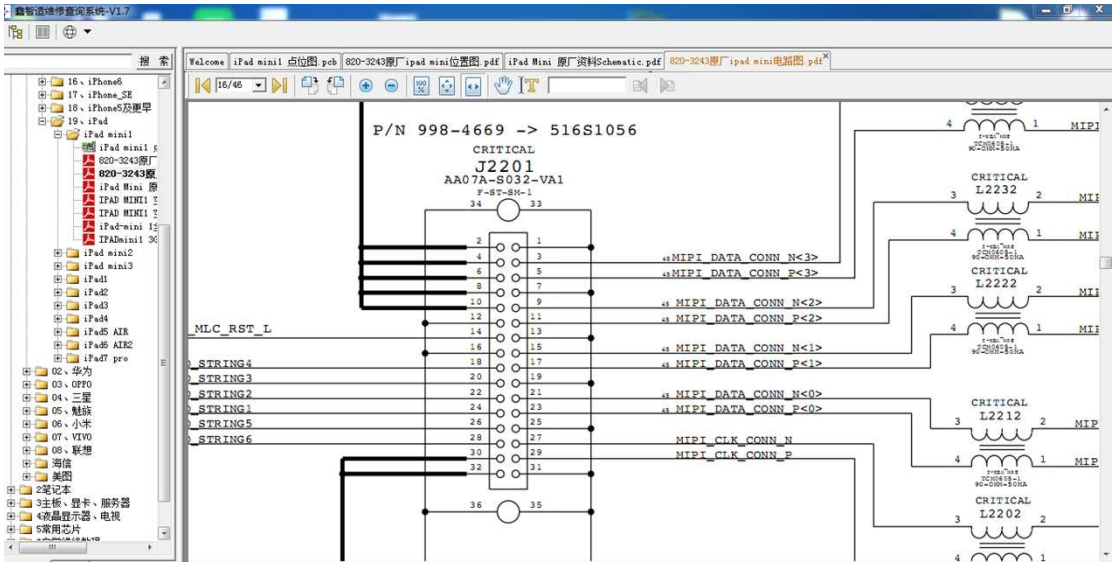
motherboard has the bit number j2201, and pulls out the line diagram to analyze the signal work, as shown in the figure:

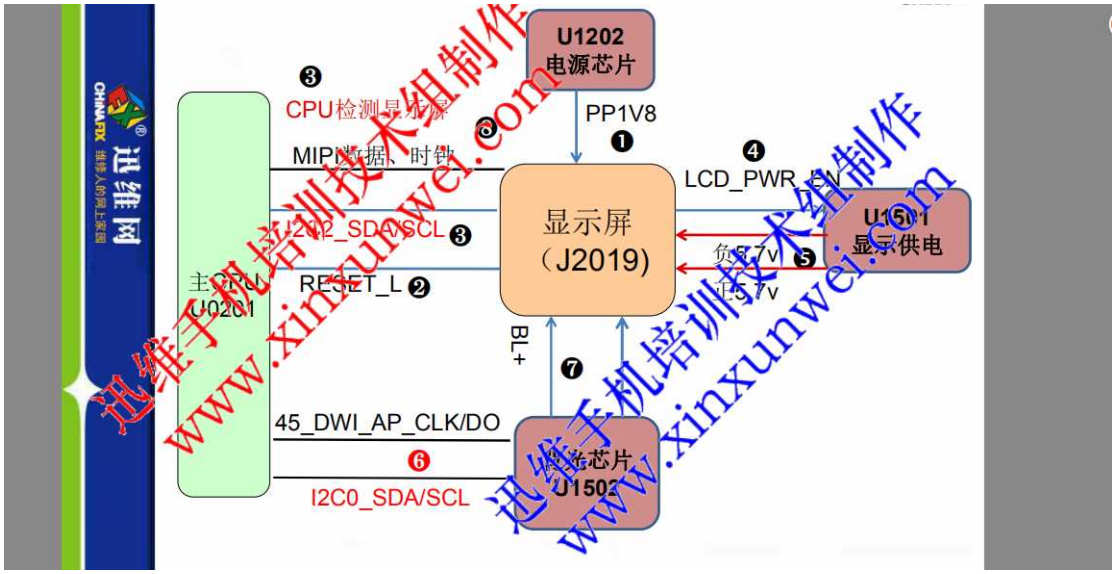
The Boardview is also positioned to the J2201.

This board physical interface is on the side of the wifi chip.

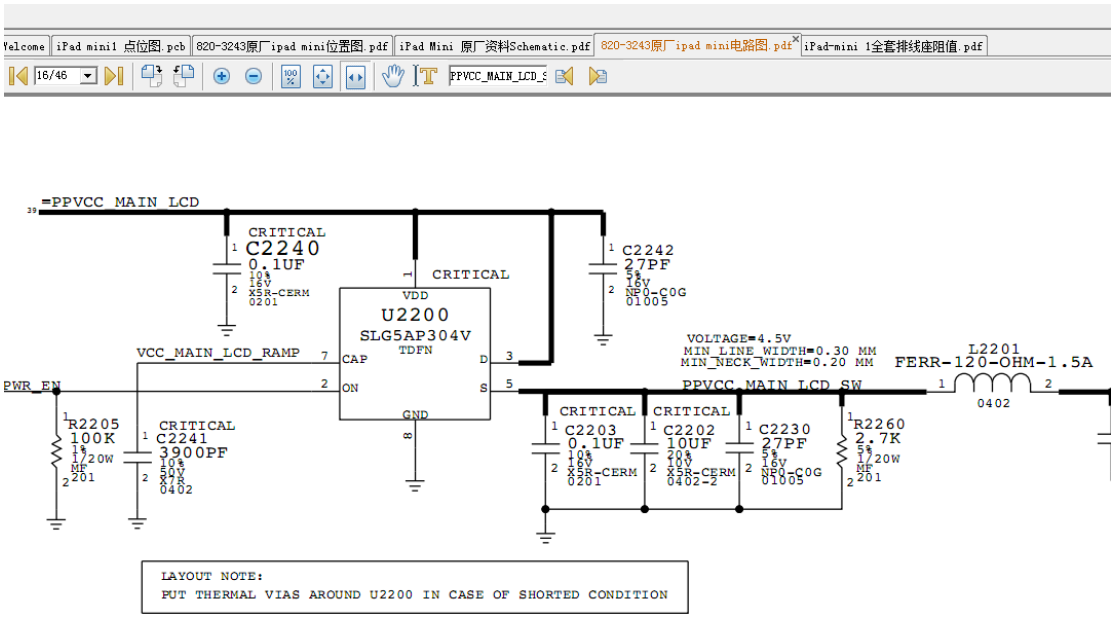
J2201 display interface 2, 4, 6, 8, 10 feet for PPVCC_MAIN_LCD_SW_CONN screen VCC, provided by L2201 and U2200 SLG5AP304 power chip PWM circuit,

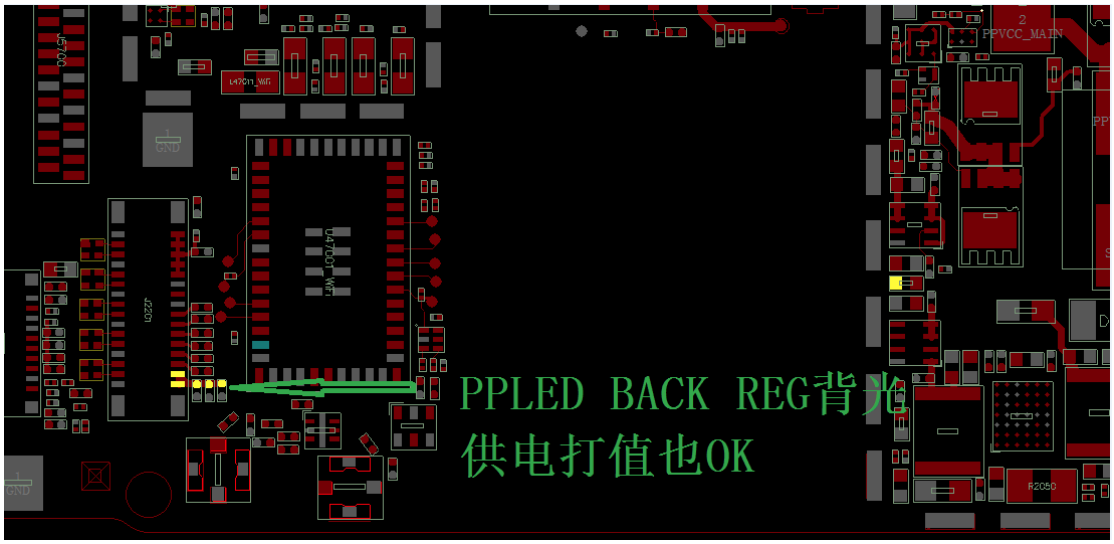
which ultimately comes from the main power chip N23.

measured J2201 seat 30 feet 290, no obvious abnormalities were found in the diode value chart.

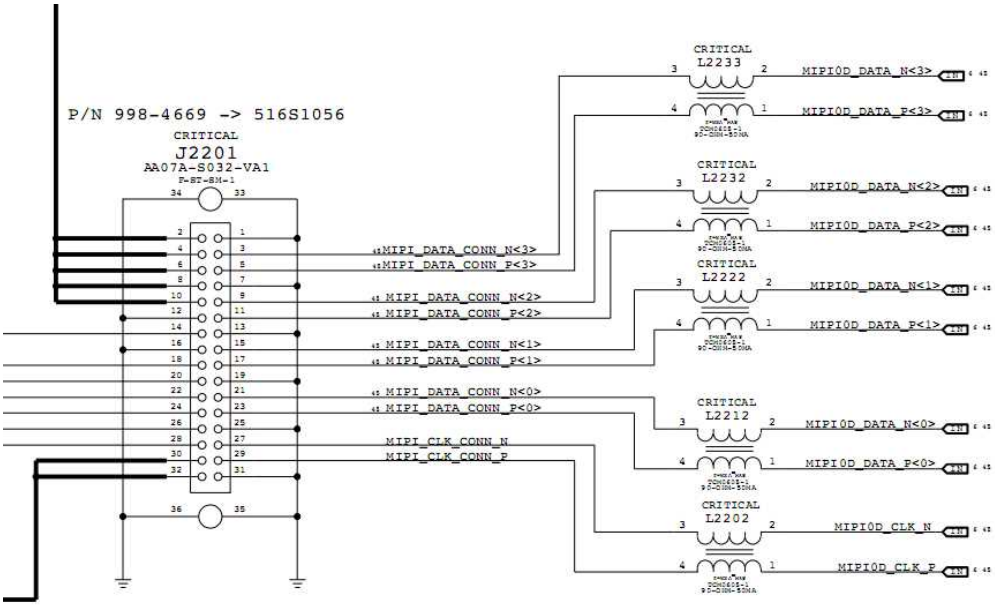
shows that the MIPI consists of 4 pairs of data and a pair of clock signals.

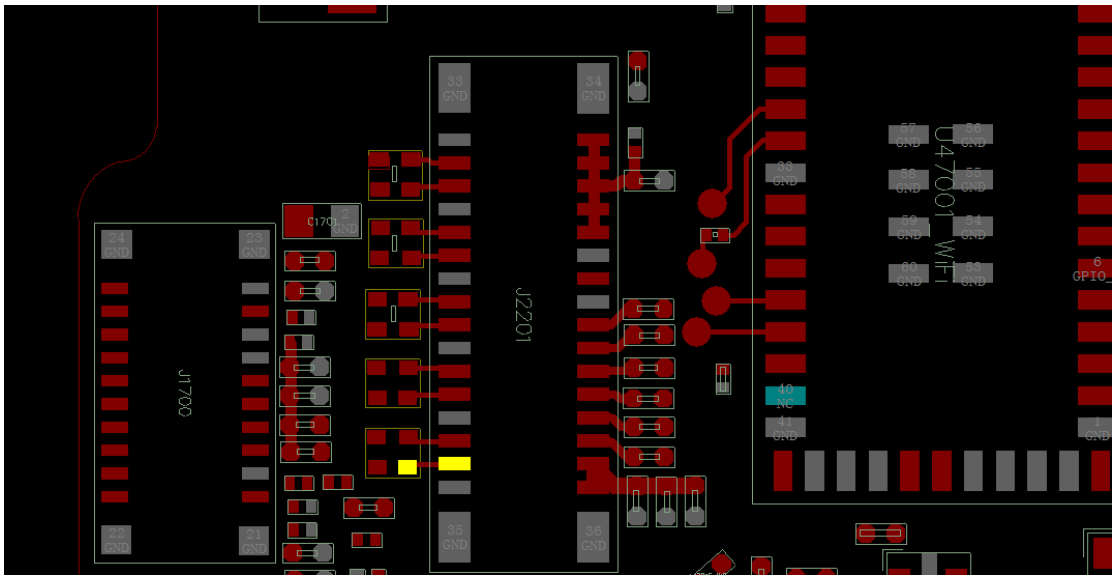
multimeter two poles one by one measured, and finally found that the 29th foot of the seat is infinite (normal diode value to 400 or so),

to the rear line to L2202Inductor on

confirmed that the Inductor is damaged, after deducting Inductor, use a soldering iron to open Electric tin is directly connected.The motherboard is installed and tested after booting, and the function is repaired.Bright machine diagram:
