[Faulty model] iPad mini2

[Fault phenomenon] The customer description does not display after the external touch screen is replaced after the fall, and the charging has sound.

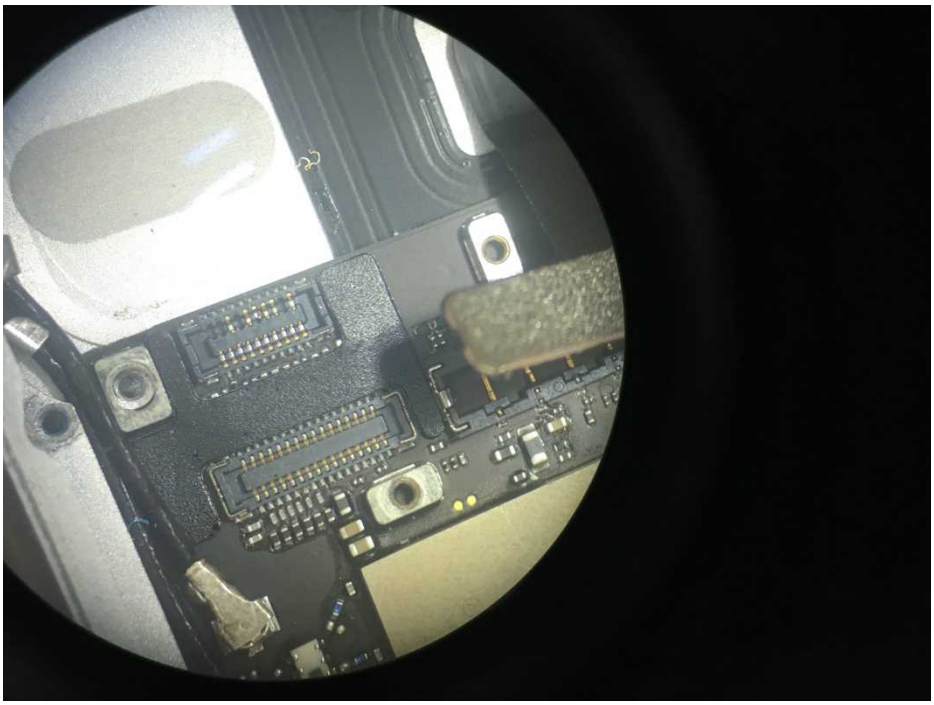
[Maintenance process] First, measure the diode value on the connector as shown in the figure:

The 32nd pin of the connector is displayed, the backlight circuit is broken, and it is observed that the touch connector has also been damaged.

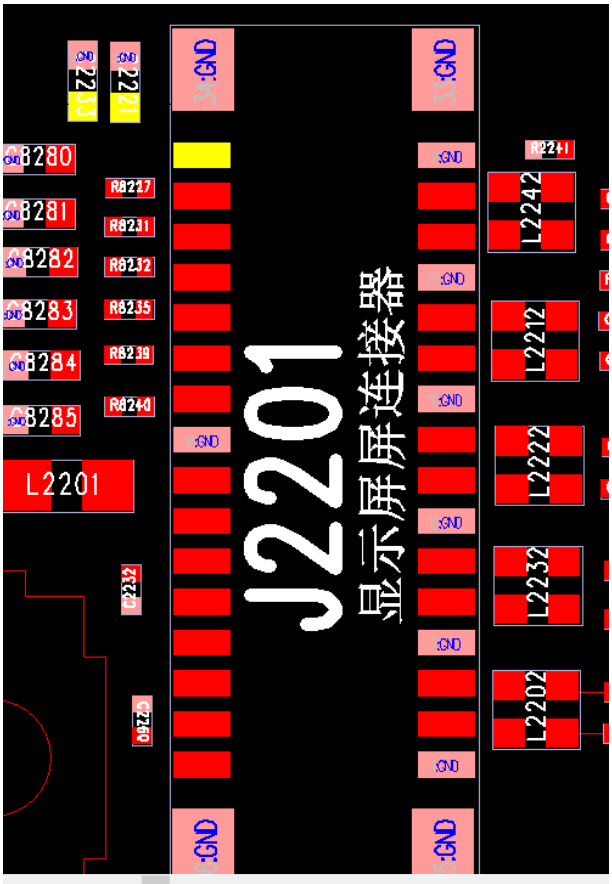
This line passes the insurance Inductor L2200.

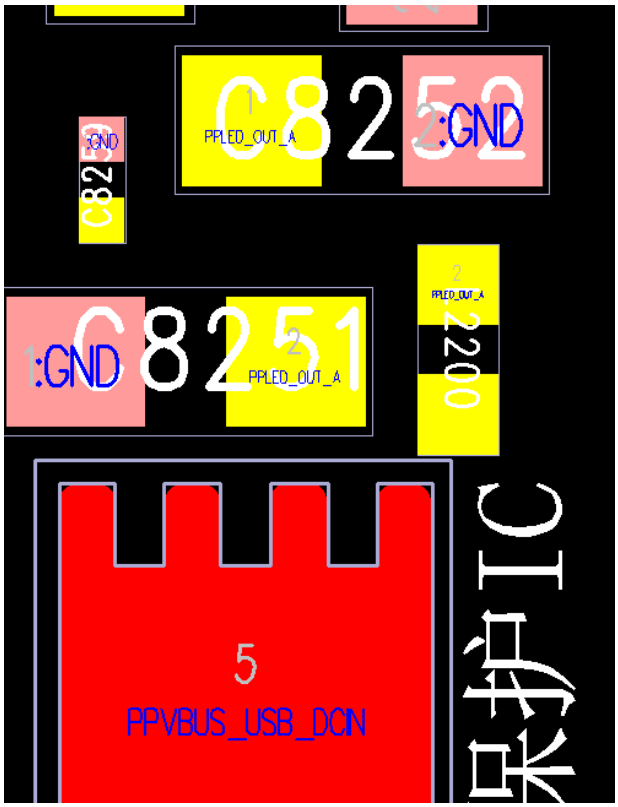
Dismantling the Shielding cover under the microscope revealed that the L2200 insurance Inductor had damaged the open circuit.

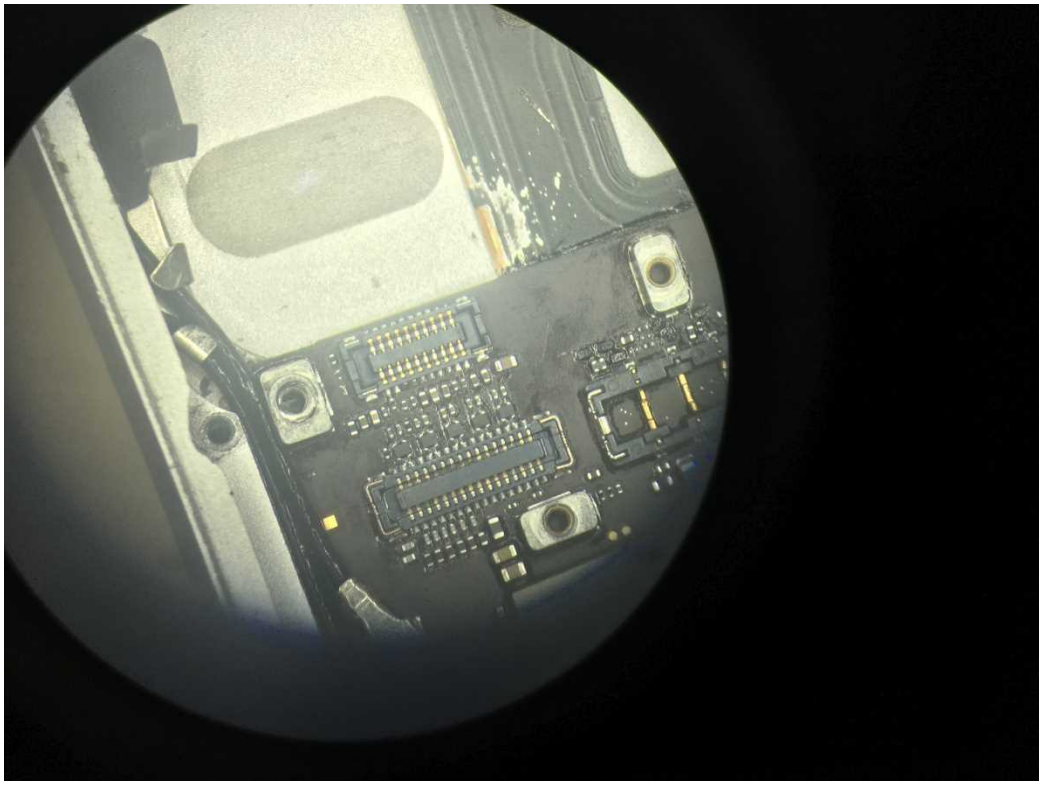
The touch screen and the display display the touch normally.
