IPAD MINI2No Power ON Front Camera cannot be used

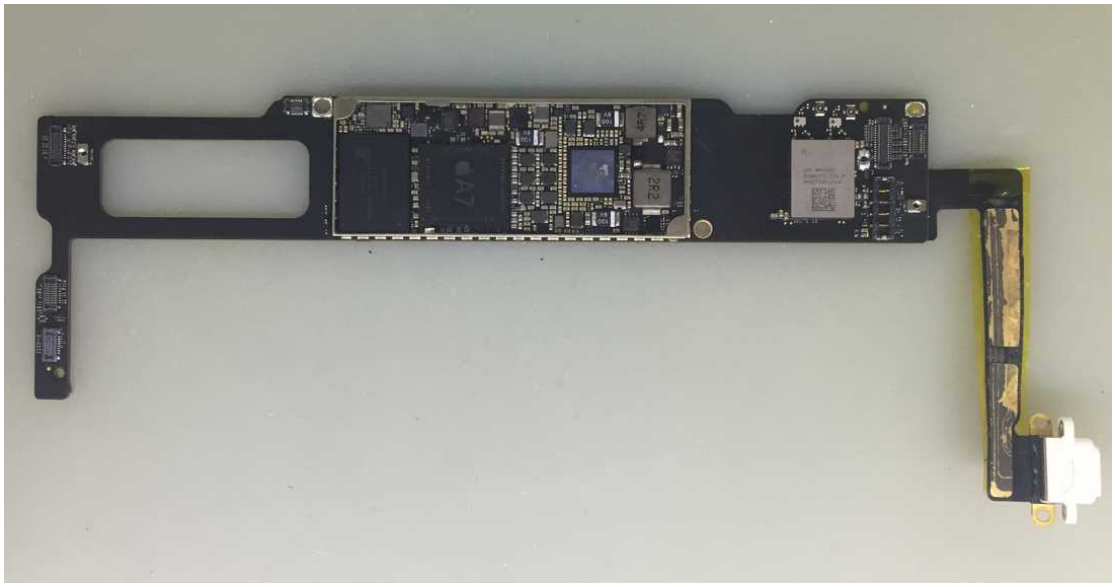
Remove the motherboard and measure the front Camera interface diode value, and find that the ISP1_CAM_FRONT_SDA_F and ISP1_CAM_FRONT_SCL_F values are infinite.

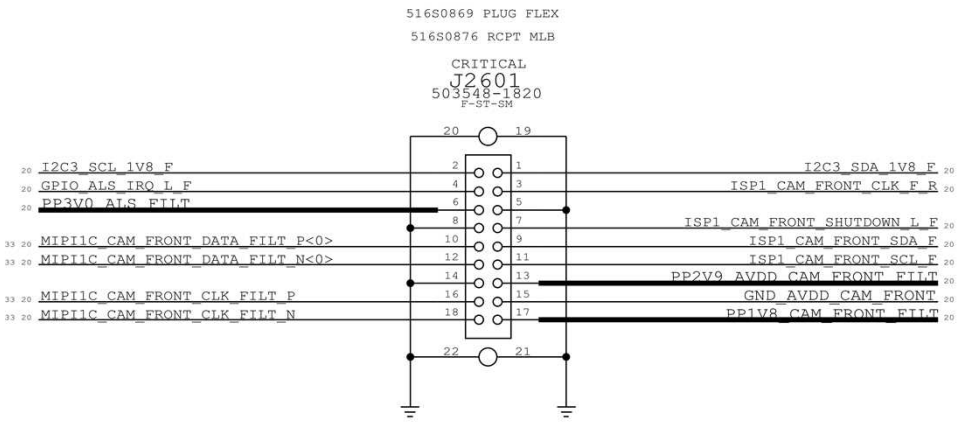
The map isp1_cam_front_sda_f and isp1_cam_front_scl_f enter the cpu via u2600.

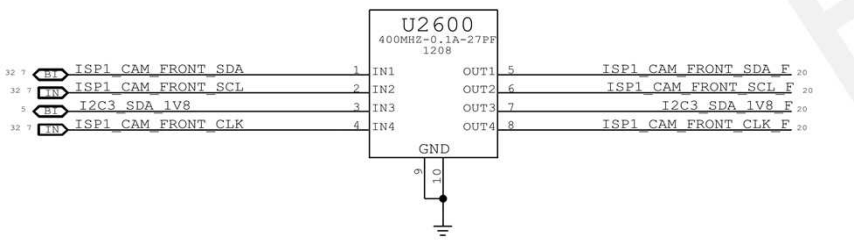
Measure the ground value of the u2600 into the cpu end and determine that the u2600 is damaged.
