mini2No Power ON repair

Faulty model: IPAD mini2

Symptom: No Power ON

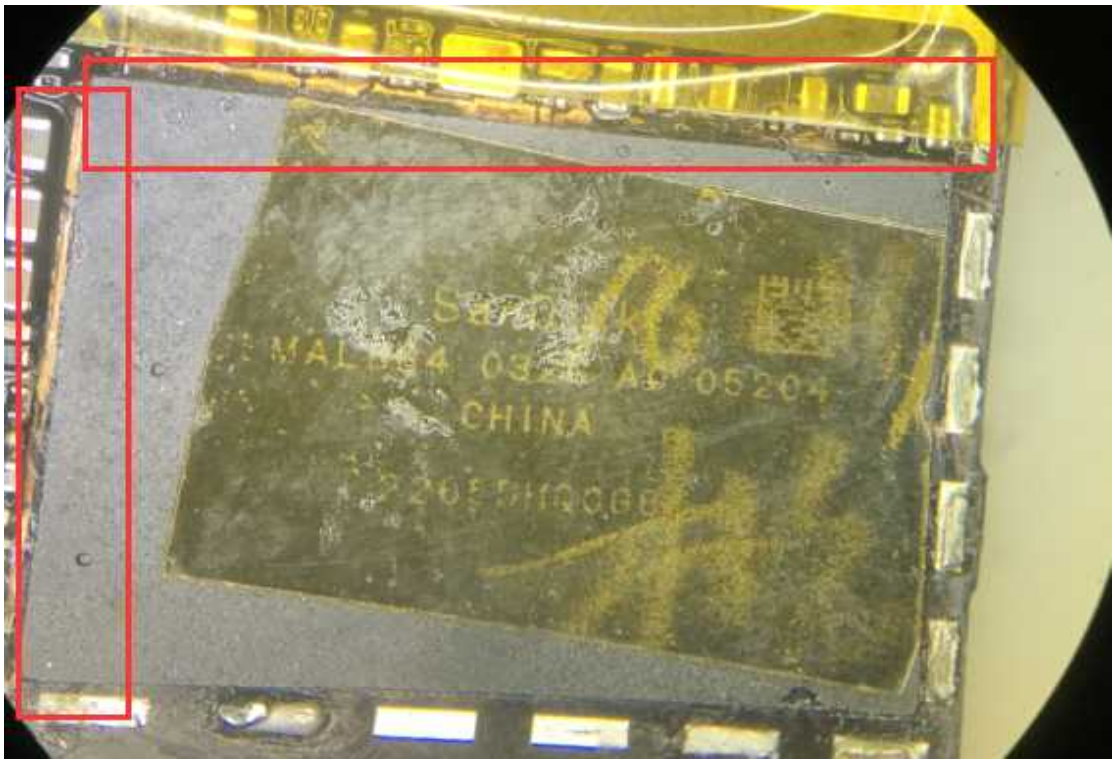
Repair process: The motherboard NAND has been removed and soldered.And there is leaking copper around.

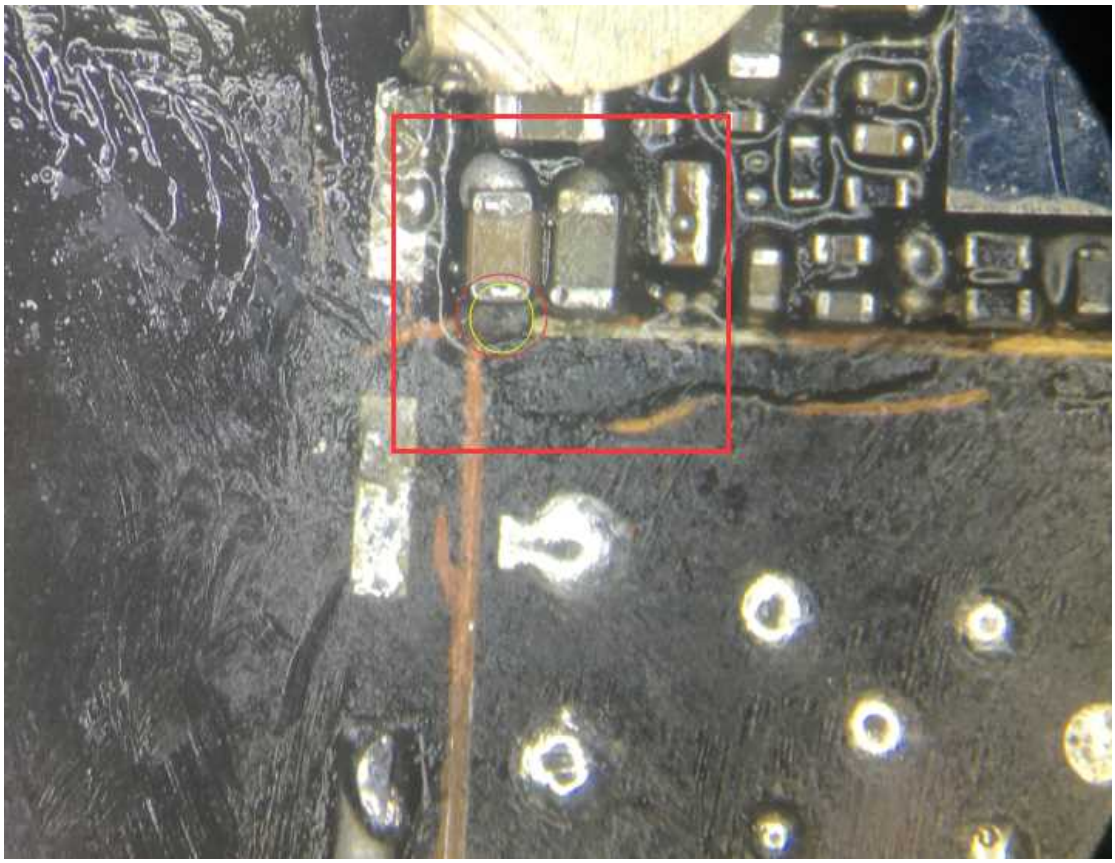
Trigger about 1A, the trigger current is unchanged after the NAND is removed.The measurement is a short circuit of the XV6301's 3VVCC.It has been observed that the filter capacitor of NAND 3vVCC is connected to GND.

Maintenance results: It is not good to use the insulated paint（green oil） in the copper leakage. The short-circuited grounding capacitor is removed, and the NAND and Recovery are welded.The repair of the fault is completed.
