[Faulty model] mini4

[Fault phenomenon] The customer describes the No Power ON after the fall.

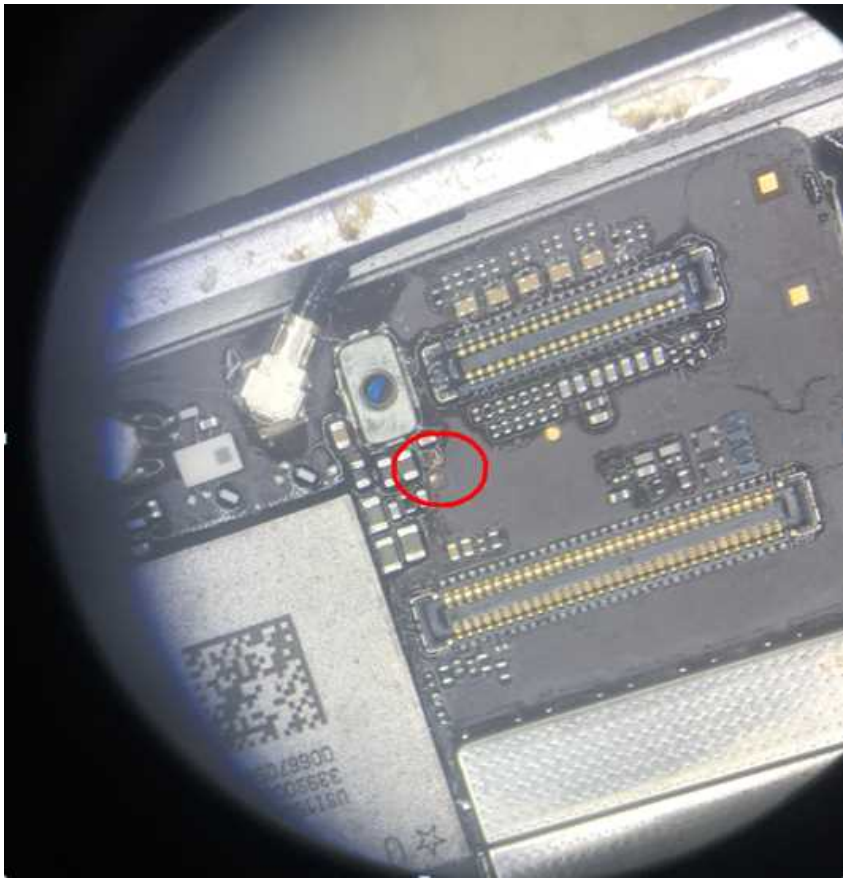
[Maintenance process] Disassemble the mini4 screen assembly. Note that the mini4's screen and cover are integrated. It is not easy to be responsible for scalding the backlight during the heating process.Remove the screen assembly and found that it has been repaired as shown:

In the picture, there are obvious signs of falling off the red circle. The circuit diagram is a backlight display backlight circuit insurance Inductor, short-circuited.
