[Faulty model]: ipad pro 12.9 inch

[Fault phenomenon]: Electricity consumption too fast, the speaker in the lower right corner does not ring

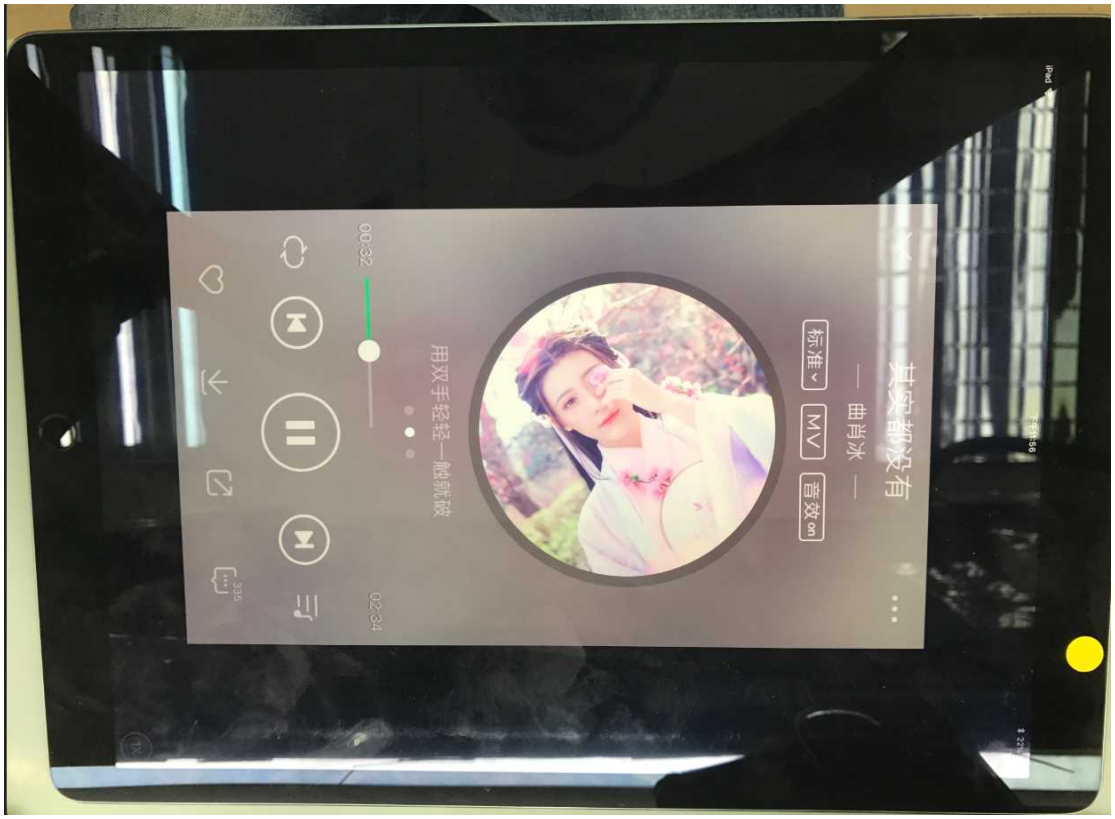
The tablet consumes a lot of power, and the speaker in the lower right corner does not ring, no sound.

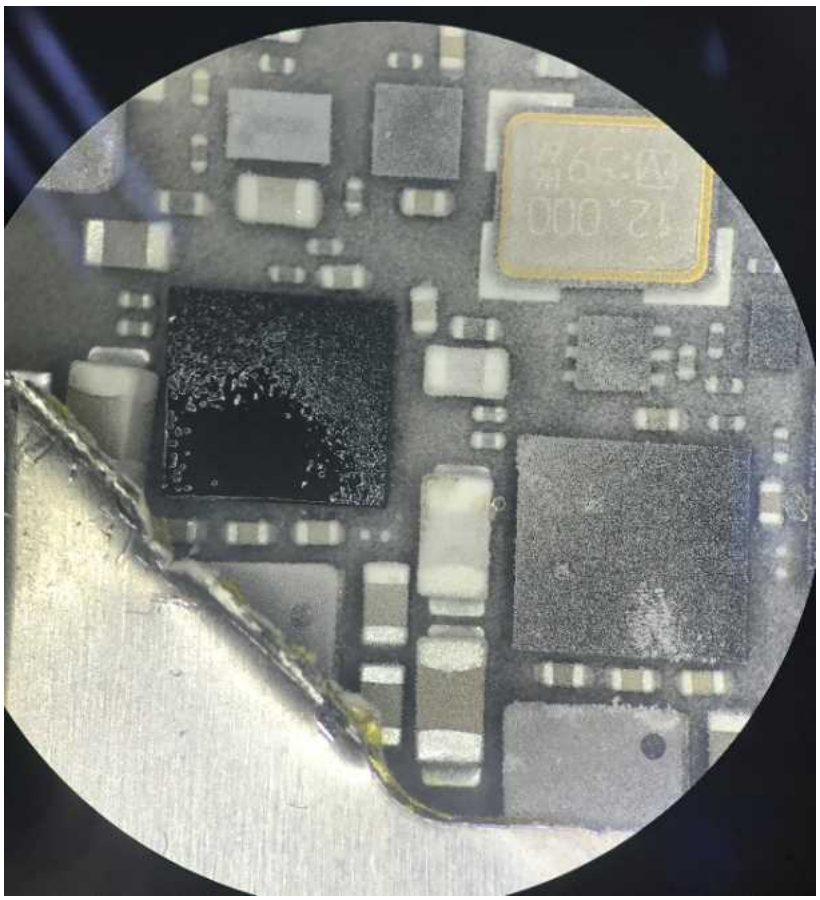
Power on the leakage of electricity(battery abnormal consumption), you can smoke Colophony (Solder) to see where it is shorted.The inspection found that the codec Amplifier was short-circuited, and the Colophony (Solder) melted quickly.

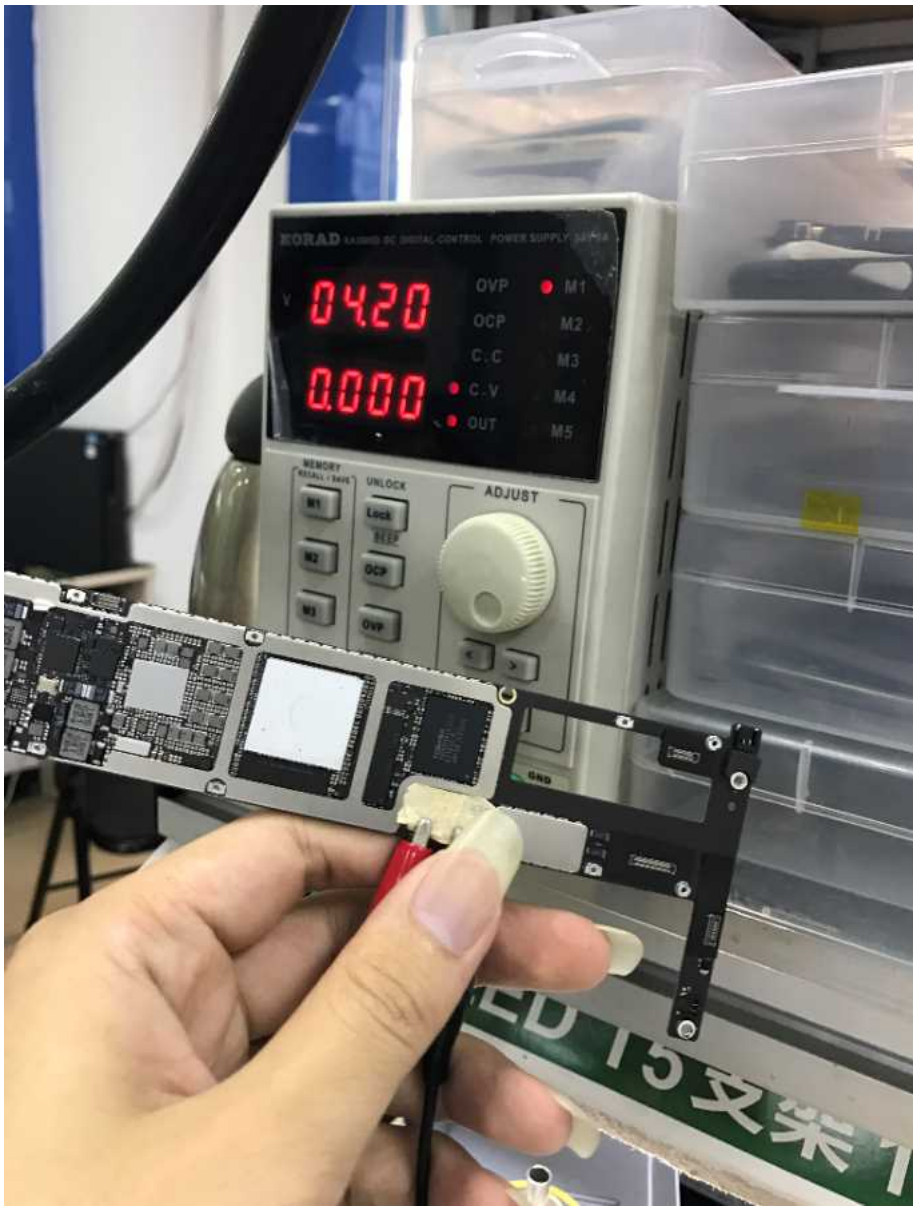
Remove the codec Amplifier chip and connect it to the leakage of electricity(battery abnormal consumption).

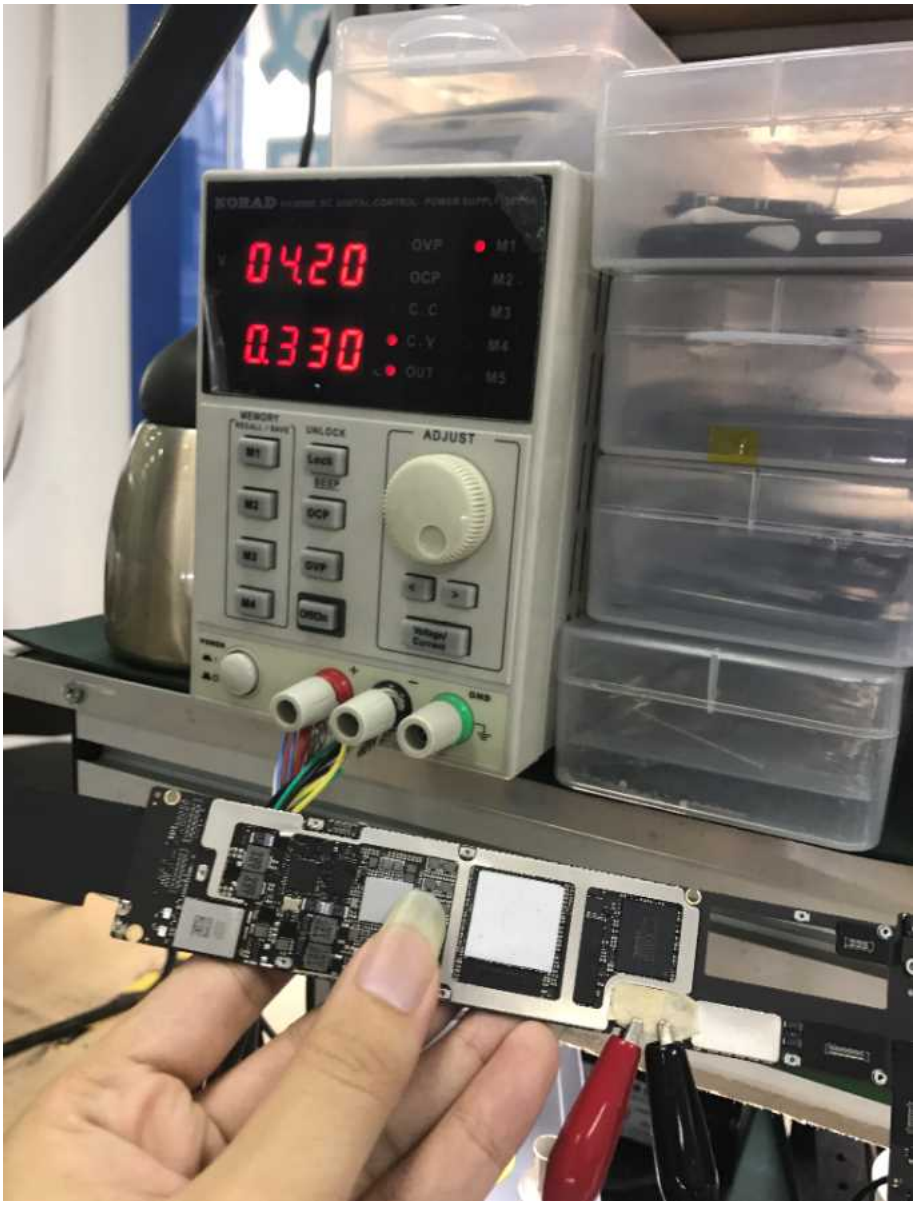
Replenish the codec Amplifier chip, and the leakage of electricity(battery abnormal consumption) is also connected. It seems that there is a short circuit afterwards.

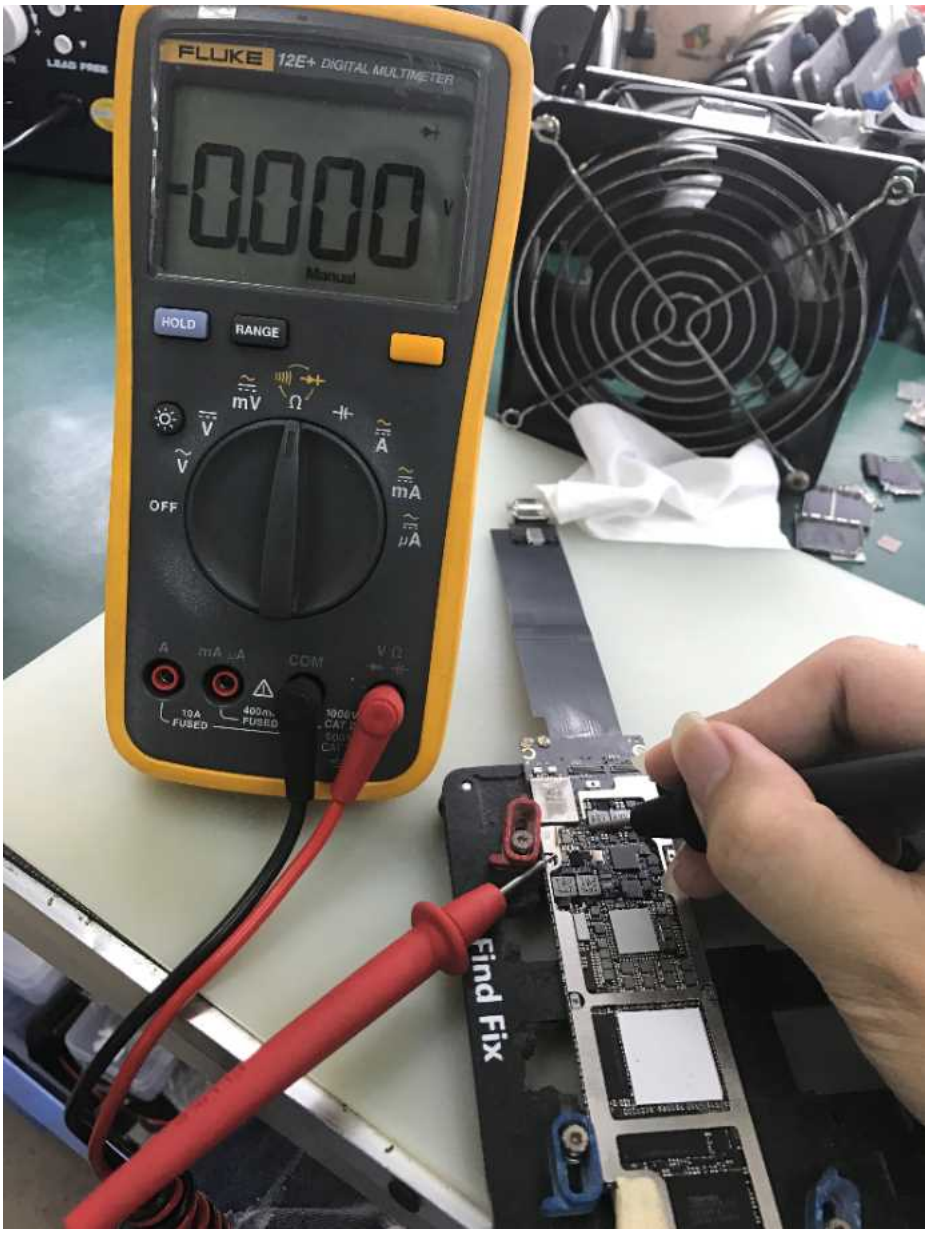
The measurement found that the booster circuit of the rear pole was shorted to ground.

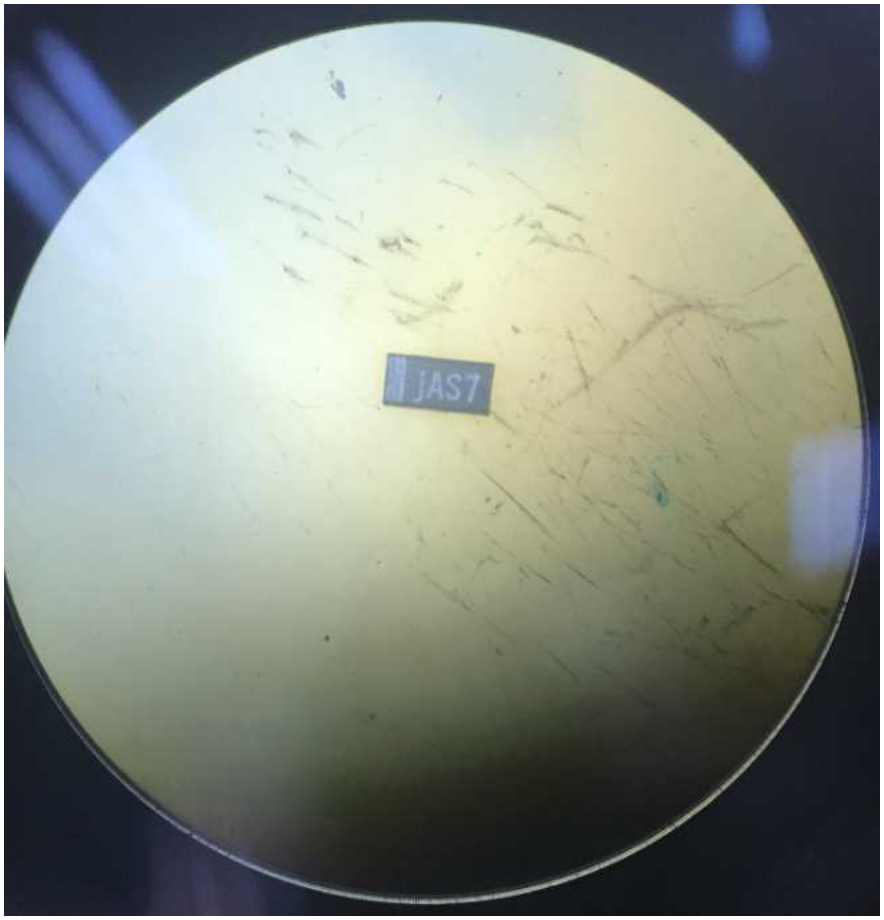
Remove the capacitor on this boost line and find that a tantalum capacitor is shorted.

Replenish the capacitor, install the test, power consumption repair, the sound of the right lower horn is normal, the repair is over, this fault is caused by the short circuit of the capacitor of the codec Amplifier chip boost line.
