IPAD5 No Power ON repair

Fault model: ipad 5

Symptom: No Power ON

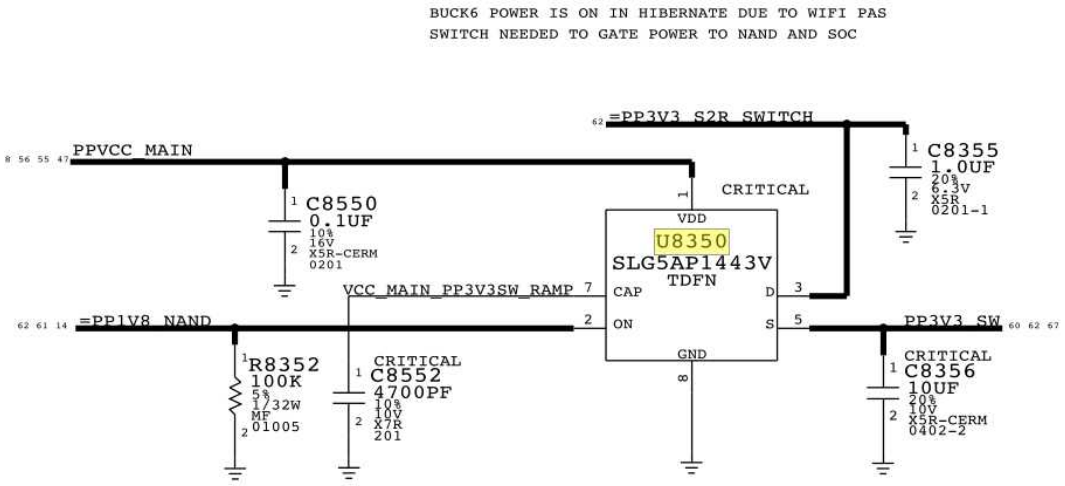
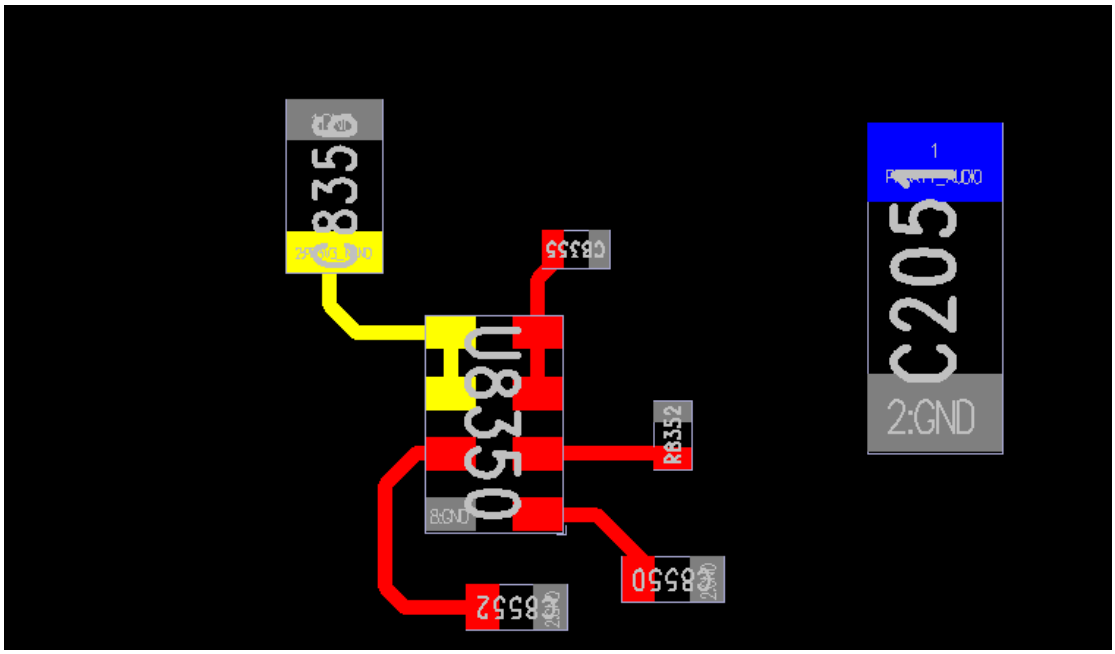
Maintenance process: stop at Fixed current 40MA after power-on trigger, link computer machine in DFU mode, Recovery error 40, brush into recovery mode and found no serial number.Combined with the error code.The fault is judged to be in the NAND or NAND circuit.The disassemble found that the NAND had traces of dismantling.Measurements NAND 1.8 and 3.3V have no VCC.Finding the drawings The VCC is converted from the U3850. Due to the removal of the NAND, the VCC tube may be blown by the Void welding. After reinstalling, the VCC returns to normal, but the fault remains.Only the NAND can be removed, and the NAND is removed. The solder pad has the solder dot dropped.

Repair result: Replenish the solder pad, replace the NAND, and repair the fault.
