[Faulty model] iPad 5

[Fault phenomenon] Customer description Start White Apple restart, can not enter the system can Recovery.

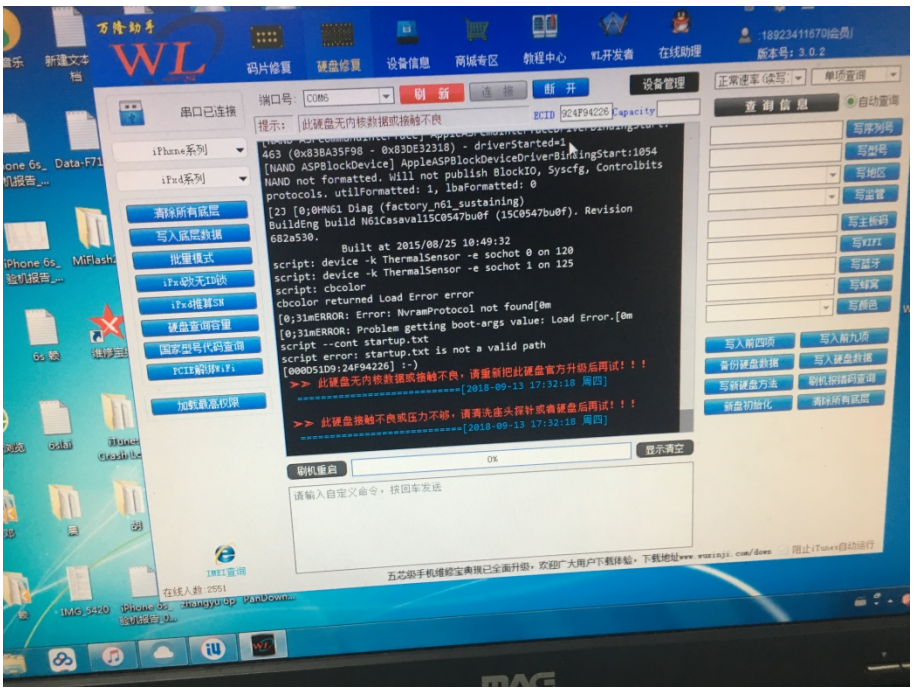
There are two possibilities for this kind of fault. The NAND is not damaged. The VCC or PCB layer is disconnected, causing the CPU to communicate with the NAND. After removing the VCC problem, remove the iPad 5NAND and put it on the test rack to read the NAND internal information.

The test rack reported an error. The fault was found to cause the NAND to be damaged. The Recovery was reported incorrectly. The new NAND code Recovery needs to be replaced.

After the Recovery is activated, it successfully

enters the system fault repair.
