Ipad air backlight abnormal

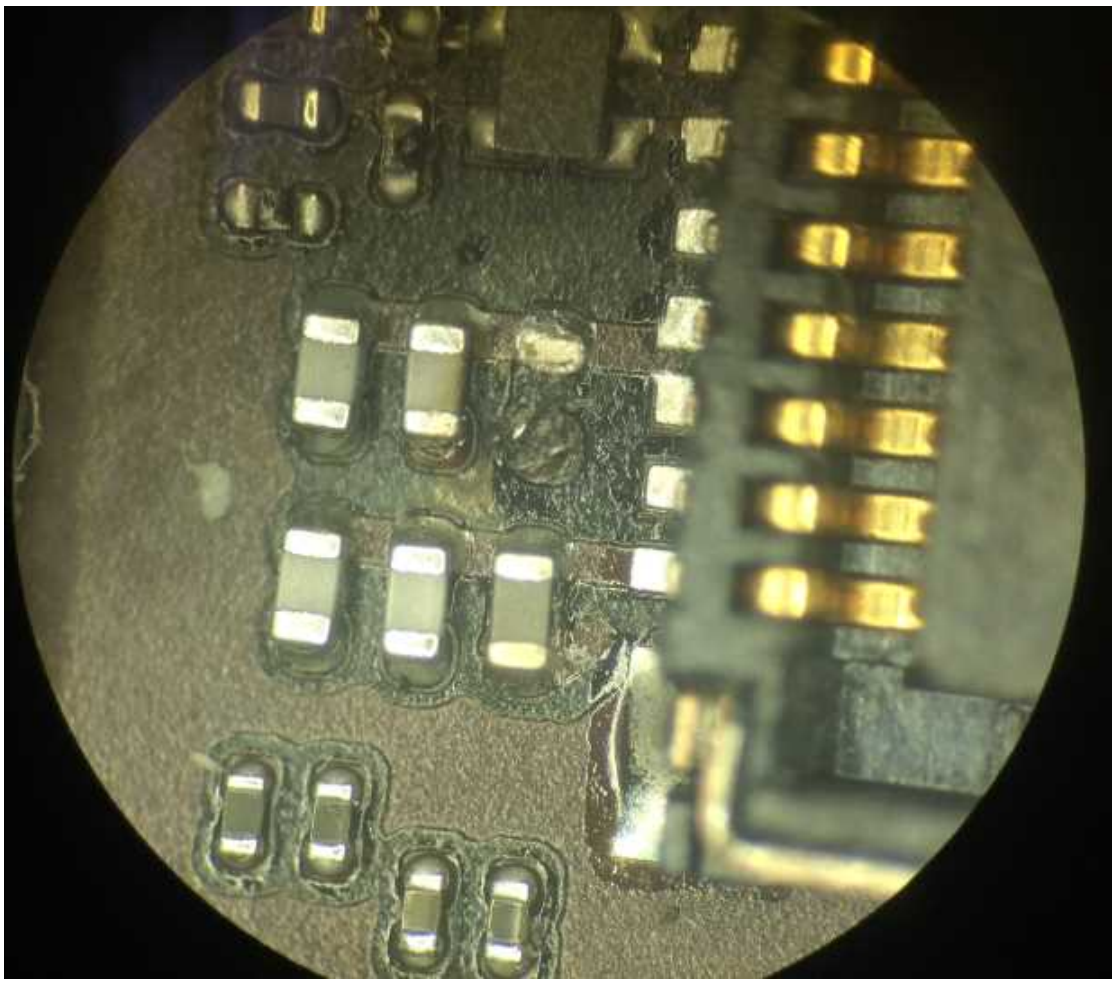
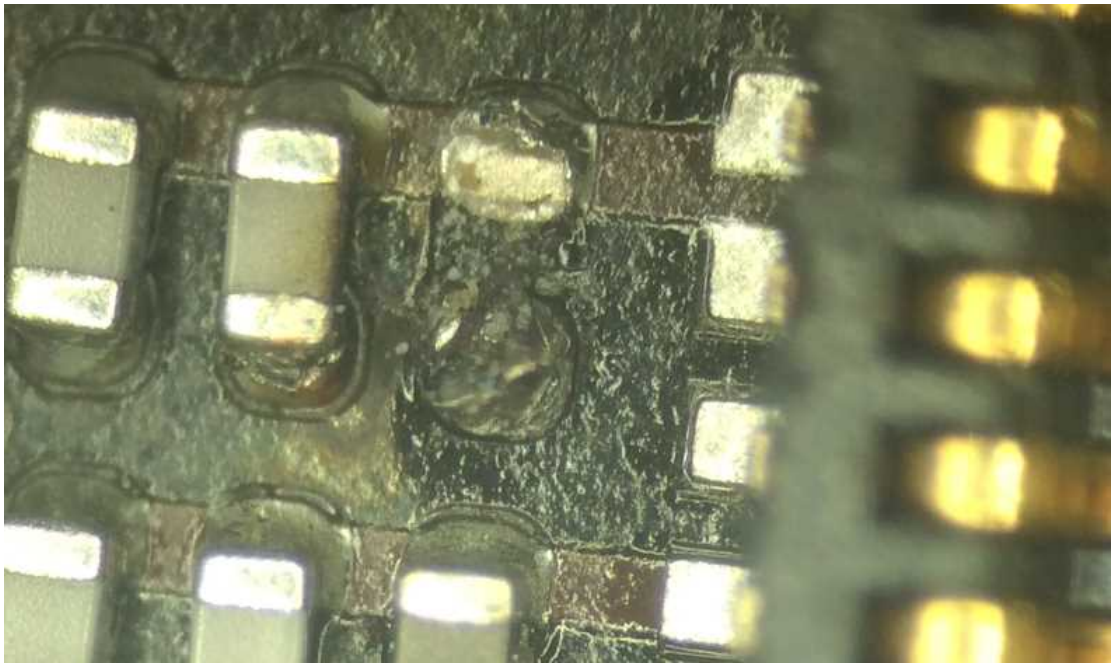
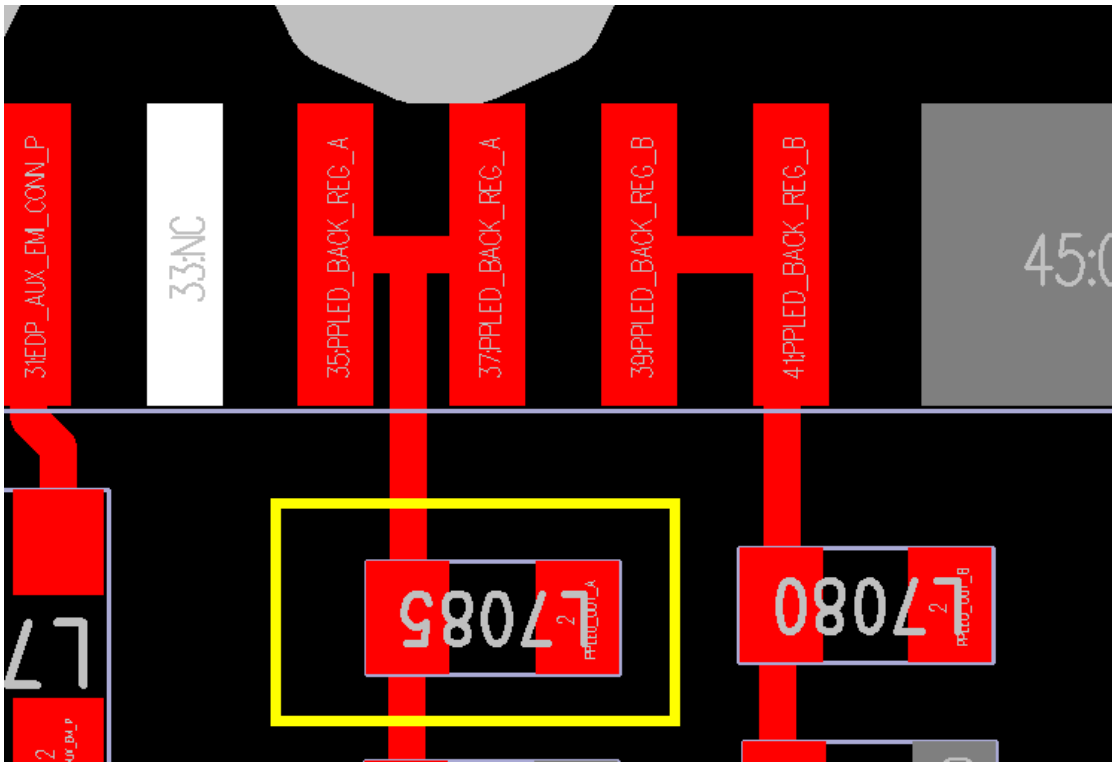
Replacing an iPad air failure phenomenon The backlight on the left side of the screen is intermittently dark.The disassemble uses a multimeter diode to display the diode value of the row of seats, and finds that the backlight group AB VCC has four feet, two of which have infinity values.Placed under the microscope and found a fuse Inductor burned.Use the soldering iron to iron the Inductor and short-circuit it with solder. The power-on test shows normal.
