Ipad air No Power ON

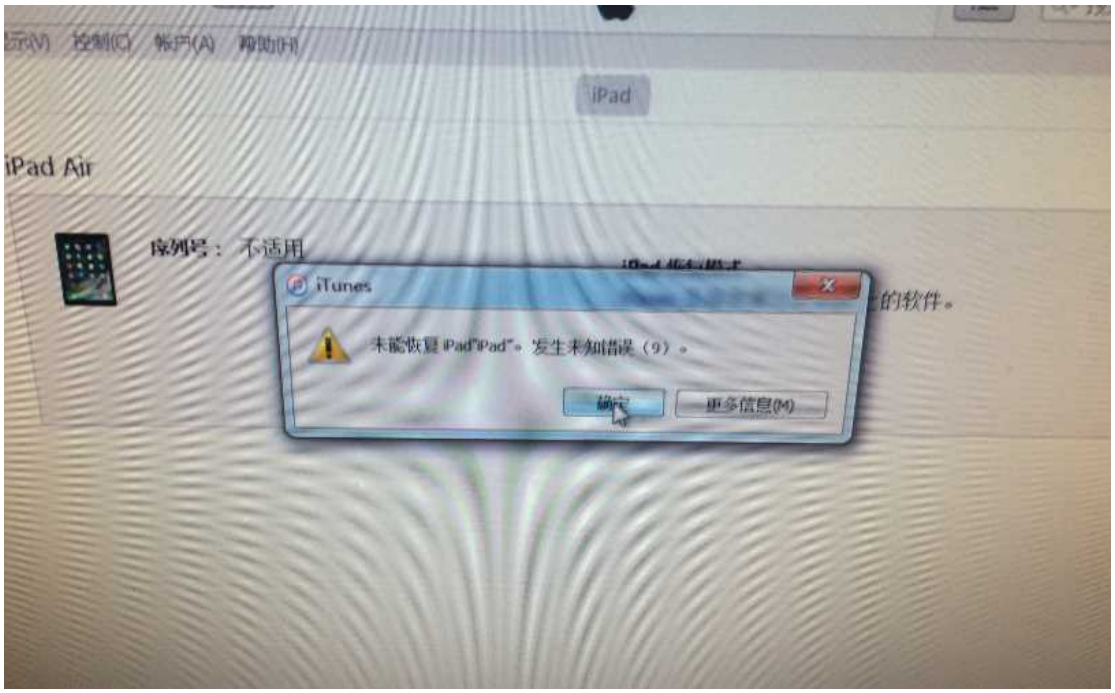
The customer sent an iPad airNo Power ON.According to the customer, the machine was previously normal, and the 4G version has an ID lock.The R1506 was removed during the process of disassembling the ID. After the disassembly, the No Power ON was removed, and the capacitor next to it also encountered one.

The yellow box removes the original for the customer and the red box is the logical EEPROM position.

After receiving the machine, put it under the microscope and look at the motherboard without Solder joints linked short circuit, directly connected to Adjustable Power supply, the current Stop at 70ma does not move.Even the computer Recovery, error 9.Observe that the position of the resistor on the motherboard is very close to the logic EEPROM. It may be that the EEPROM is broken or the Empty Solder is broken when the customer plugs in the resistor.Remove the logic EEPROM and re-ball the ball back, and the Recovery will pass the repair.

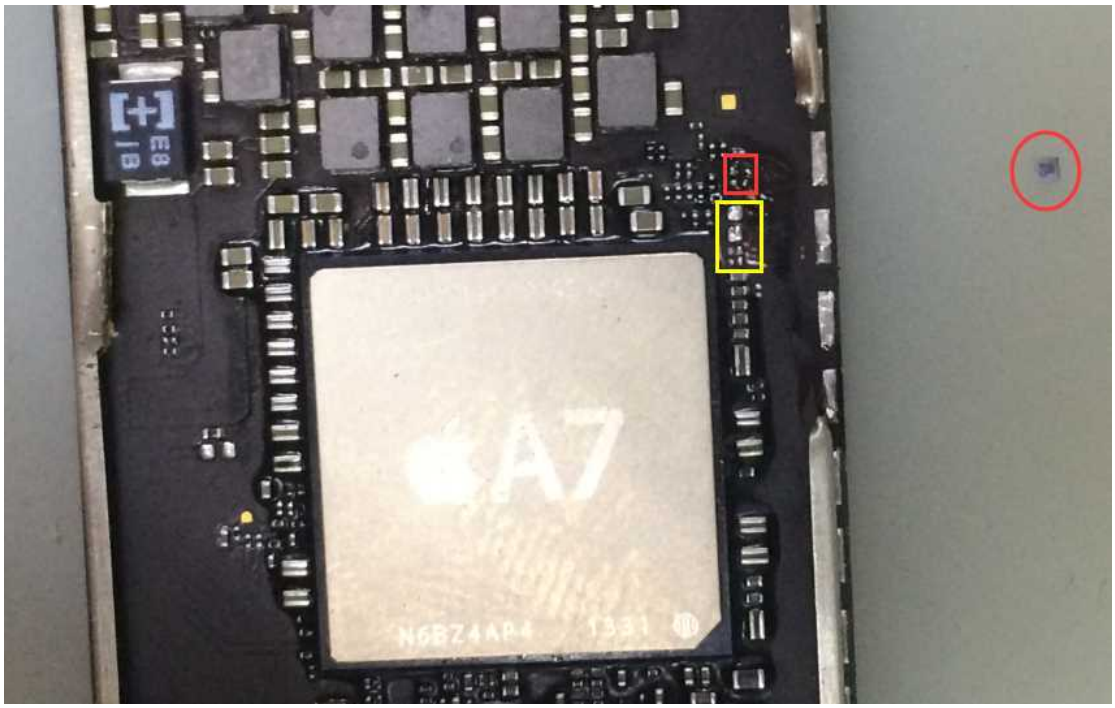
Solder back picture
