[Faulty model] iPad Air

[Fault phenomenon] No Power ON

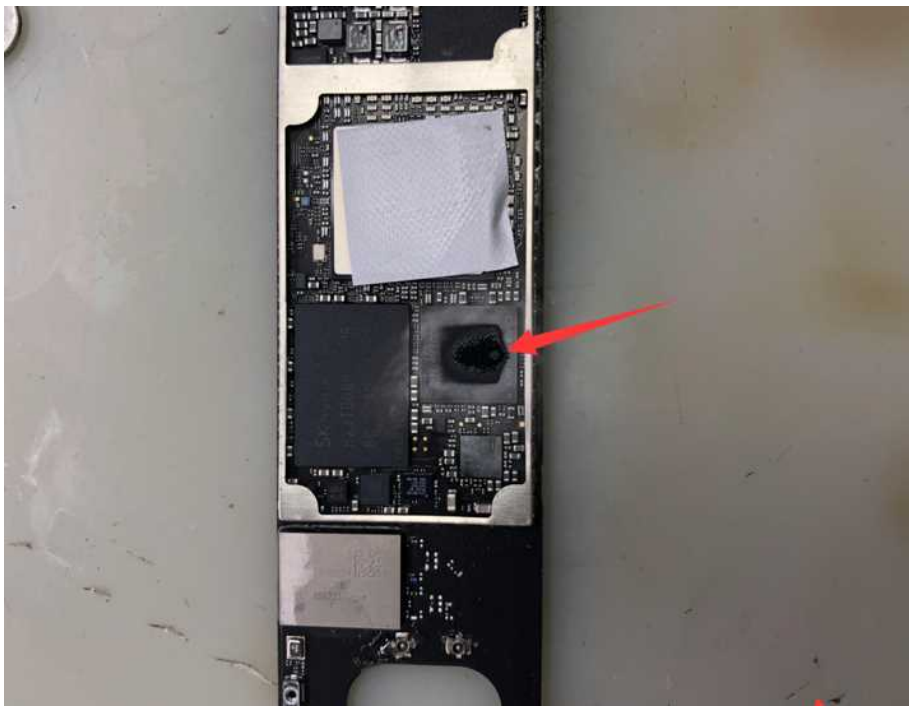
[Maintenance process] Detection of faults, boot trigger detection as shown:

The trigger current is 2.5ma, and the Colophony (Solder) Dafa is used to find the culprit.

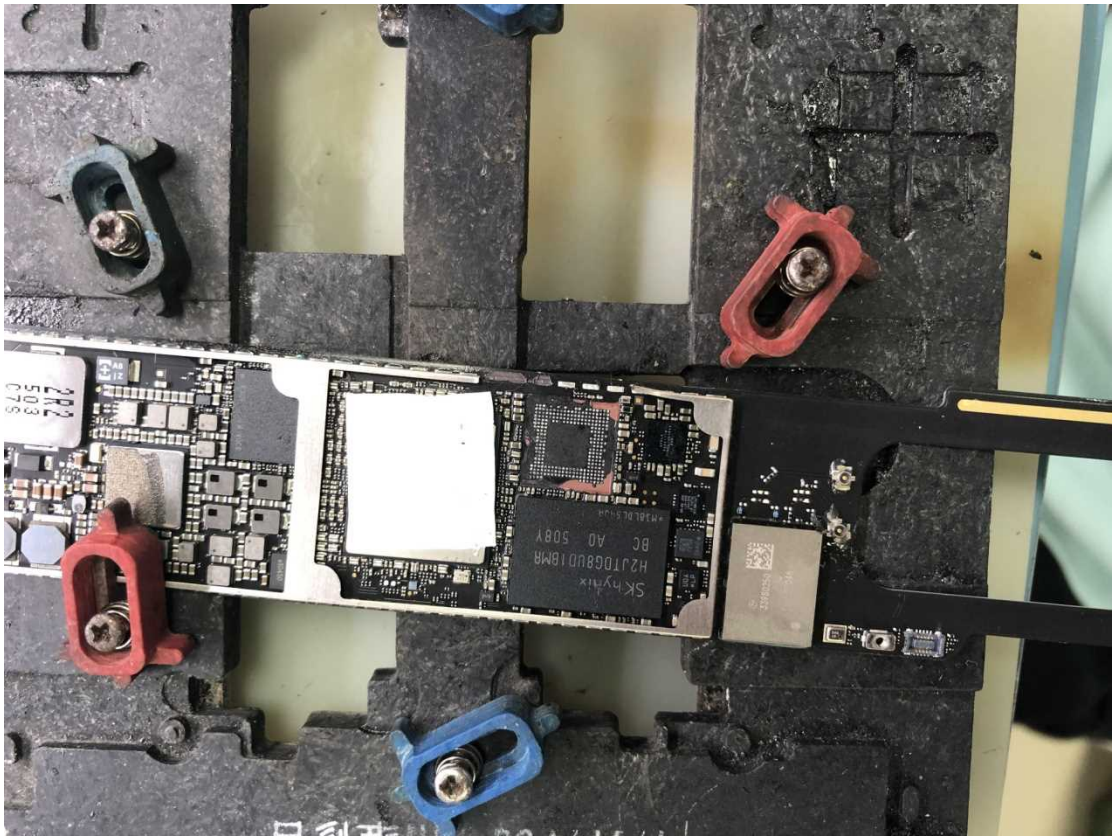
The position of SDRAM was hot and severe. After the test, it was found that the original 1.8VVCC of SDRAM was short-circuited and replaced directly.

Install the new SDRAM IC boot test to perfect the bright machine.
