PAD6 PADAIR2 Blurred screen Repair

Model: Apple Ipad air 2

Symptom: boot Blurred screen restart

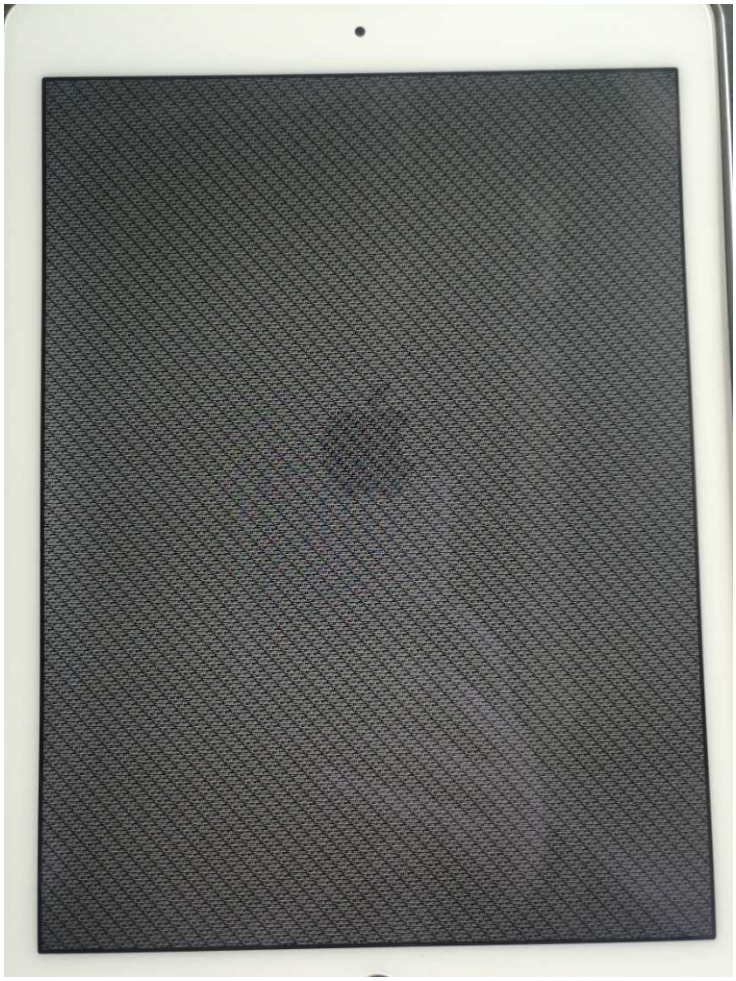
Looking at a few pictures to see a few pictures feels a bit useful for everyone to write an article.The PAD6 boot Blurred screen will also restart the system.As shown

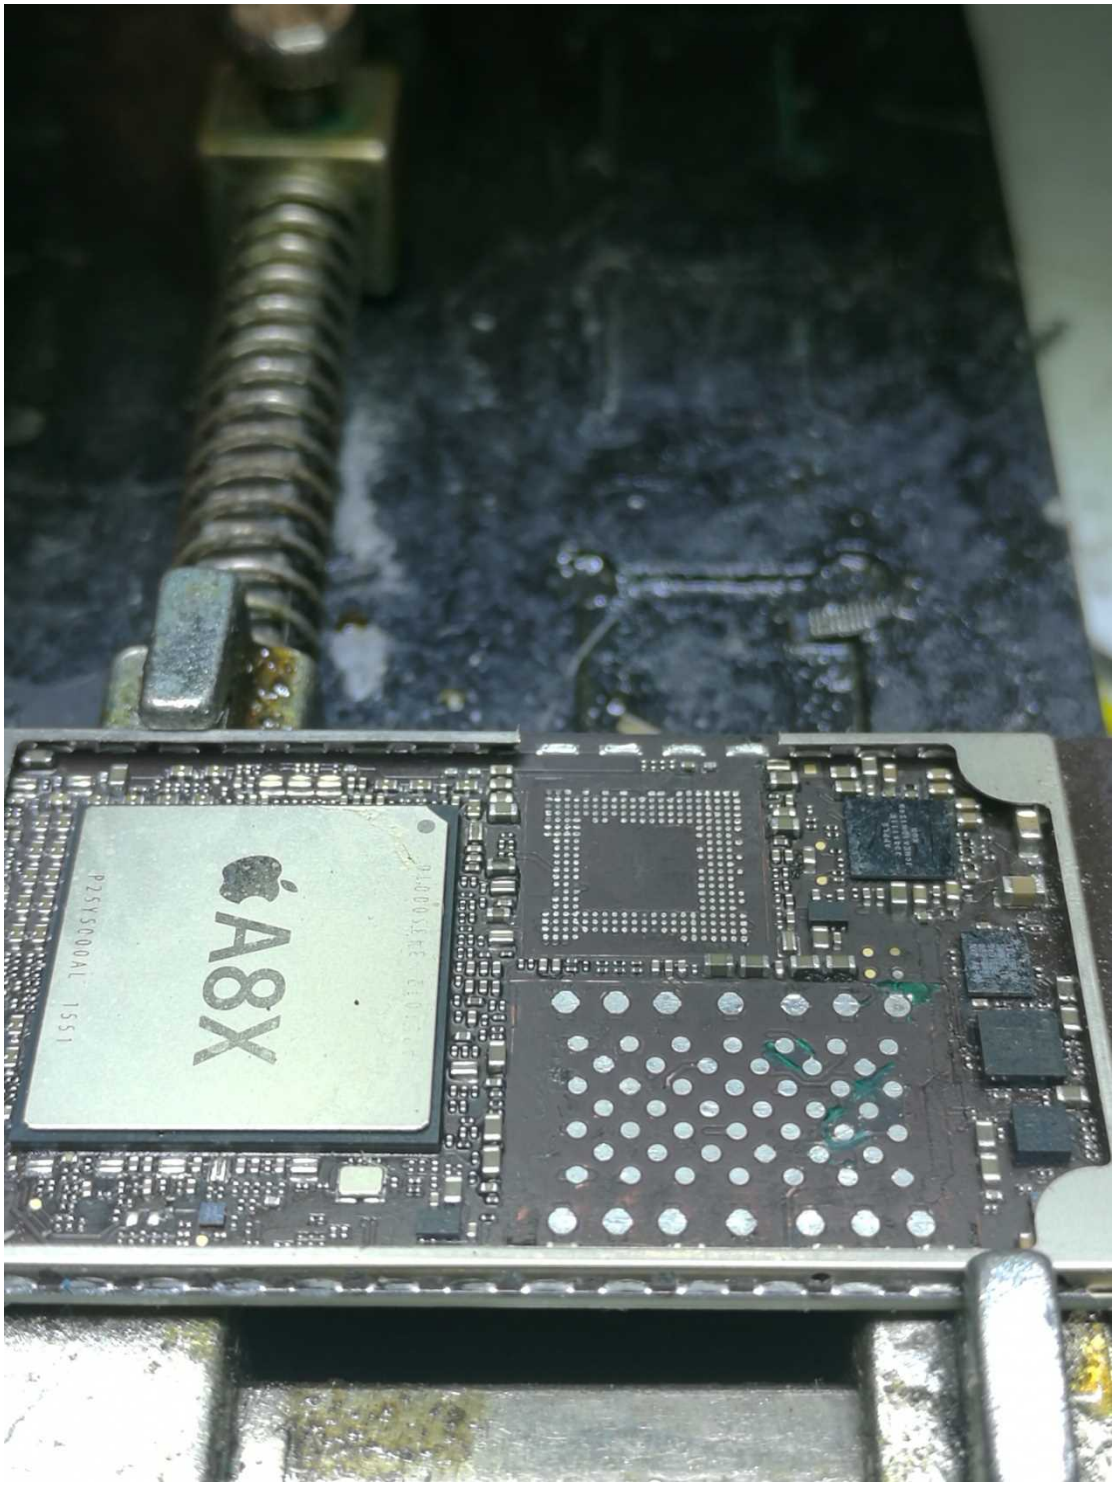
Recovery reported error 4013 feeling that the flash problem is big.

Disassemble the NAND and found it.First remove the NAND, brush it and report the same mistake.

Directly flash memory.

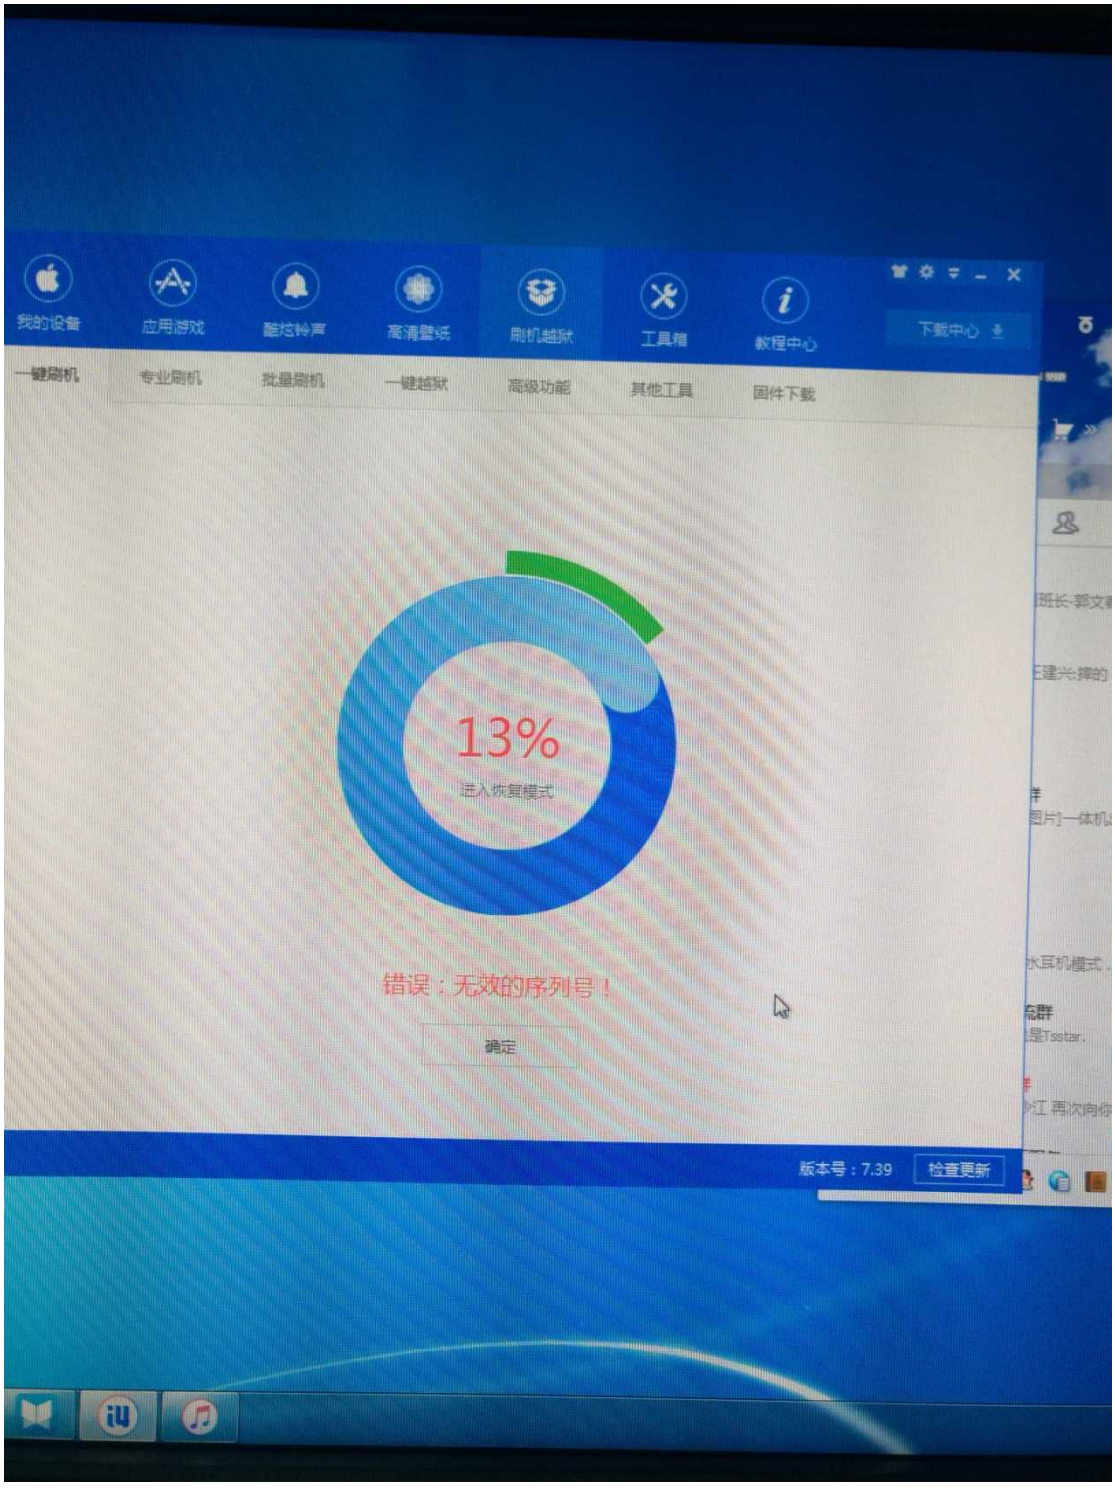
The flash memory is installed, then Recovery.Ok.Recovery reports an invalid serial number.

Everyone can do flash memory directly.The NAND was moved, and it was estimated that the flash memory was blown by the Void welding.In the previous expansion of

Brushing to the invalid serial number is basically no problem with flash.Install the NAND directly.
