Ipadmini1 standby high current

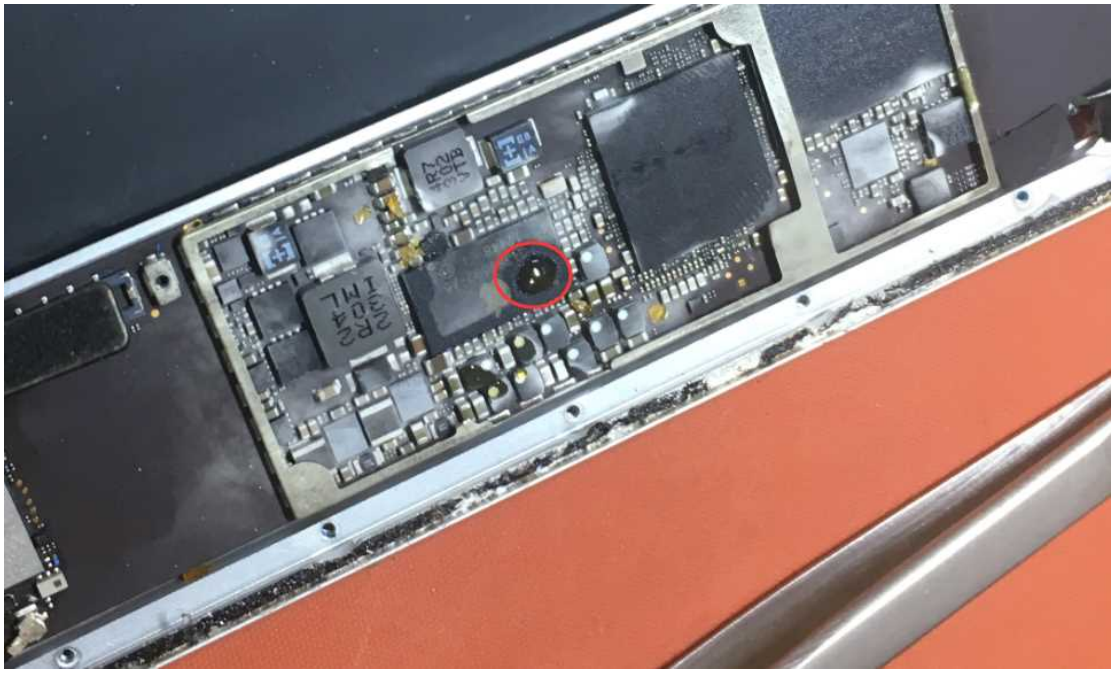
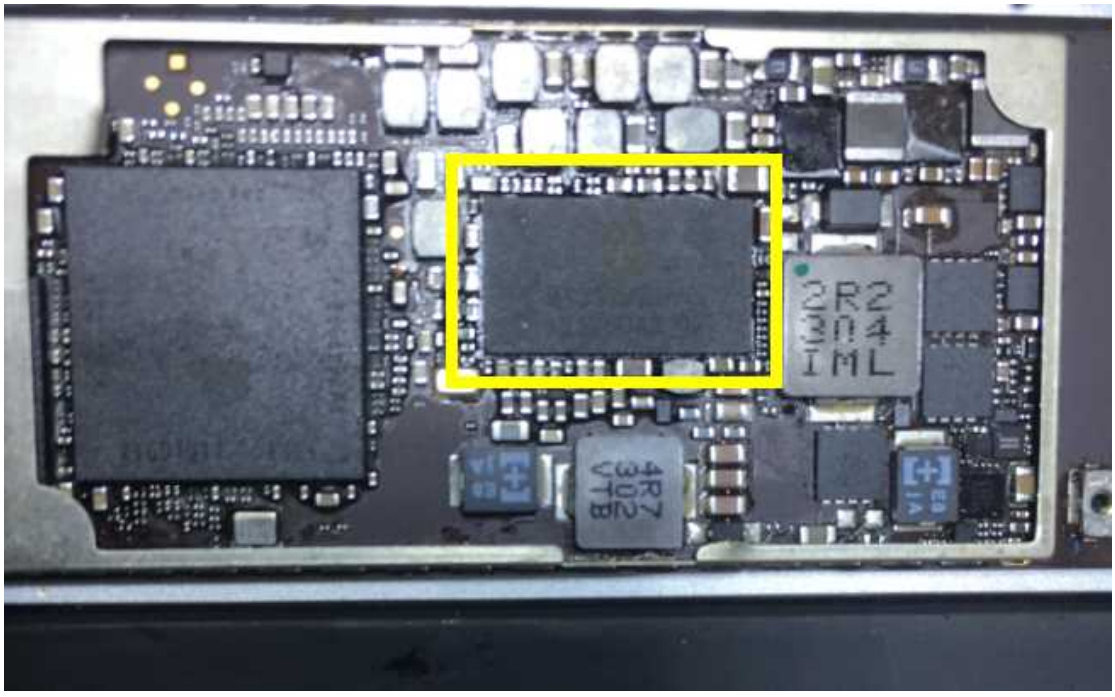
Repairing an iPadmini1 customer reflects the problem that the No Power ON power IC is hot.First open the machine to connect Adjustable Power supply, the standby current is above 1A.The power-off measurement PP_BATT_VCCVCC is normal for the ground value, and then the PP_VCC_MAINVCC is only about 50, and the normal value should be more than 300.First observe the VCC MAIN filter capacitor, there is no obvious burnout.Smoke the circuit connected to Colophony (Solder) to VCC MAIN.Power-on found that the power IC has obvious high temperature traces.Replace the power IC and test the power after the replacement.The current is normal, and the system interface is found to be unusable.Now the mini1 power supply on the market is mostly disassembled Reballing chip, the power supply may have a certain non-performing rate, and this phenomenon has been encountered before.Re-replace a power IC into the system to touch the normal, to this fault repair.
