Ipad mini2 no backlight

[Faulty model] ipad mini2

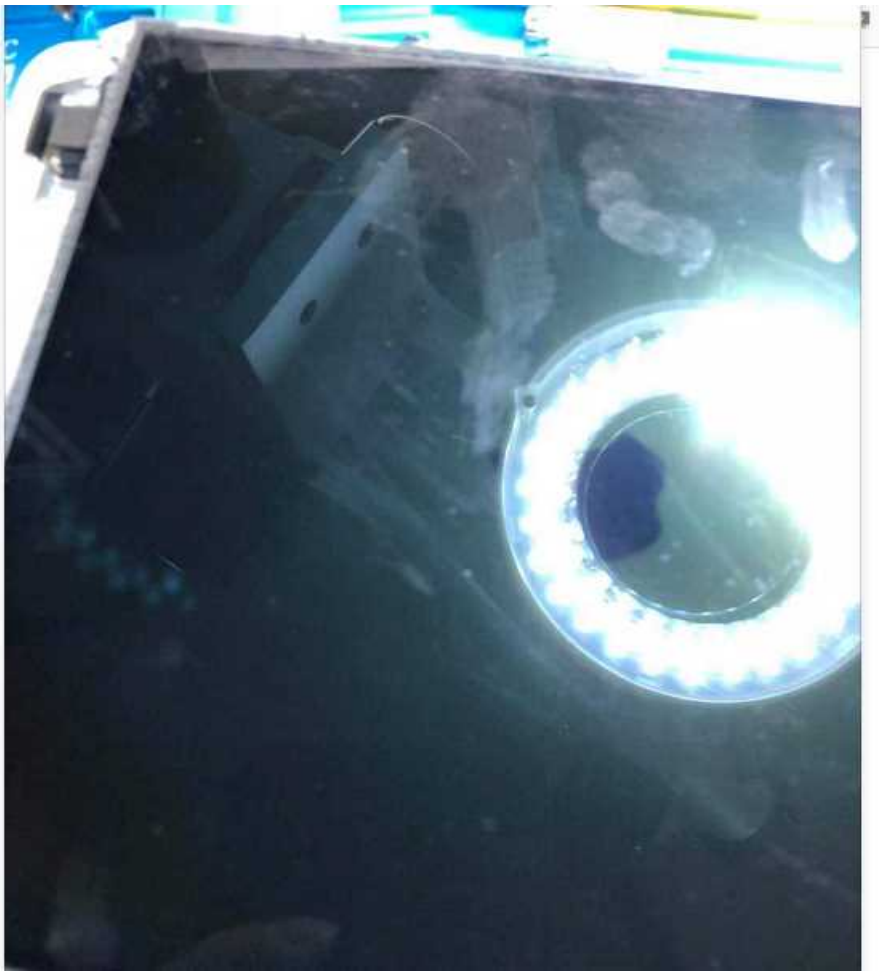
[Fault phenomenon] Customer description no backlight

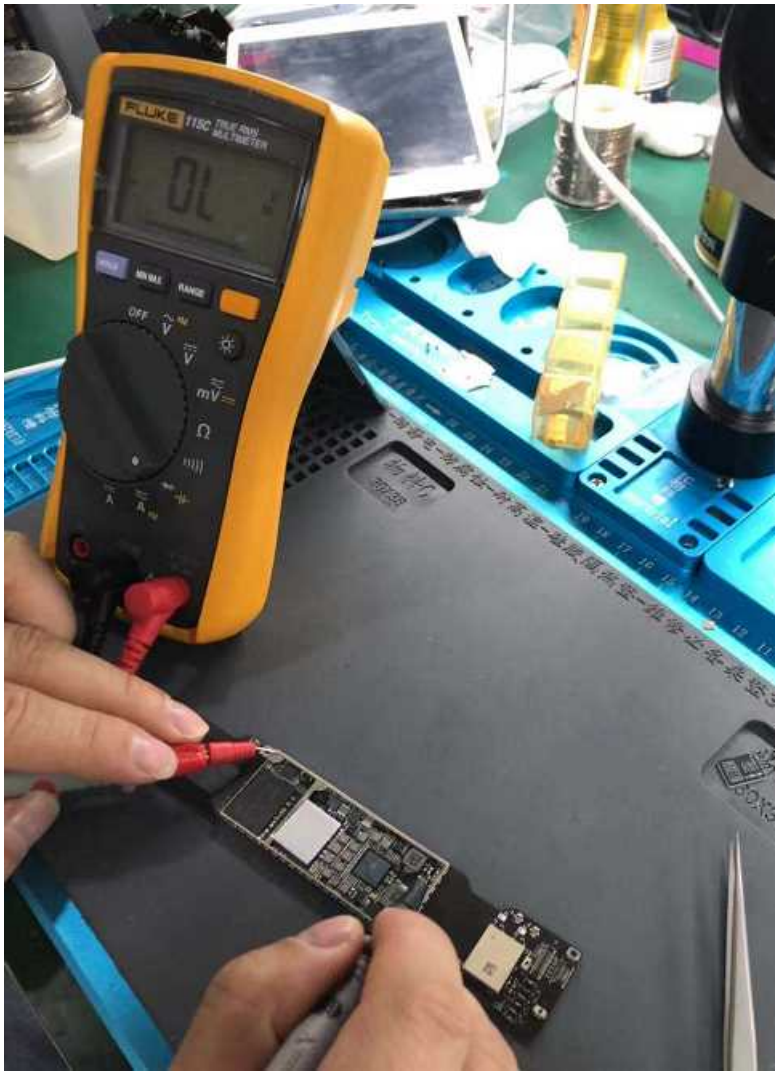
Disassemble the main board to detect the PPLED_BACK_REA_A circuit and find that the circuit is broken. The Inductor L2200 is burned out.Remove directly and short.

FLUKE 115C TRUE-RMS MULTIMETER
OL
RANGE
OFF

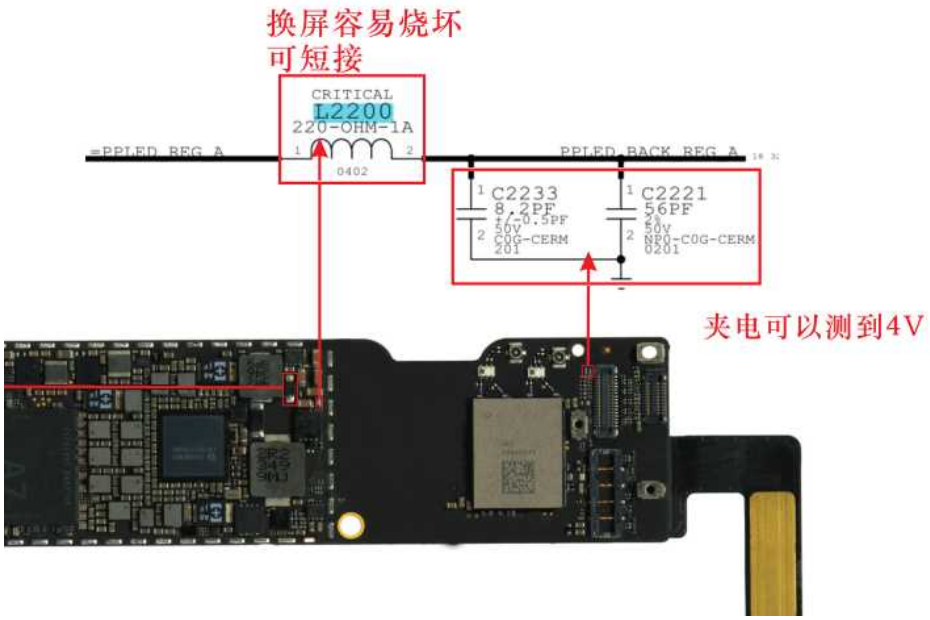
Screen change causes no backlight, and may change screen causing Inductor or diode burnout

换屏容易烧坏
可短接
CRITICAL
L2200
220-OHM-1A
0402
=PPLED_BEG_A
PPLED_BACK_REG_A
C2233
8.2PF
±0.5PF
50V
C0G-CERM
201
C2221
56PF
5%
50V
NP0-C0G-CERM
0201
夹电可以测到4V

[Maintenance result] After the short circuit, the successful bright screen repair is completed.
